Dakhleh Oasis Project
Columbia University
Excavations at Amheida 2008
Architectural Conservation Work

Architectural conservation work on the North Tower at Amheida was carried out from 16 to 23 February under the direction of Dr Nicholas Warner with the assistance of SCA Inspector Ibrahim ‘Abd al-Hamid Ibrahim and SCA Conservator Baha’a Goma’a Ahmed.

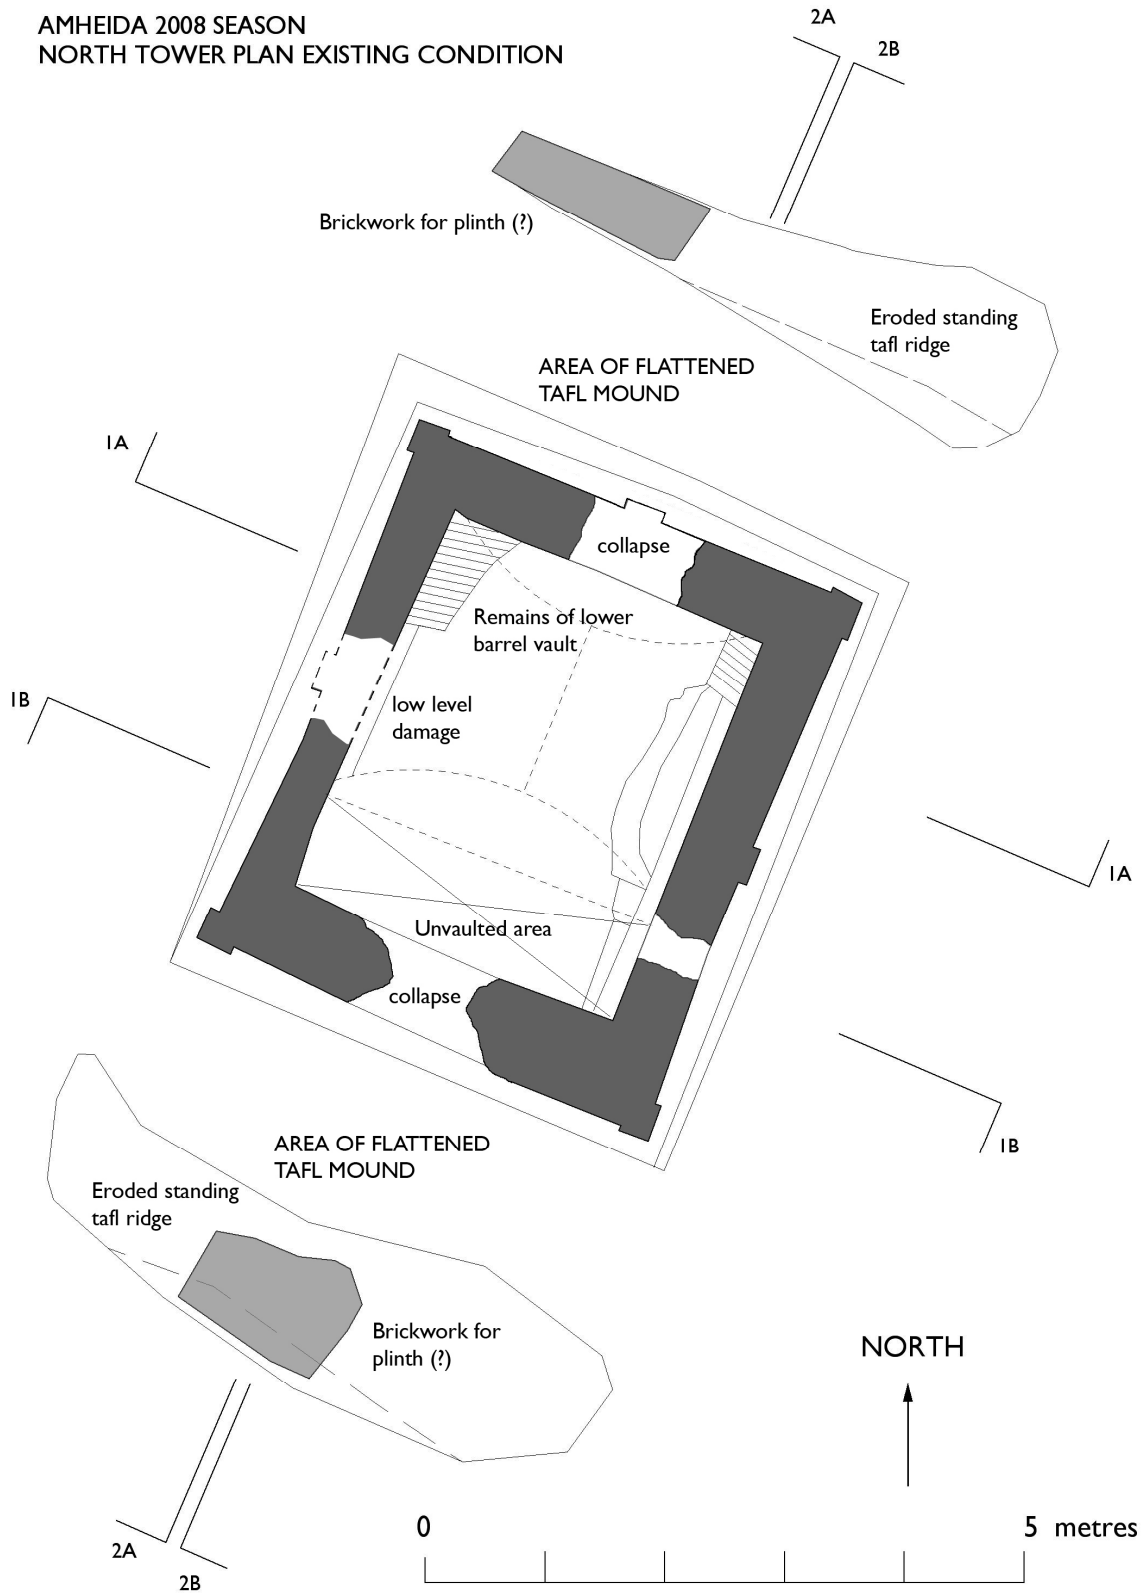
AMHEIDA 2008 SEASON
NORTH TOWER PLAN EXISTING CONDITION

plastered with mud and limewashed. A number of cracks were observed in the structure which are detailed on the attached drawings; the most severe running full height being on the west flank wall.

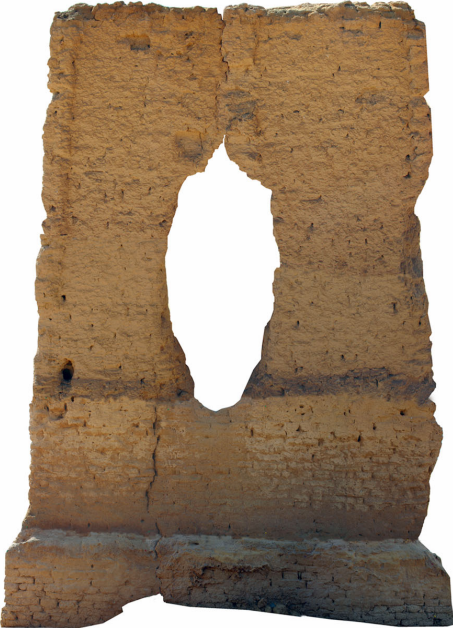
NORTH

The original entrance to the tower was at the floor level of the upper chamber, either to the north or the south. Both of these sides of the structure have substantial areas of loss in their fabric, but the relatively narrow area of loss on the north suggests that it is more likely that the entrance was on the south, where most of the wall has fallen away. This may mean that a niche may have occupied the lost area of brickwork on the north, as niches are most commonly and conveniently broken out to form doorways in the subsequent life of buildings in the Oases. Various robber holes and areas of collapse in the perimeter of the structure make a reconstruction of its original appearance difficult, but it seems that the exterior of the building was ornamented with pilasters. These are about 30cm wide and must have originally projected some 10cm from the face of each wall; they are located at the corners and at the centres of each respective elevation, excepting the south where the missing wall precludes any reconstruction except a stylistic one. The presence of the pilasters would indicate further, now lost, decoration in the form of bases and capitals and a cornice (perhaps a simple cavetto and torus moulding). The original entrance, now lost, may also have been framed by pilasters and had its own cornice. The height of the bases of the pilasters is aligned with the top of a set back of the section of the building corresponding with the assumed internal floor level above the barrel vault. A lower setback exists of 90 cm, or 12 brick courses, from external ground level. The exterior walls were undoubtedly originally

All openings due to collapse in the perimeter wall were filled with mudbrick in mud mortar to match the original bonding pattern as far as possible. On the north side, the infill provided the opportunity to reconstruct a section of the external pilaster on the external wall, and a shallow arched niche (hypothetical) on the internal wall. This niche (53 x 90cm to apex of niche head) is off-centred, being centred instead on the area of loss. The rebuilt wall follows the batter of the external façade.
