## **Amheida: Architectural Conservation and Site Development Work, 2004–2009**

Nicholas Warner

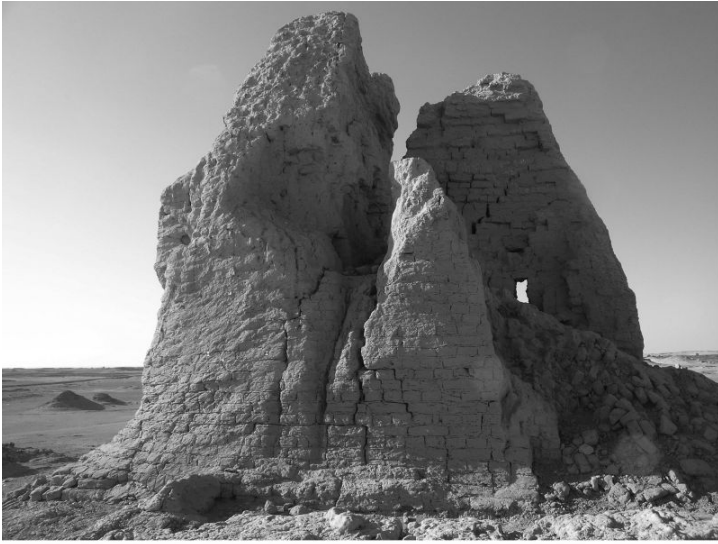
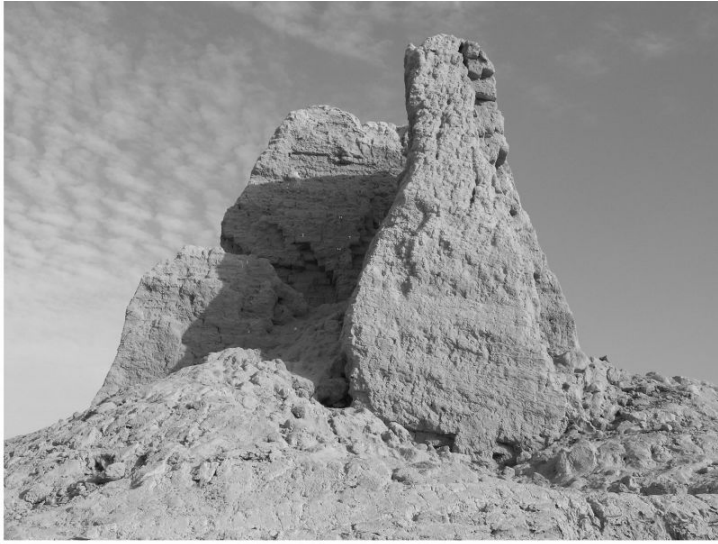
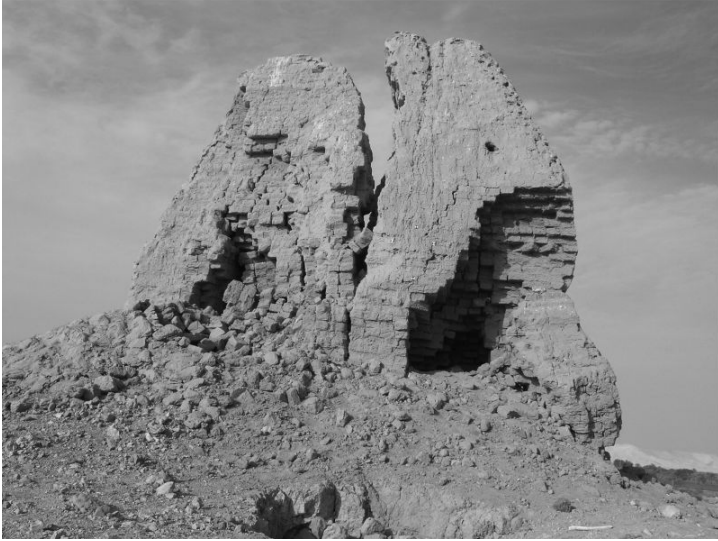
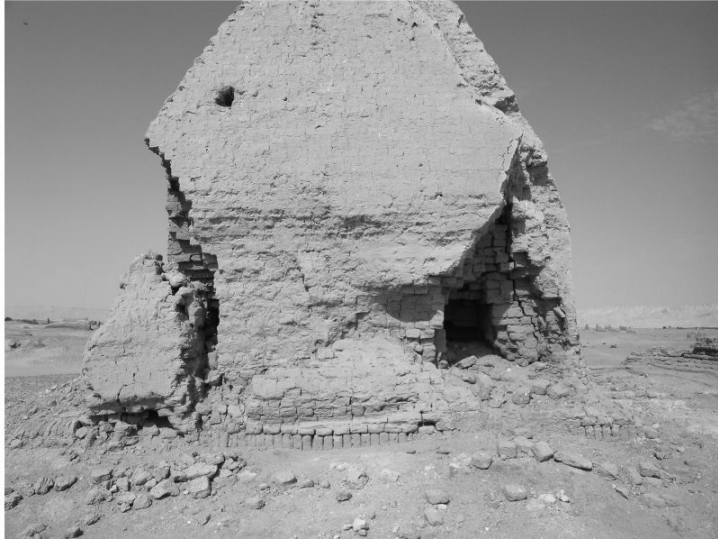
The pyramid stands on a low hill on the eastern edge of the site and is surrounded by the remains of a cluster of mud brick buildings, as yet unexcavated. These are most likely the remnants of an élite necropolis. Prior to conservation, the best-preserved faces of the podium and pyramid were those on the east, south and north sides (Plate 2). There had been significant wind erosion on the north side, and robbers had destroyed major areas of brickwork in the lower areas, particularly in the corners, causing further masonry collapse. The southeast corner of the pyramid itself was well preserved to a relatively high level. The remains of the west side of the structure were in a seriously unstable condition, however, either due to the undermining activities of robbers or subsidence caused by the structural failure of internal chambers. There was the real possibility of the collapse of this section of the structure. No external plaster survived anywhere on the pyramid.

Fig.2 The pyramid prior to consolidation (author's photos).

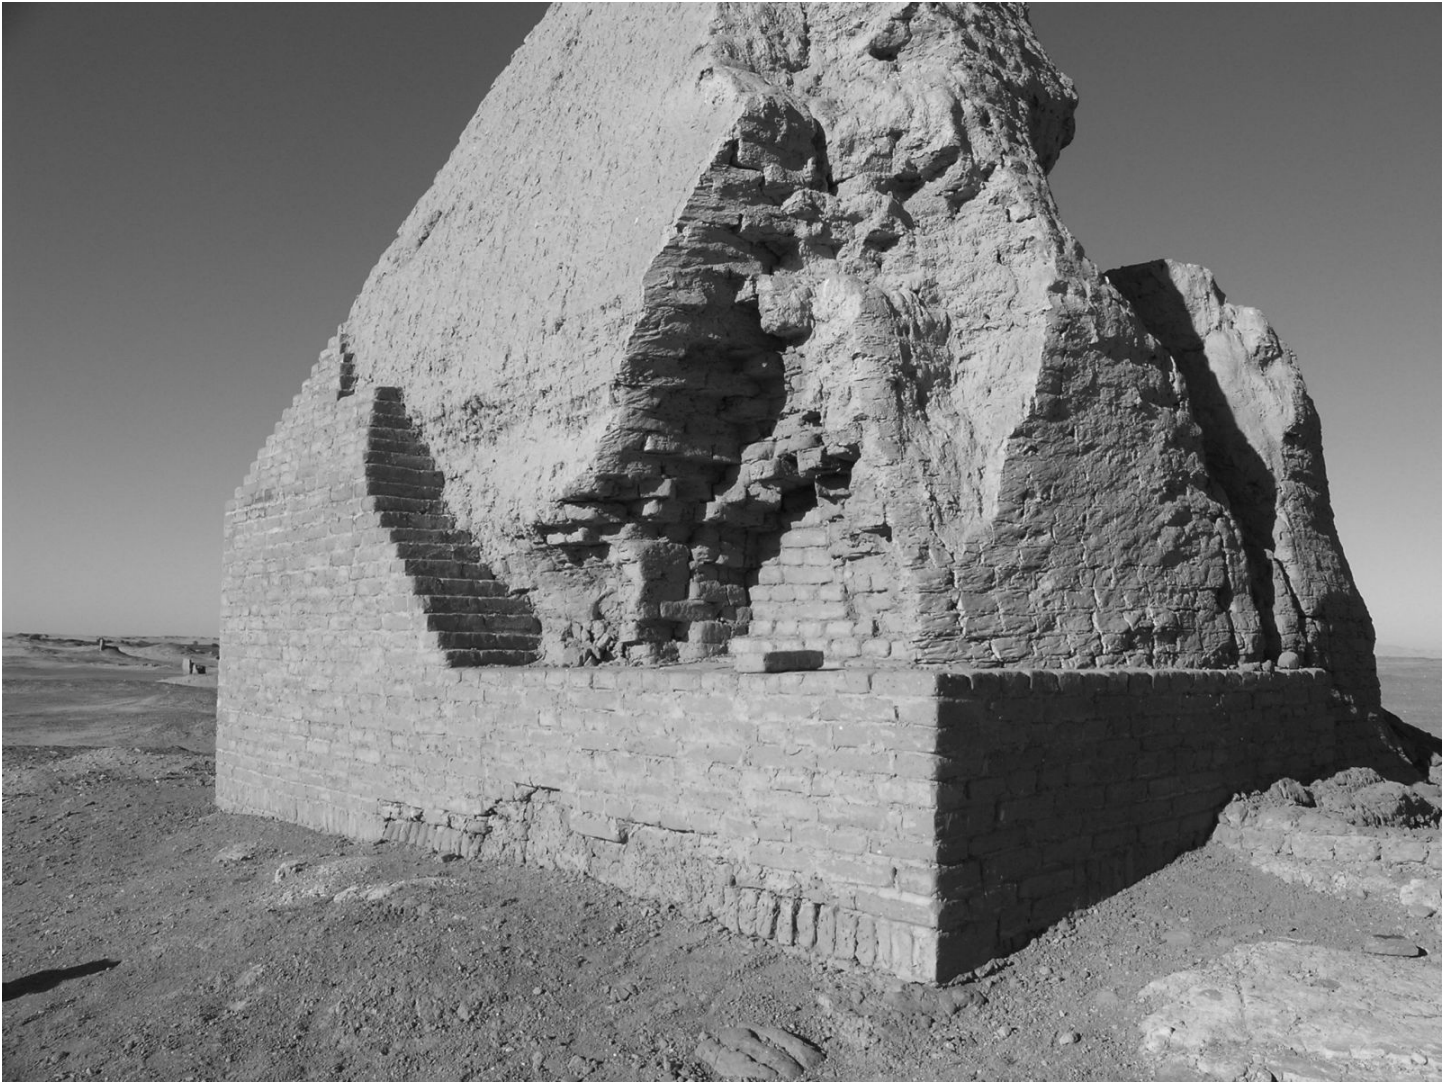
Consolidation of the northeast and southeast corners of the pyramid, which had been seriously damaged by the penetration of robbers' holes, commenced in 2006 (Plate 3). These holes had caused the collapse of significant sections of the corners, leaving the remains in a highly unstable condition. Some clearance of the robbers' holes was carried out to establish a secure base for new brickwork, but threat of further collapse prevented a full excavation of these holes from being carried out. An investigation of a large robbers' tunnel immediately to the south of the pyramid proved that this shaft was substantially blocked by fallen rocks, and it would have been hazardous to reopen it, as the rock is extremely friable in this area. This tunnel was accordingly backfilled. A limited excavation of the southeast section of the pyramid revealed the presence of the original corner, allowing the dimensions of the base to be accurately established in conjunction with the surviving few courses of the northeast corner. The line of the south face of the pyramid was also found through excavation, while the north and east faces were still partially visible above ground level. Severely wind-eroded bricks on the faces were replaced with new bricks wherever a secure bond between old and new brickwork was required. The brickwork was carried up to a temporary level of one meter on the northeast corner. In the southeast corner the brickwork was continued to a height of 2.2 meters, which formed the plinth for the original angled setback of the pyramid. The setback itself was reconstructed to a height of 1.2 meters above this base line.

Fig.3 The north-east corner of the pyramid after the first season's consolidation (author's photo).

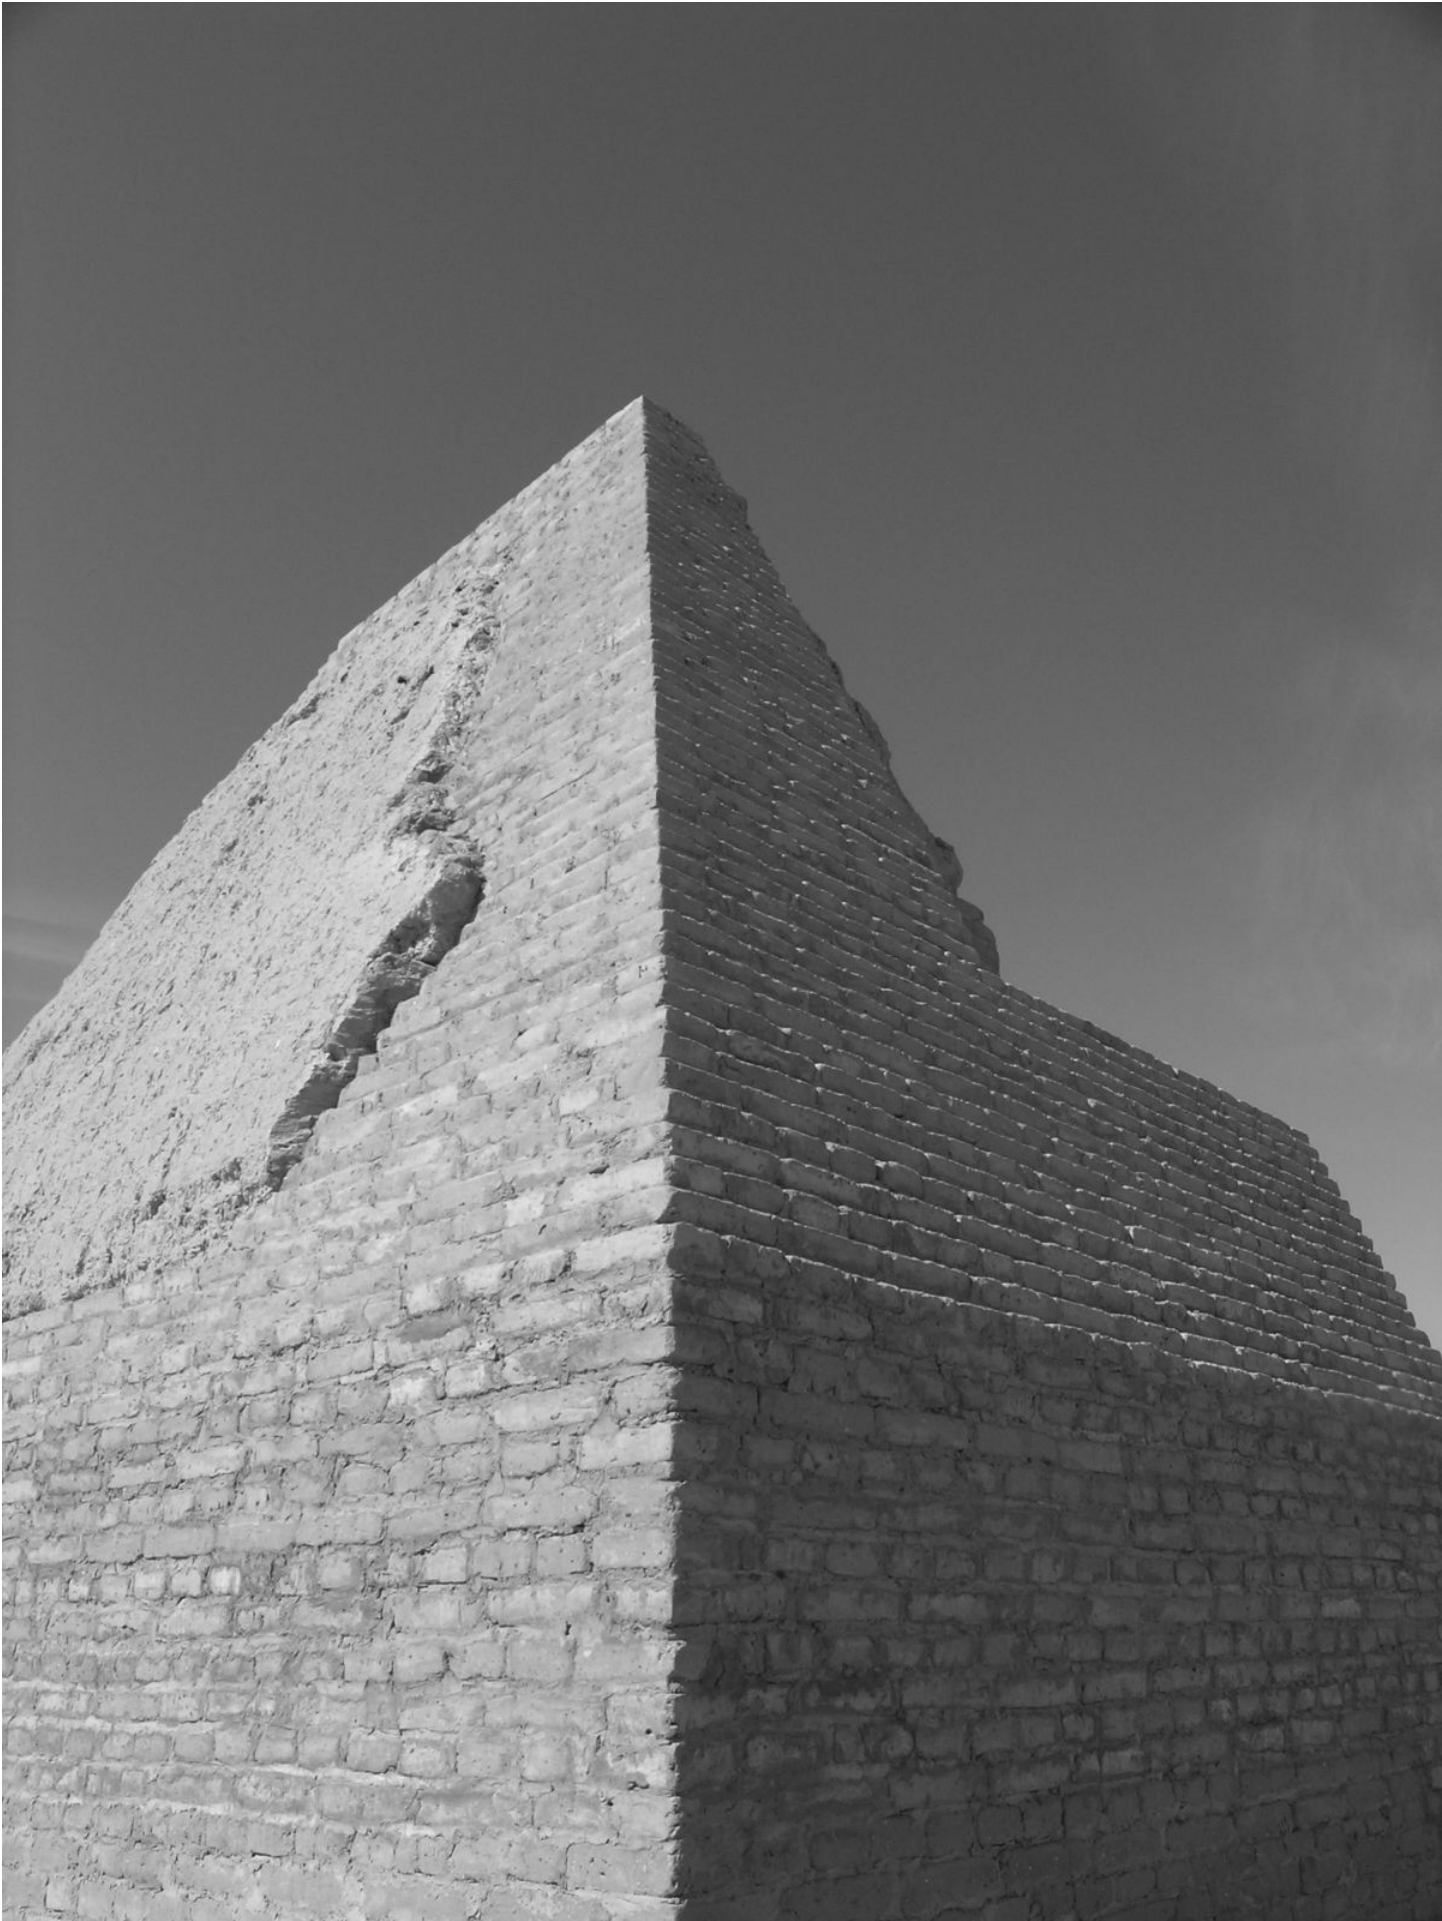
The northeastern corner of the pyramid was also rebuilt above the line of the base, following an angle of inclination that was arrived at by eye rather than any geometrical calculation. This had to reconcile the two distinct angles used in the construction of the original pyramid: an initial, extremely steep angle which, at a height of approximately 1.2 meters above the top of the plinth, was adjusted to a lesser angle. This was presumably done, as at the Bent Pyramid of Dahshur, to correct the angle of inclination once it was realised that it would result in an excessive, not to say impractical, total height for the completed structure. The correction also suggests that the construction was started without any prior mathematical calculation of the precise angle of inclination. A single line for the corner was therefore adopted, set back by between 10 and 15 centimeters, which permits the easy appreciation of this subtle feature of the original construction (Plate 4). Another feature of the original building that was replicated in the consolidated sections of the base was the use of diagonal courses of masonry within the core of the structure. These courses appeared randomly in the original structure, and were presumably intended to provide greater strength through cross-bonding the brickwork.

Fig.4 The north-east corner of the pyramid after consolidation showing change of in angle of inclination of original brickwork (author's photo).

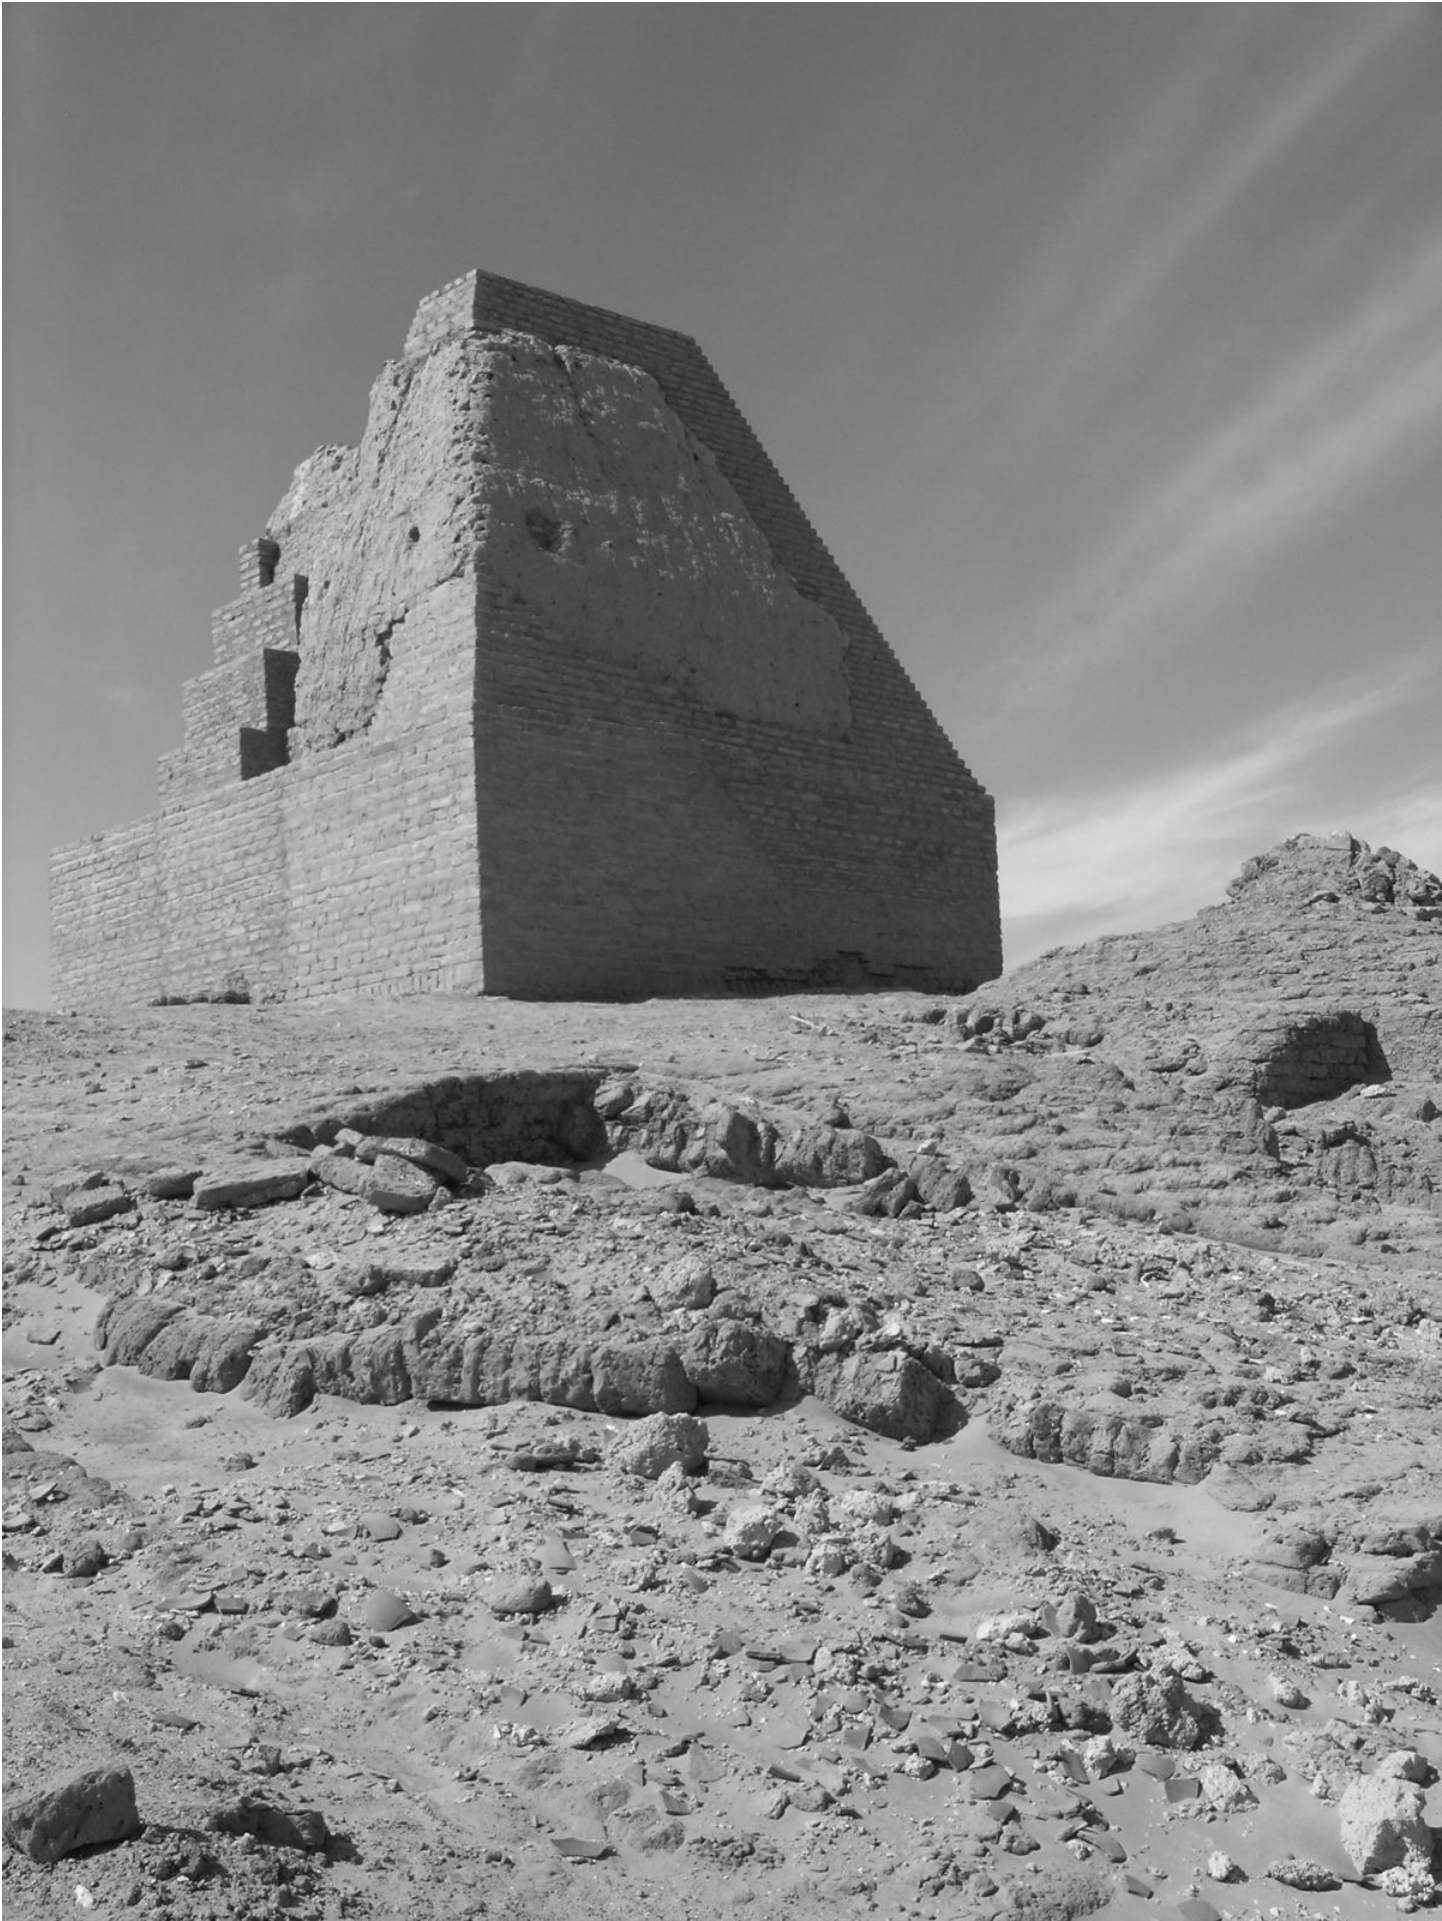
Fig.5 View of pyramid from south-east after consolidation (author's photo).

The consolidation of the second tier of masonry on the north side of the pyramid was designed to deny visitors the opportunity of climbing the pyramid after conservation and at the same time to provide for scaffolding access to the top of the structure during the works. The crown of the surviving masonry on the east face was capped with new brickwork to retard erosion. This capping, combined with the rebuilt north-east corner of the structure, contributes greatly to the realisation of the overall silhouette of the pyramid while adding as little new material as possible (Plates 5 and 6).

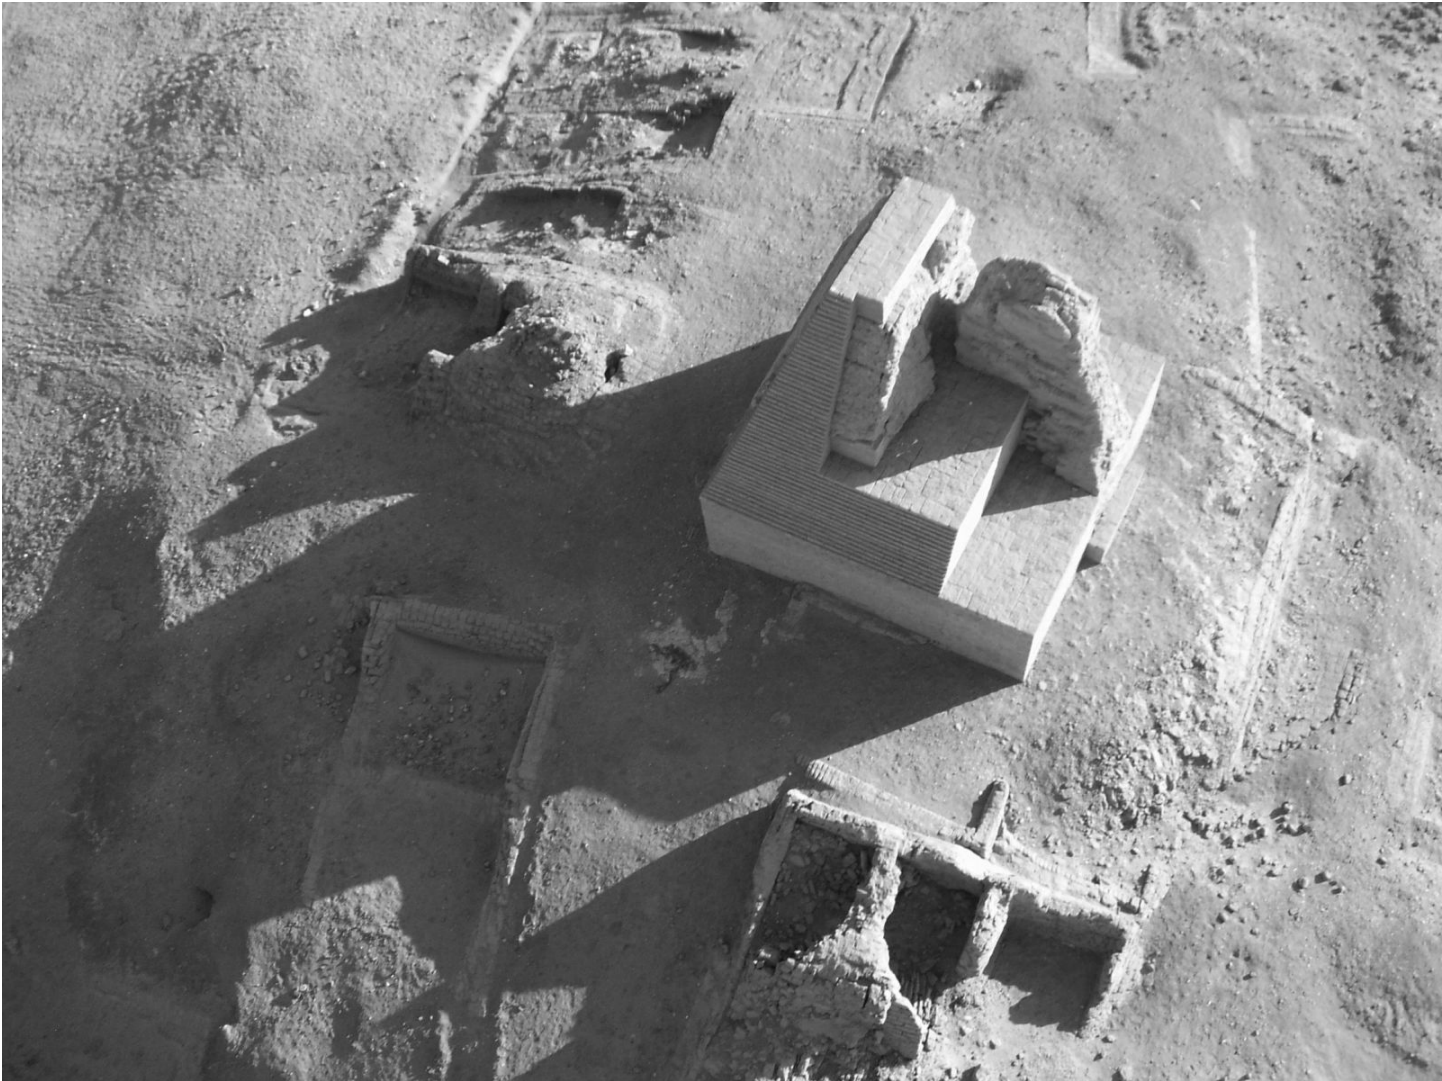
Fig.6 Aerial view of consolidated pyramid from the north (photo: John Ruffle).

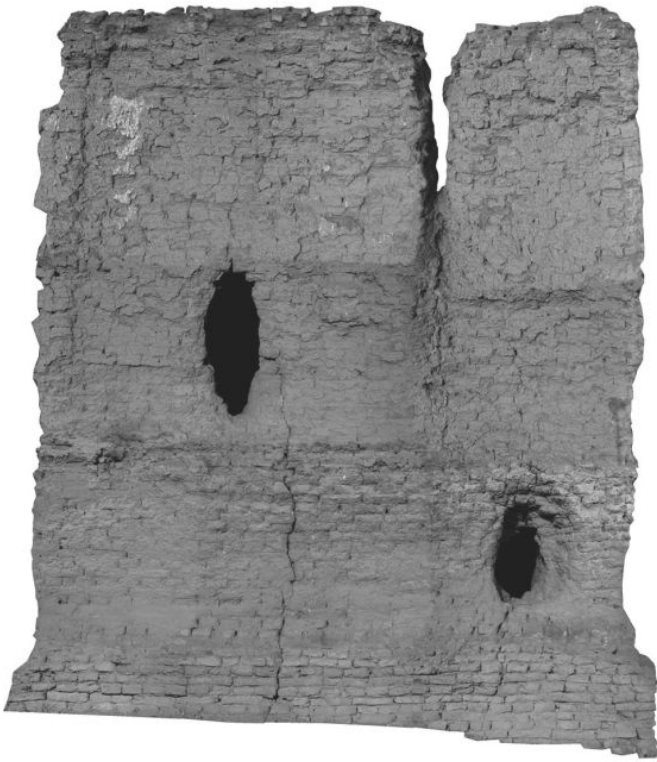
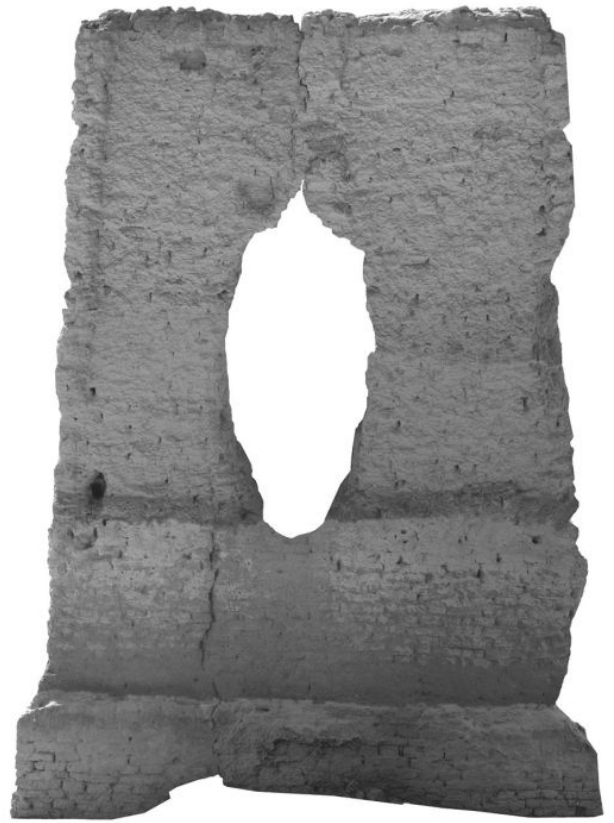
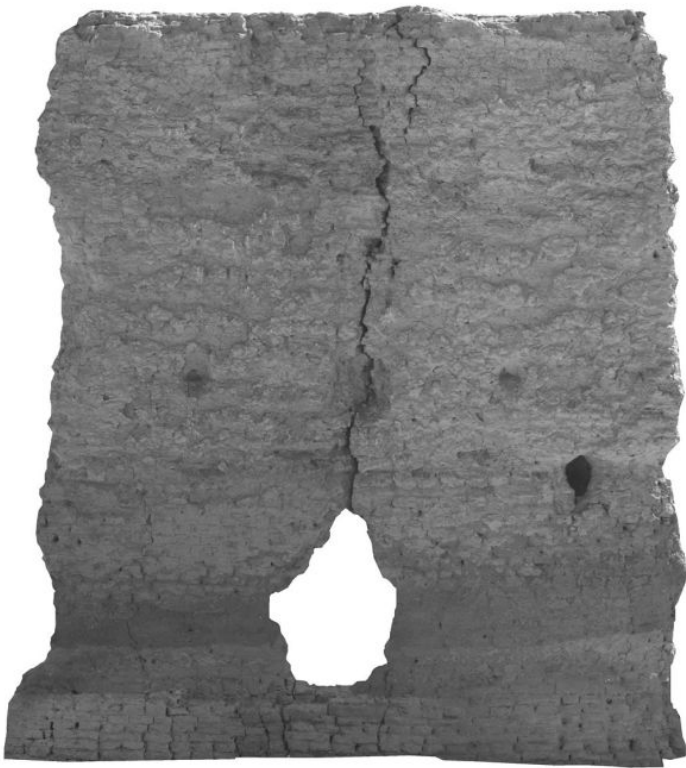
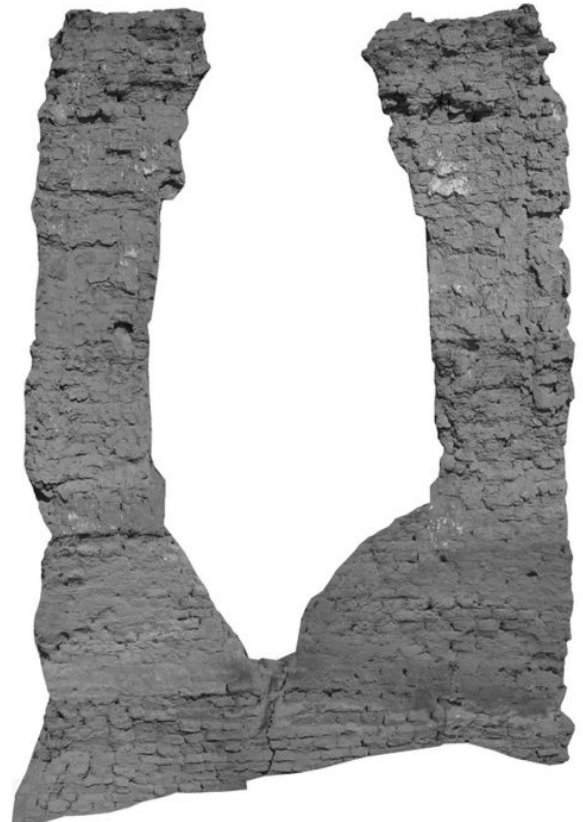
and torus moulding). The original entrance, now lost, may also have been framed by pilasters and had its own cornice. The height of the bases of the pilasters is aligned with the top of a set back of the section of the building corresponding with the assumed internal floor level above the barrel vault. A lower setback exists of 90 cm, or twelve brick courses, from external ground level. The exterior walls were undoubtedly originally plastered with mud and limewashed. A number of cracks were observed in the structure, the most severe being on the west flank wall running the full height of the structure.

Fig.7 Rectified photography of tower elevations before consolidation (photos: Fabrizio Pavia and Silvia Maggioni).

Following the preliminary survey (Plate 7) and photogrammetric recording, consolidation work proceeded in 2007 using the same materials and techniques employed on the structure of the pyramid. All openings due to collapse in the perimeter wall were filled with mud brick in mud mortar to match the original bonding pattern as far as possible (Plate 8). On the north side, the infill provided the opportunity to reconstruct a section of the external pilaster on the external wall, and a shallow arched niche (hypothetical) on the internal wall. This niche (53 x 90 cm to apex of niche head) is slightly off-centered, being centered instead on the area of loss. The rebuilt wall follows the batter of the external façade. On the south side, a painted steel grille double door with padlock was installed at the presumed level of the original entrance. Acacia wood (*sunt*) lintels, treated against insect attack with sump oil, were provided for this opening. Access to the interior is now only gained by ladder. The springings of the pendentive dome were consolidated or reconstructed following the original design of four consecutive rebates (Plate 9). The fifth rebate was created in the same manner, rather than following the original concentric rings of infill brickwork for reasons of ease of construction. This work was mostly carried out on the south internal elevation above the new door, but a small section of the east elevation was also repaired in the same way. After consideration it was decided not to stitch the crack on the west flank wall, as the areas of surrounding masonry had been consolidated. No sign of further movement has subsequently been detected.

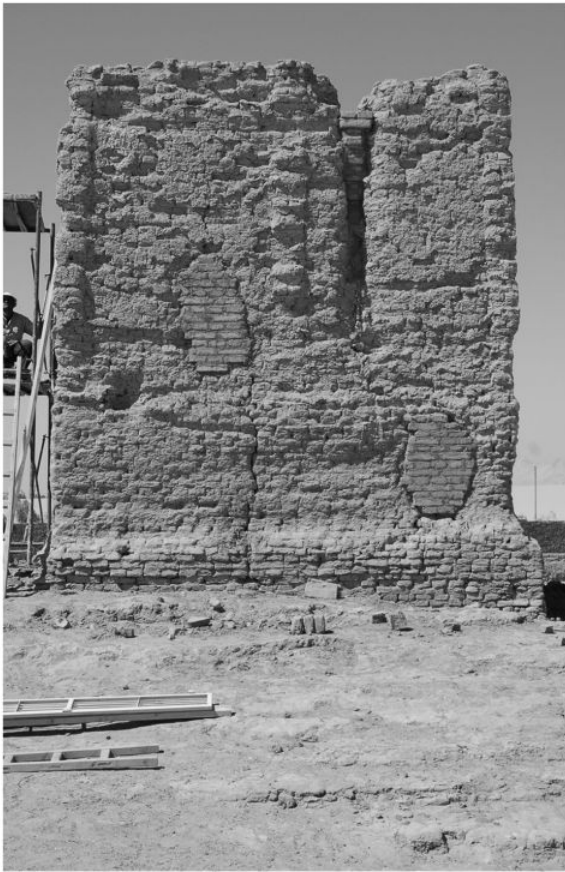
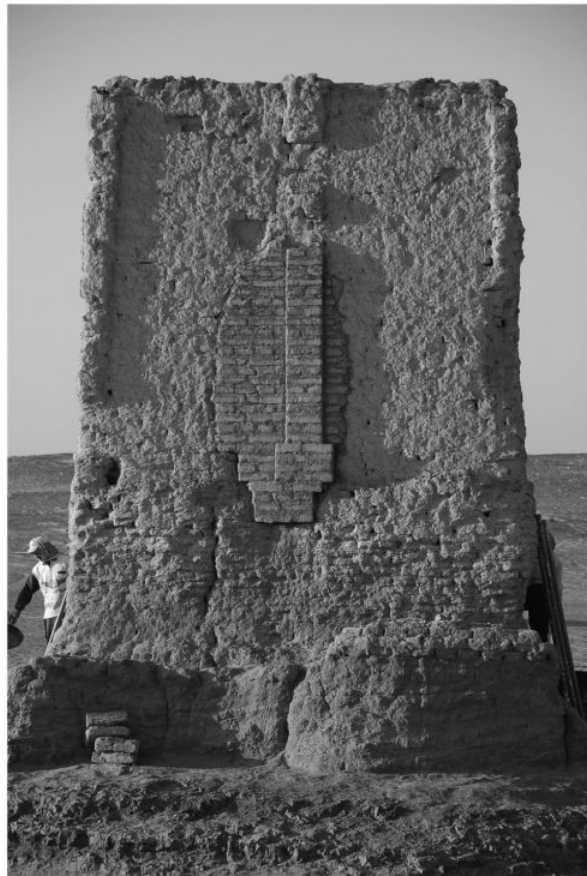
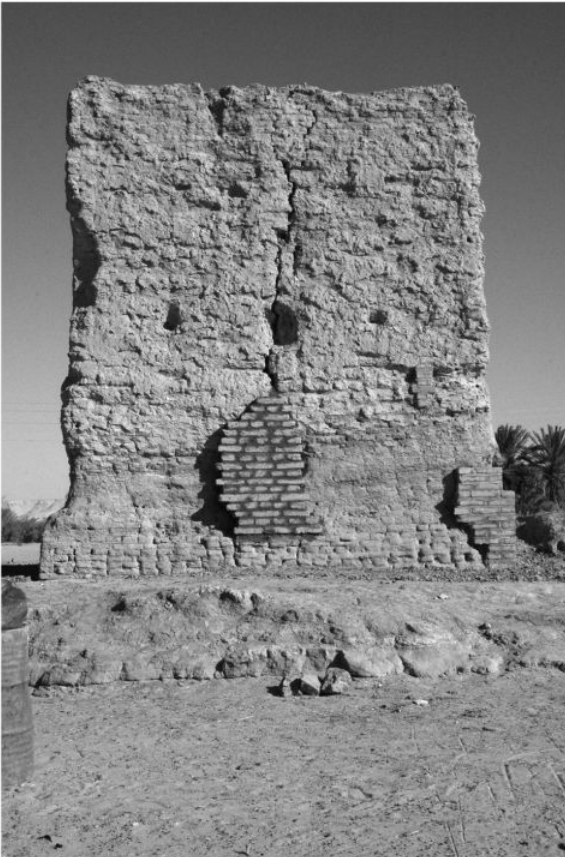
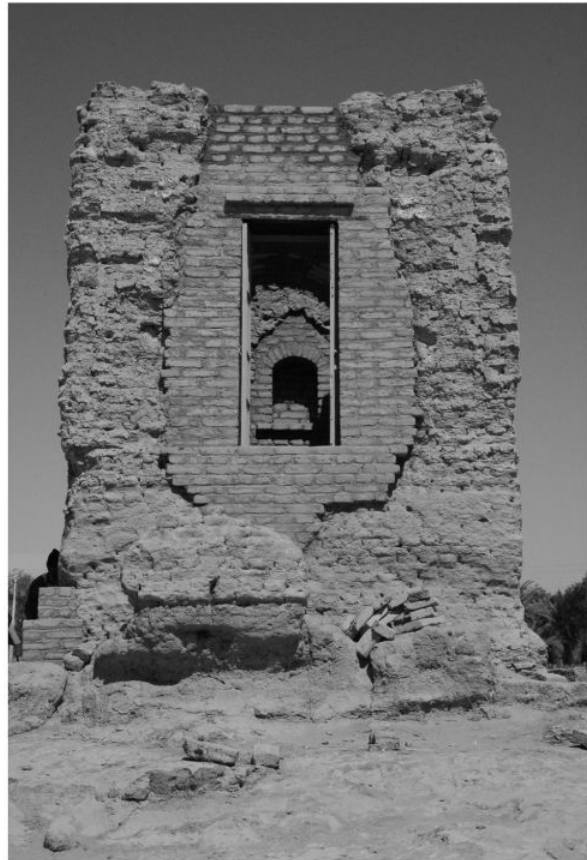
Fig.8 Views of tower elevations after consolidation (author's photos).

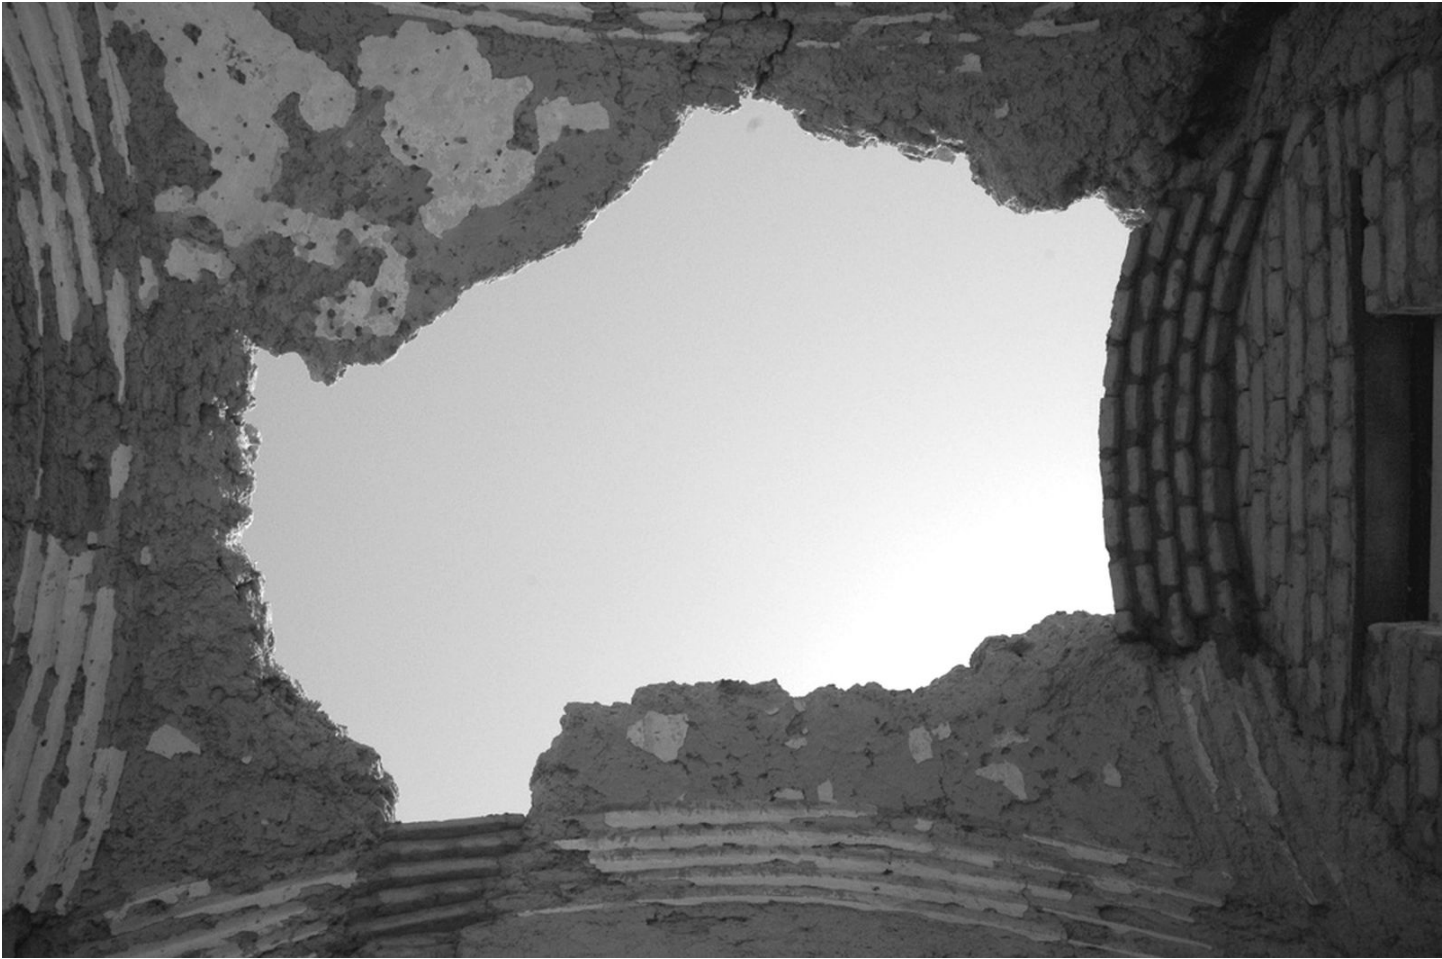
Fig.9 Rebated pendentive dome of tower after consolidation (author's photo).

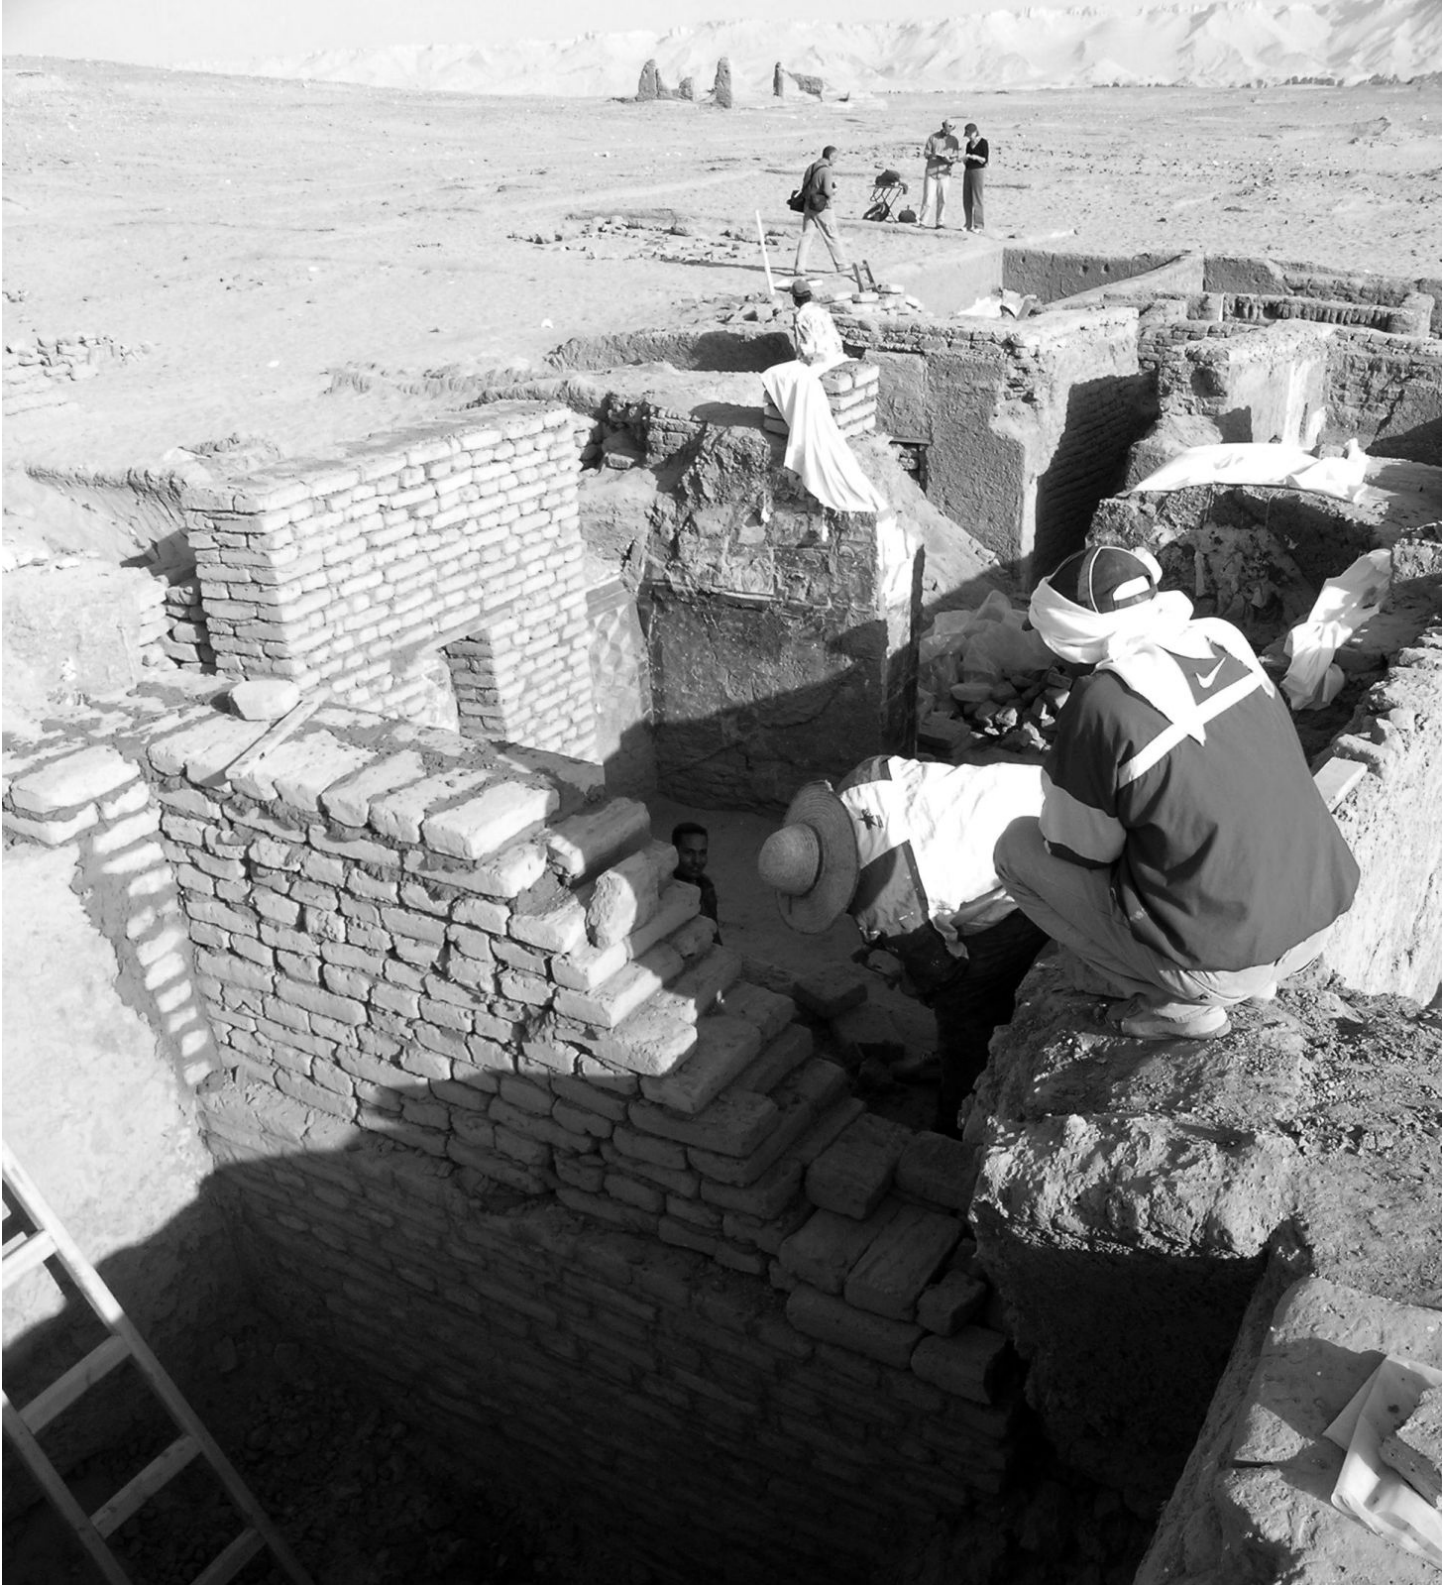
Fig.10 House of Serenos: consolidation of mud brick masonry of south wall in progress (author's photo).

still adhered to some of the internal surfaces.<sup>3</sup> This was intended to improve the stability of the structure and to facilitate the compartmentalised “room by room” method of excavation and backfill. New brickwork was used in the reinstatement of the missing south wall of the main domed room of the house (Plate 10). The existing bonding pattern was replicated wherever possible, although the original brickwork was of a variable character with many inconsistencies in sizes and coursing of bricks. Elsewhere, new mud brick blocking walls were built to divide the excavated from the unexcavated areas and to create a series of protected compartments within the area of the house. A temporary shelter was also built over the main space of the house, made of timber and palm ribs, to discourage unauthorized excavation and viewing out of season.
