## **Ain el-Gedida 2008 Excavations**

### **SCA Report**

The 2008 excavation season at the site of Ain el-Gedida (Dakhleh Oasis Project site no. 31/405-N3-1) was carried out from 8 January to 14 February 2008 by a team sponsored by Columbia University, under the direction of Professor Roger Bagnall.

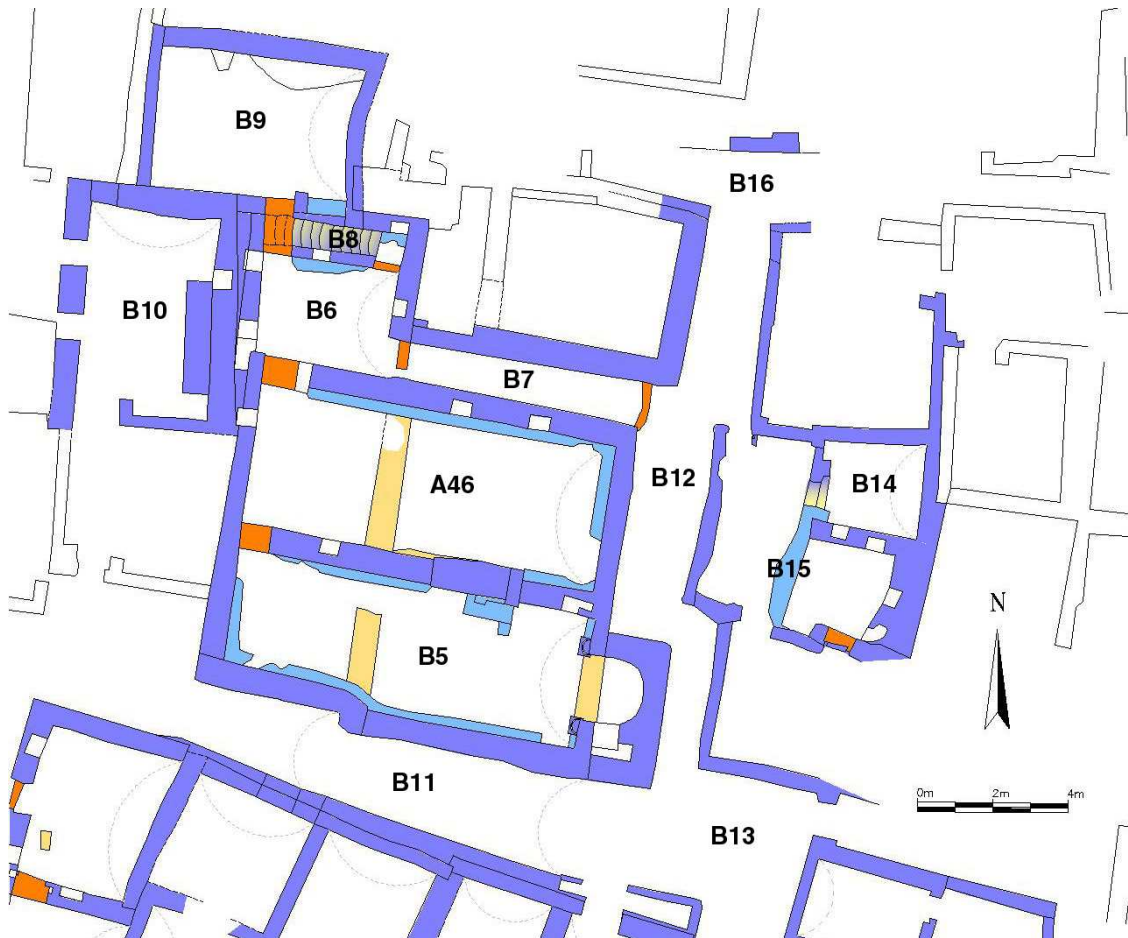
Plate 1: church complex and new rooms excavated in 2008.

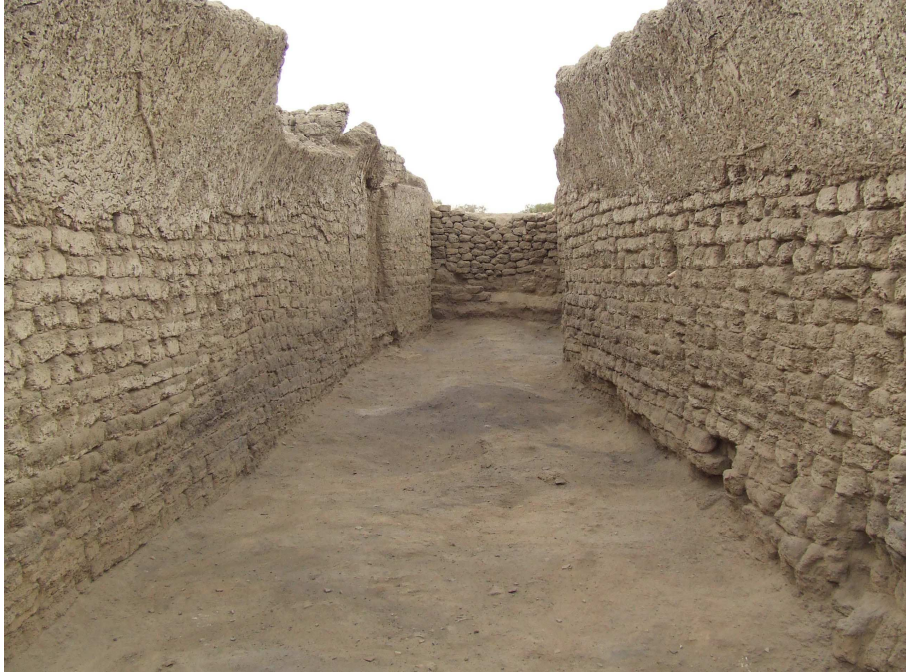
Plate 3: vaulted passageway B11 (view to the W).

A long, E-W oriented passageway (B11) was excavated to the south of the church, along the north edge of area A (excavated by the SCA in the 1990s). It measures approximately 10.76 m E-W by 2.15 m N-S and has walls preserved to a maximum height of 2.09 m. It was originally vaulted, as significant remains of spring vaults are still extant. The passageway, leading from the east to the west half of Mound I, is not perfectly rectilinear; the western sector seems to have been built at a later time, with its two walls (and the vault springs on top of them) having a slightly different orientation from the eastern half of the corridor. A door, originally opening into room A16 (unexcavated) to the SW of the corridor, was bricked in at some point before the construction of the western vault.

A floor of compacted mud, with several organic inclusions and small pottery fragments, was found below layers of sand, organic deposits, and ash. The presence of animal coprolites and signs of wear along corner walls suggest that the passageway was accessible not only to men but also animals and carts.

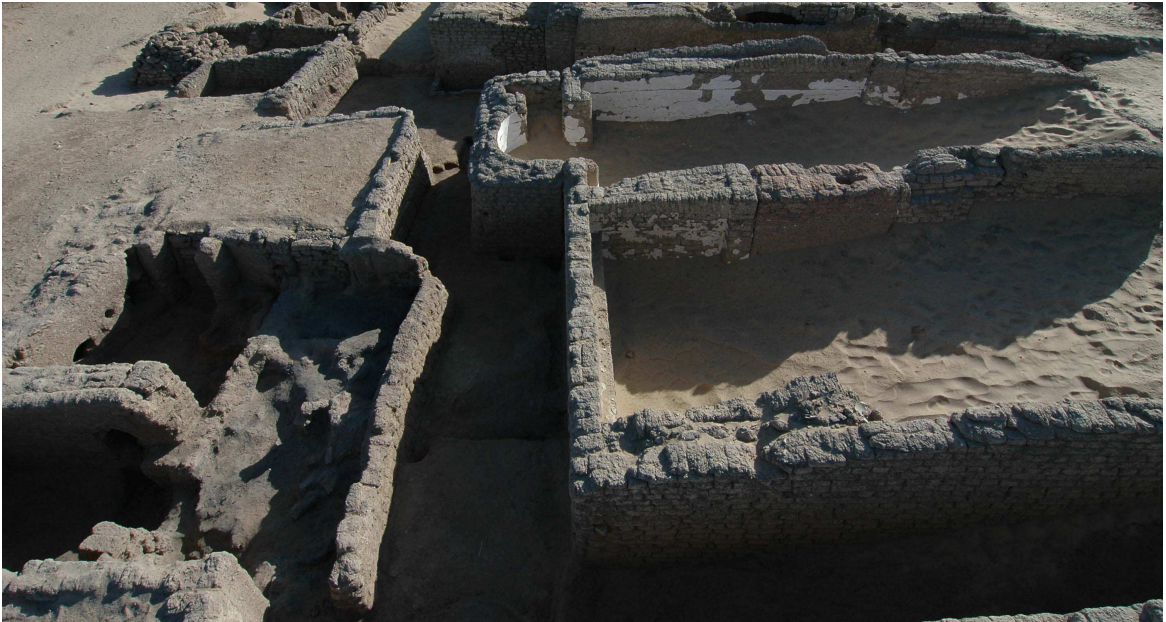
Plate 4: excavated area to the E of the church complex (aerial view to the S).

The excavation was first carried out in the area immediately to the south and to the east of the church complex, with the goal of ascertaining the topographical relationship of the complex with the surrounding buildings, within the urban fabric of the main mound of Ain el-Gedida (plates 3-4).

To the east of the church, a long N-S oriented street (B12, measuring 14.75 m N-S by 2.04 m E-W, with walls preserved to a maximum height of 1.90m) was excavated. The street has an irregular layout, due to the different constructional phases of the buildings whose walls define its outline (cf. description of room B15 below). Three sectors, all running N-S and joined among them, formed the street: one to the north, stretching northward from the eastern end of corridor B7 and crossing another E-W passageway (B16), which is the northern boundary of B12 and was excavated only in part this season; a central area lying to the east of room A46; and a third sector running along the east side of the church (room B5) and ending to the south into room B13, an open-air courtyard at the crossing of B11 and B12. The investigation revealed scattered remains of several

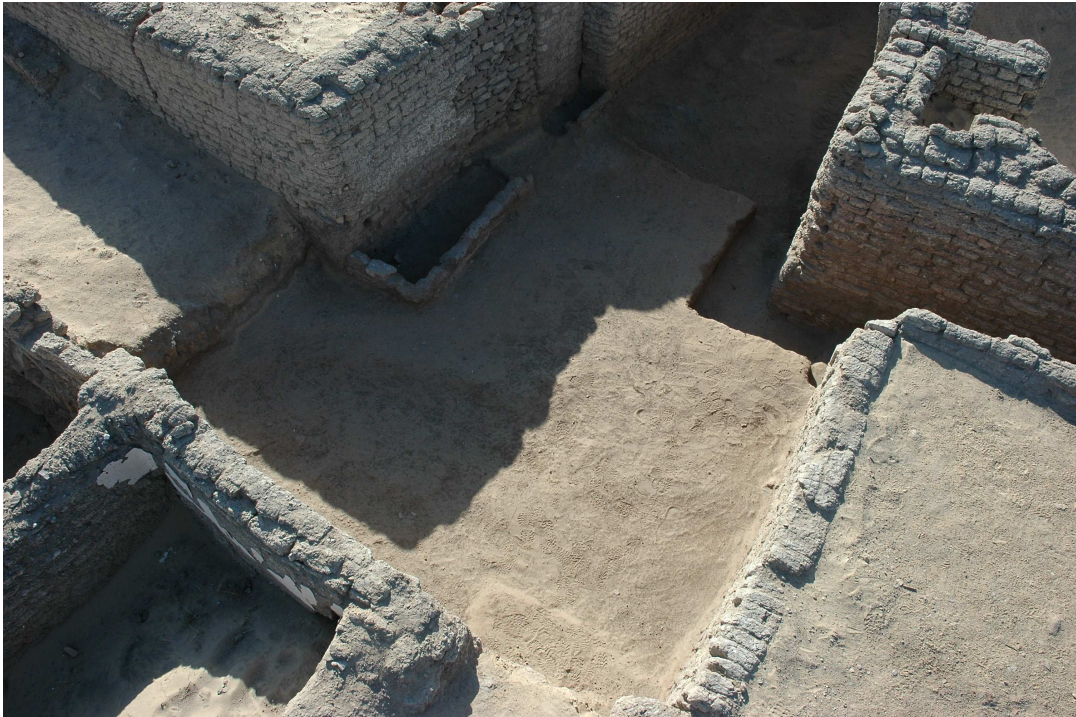
Plate 5: room B13 (aerial view to the SW).

To the south, street B12 led to room B13, which is an open-air courtyard at the intersection of streets B11 and B12 (plate 5). B13 is roughly rectangular and measures 4.45 m E-W by 3.41 m N-S, with walls preserved to a maximum height of 2.10 m. This space also opens onto an unexcavated area to the east and to a N-S passageway (A34) partially excavated in the mid-1990s. A doorway, located along the south wall of B13 connects the courtyard with unexcavated room A19 to the south. Two mud-brick basins were found at floor level to the sides of a doorway opening onto B13 along its south side (plate 6). Their function has not been ascertained beyond doubt, yet. Patches of floors belonging to at least three different phases were identified throughout the room.

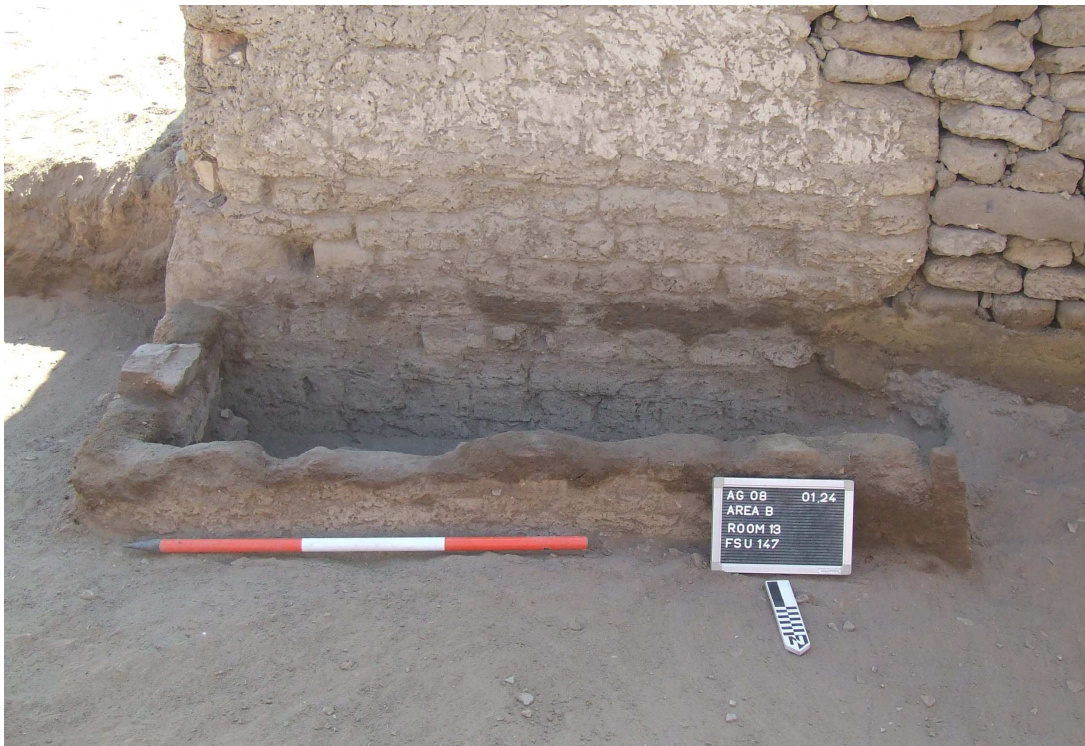
Plate 6: rectangular mud-brick feature along the S wall of room B13 (view to the S).

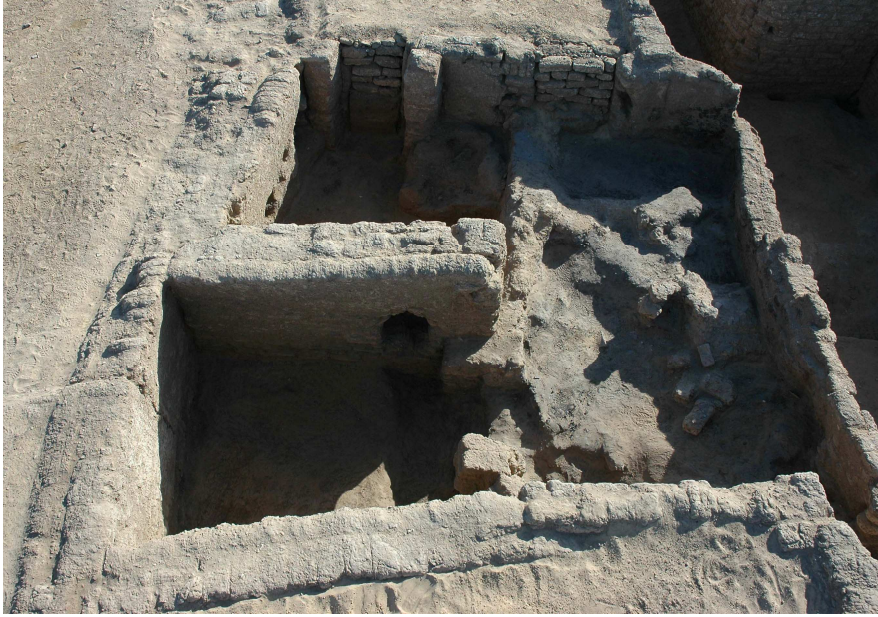
Plate 7: rooms B14-15 (aerial view to the S).

After the area including streets B11-12 and room B13 was completely excavated and documented, the investigation was extended further east, in the vicinity of the entrance to the church complex. A set of two interconnected spaces was dug, i.e., rooms B14-15 (plate 7). B15 is an L-shaped room, measuring approximately 4.81 m E-W by 4.55 m N-S and has walls preserved to a maximum height of 1.97 m. Three floor levels, visible in the south-east part of the room are evidence of different occupational phases. The removal of a large collapse in the western part of B15 revealed significant remains of substructures related to the presence of ovens, whose traces are still visible on the surrounding walls. Other evidence for the identification of the room as a kitchen was the clay stove found against the wall separating room B15 from B14. The west and the south-west walls were poorly constructed and seem to be the result of an enlargement of room B15 protruding into street B12, which possibly happened at the same time or after the apse was added to room B5, to the south-west of B15. Three niches were built within the E wall of room B15 (the wall seems to have been built as a thick facing against an earlier N-S wall): a small niche in the center, about the size of an oil lamp, and two larger ones to the sides.

These two side niches are connected inside and form one storage space. Another niche is located within the south face of the E-W wall (possibly plastered at some point) that divide room B15 from room B14. A small doorway located at the north-west corner of B15 allowed for the passage from this room onto B12, near the main entrance to the church complex. Two other doorways once led onto an unexcavated space to the south. No evidence of any roof was found *in situ* or inside room B15; also, the presence of ovens suggests that it was an open-air space.

B14 is a fairly small room (2.69 m E-W by 2.31 m N-S), located to the north-east of room B15 and originally opened onto it through a doorway that was found shifted from its original location and that had partly collapsed in antiquity. The maximum height of the walls is 1.97 m. The room bears traces of two floors and possibly served as a storage facility for kitchen B15. A test trench was excavated down to gebel along the doorway on the N side of the room.

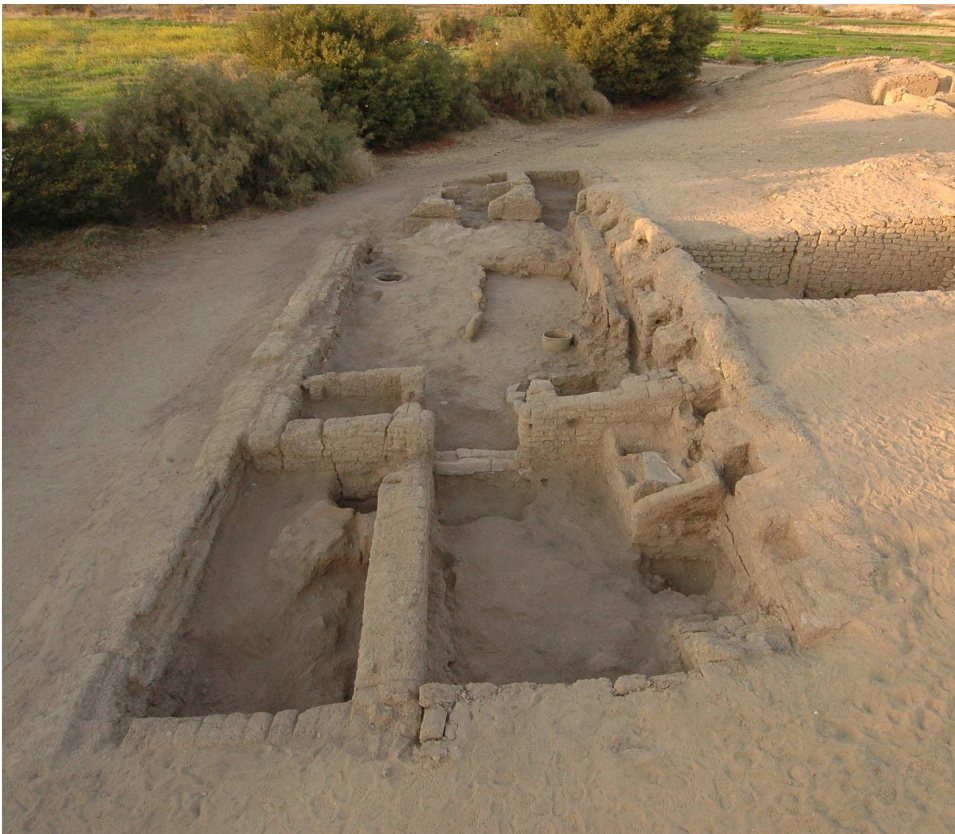
Plate 8: excavated area along the W edge of Mound I (aerial view to the N).

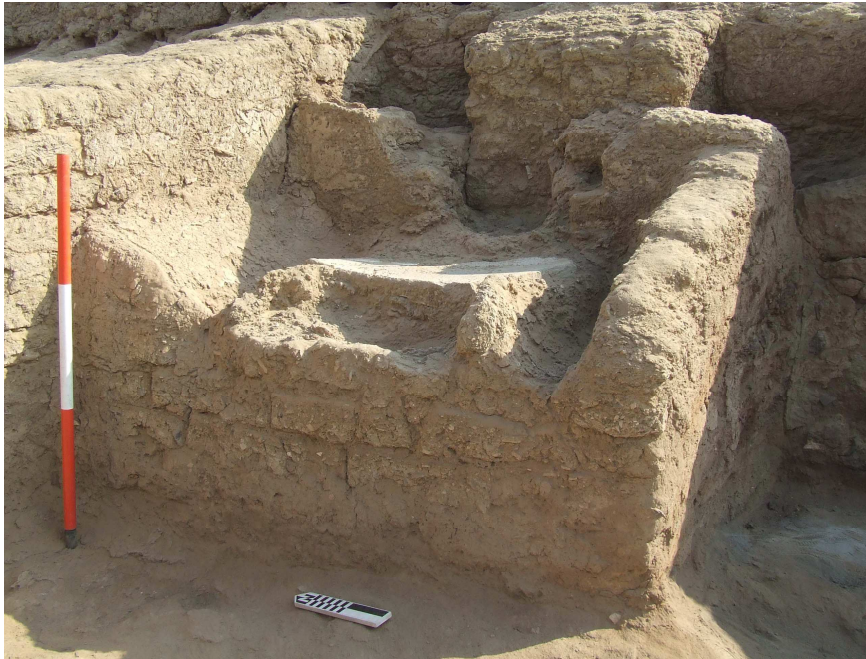
Plate 9: rectangular mud-brick feature in the NE corner of room B18.

To the east of B17 is room B18, whose dimensions are 3.65 m N-S by 3.21 m E-W (maximum wall's height: 2.19 m). B18 seems to have been the only access to the whole complex of rooms B17-24. A mud-brick staircase, which was found, in fairly good conditions, against the south-east corner of B18 once gave access to an unexcavated area. Puzzlingly, no wall was found against the south side of the staircase, and no traces of a south wall for room B18 were identified. A mud-brick rectangular feature was also built against the north-east corner of B18, with a large stone slab placed horizontally on top of this structure and two channels running to both sides (plate 9). The nature and original function of this feature have not been identified, yet. Consistent traces of at least two floor levels were found throughout the room. An analysis of the walls and the study of the stratigraphy of B17 and B18 shows that these two rooms had not been built originally as separate spaces, but only some time after the construction of the long east and west walls of the complex.
