**New York University**  
**Excavations at Amheida 2012**  
**Preliminary Report**

The excavation continued in two areas where the exploration already started in previous years (the temple Area 4.1 and the residential/public Area 2.2). A new area has been opened (Area 2.3) east of Area 2.2, where a public building with columns was mapped earlier during the topographic survey.

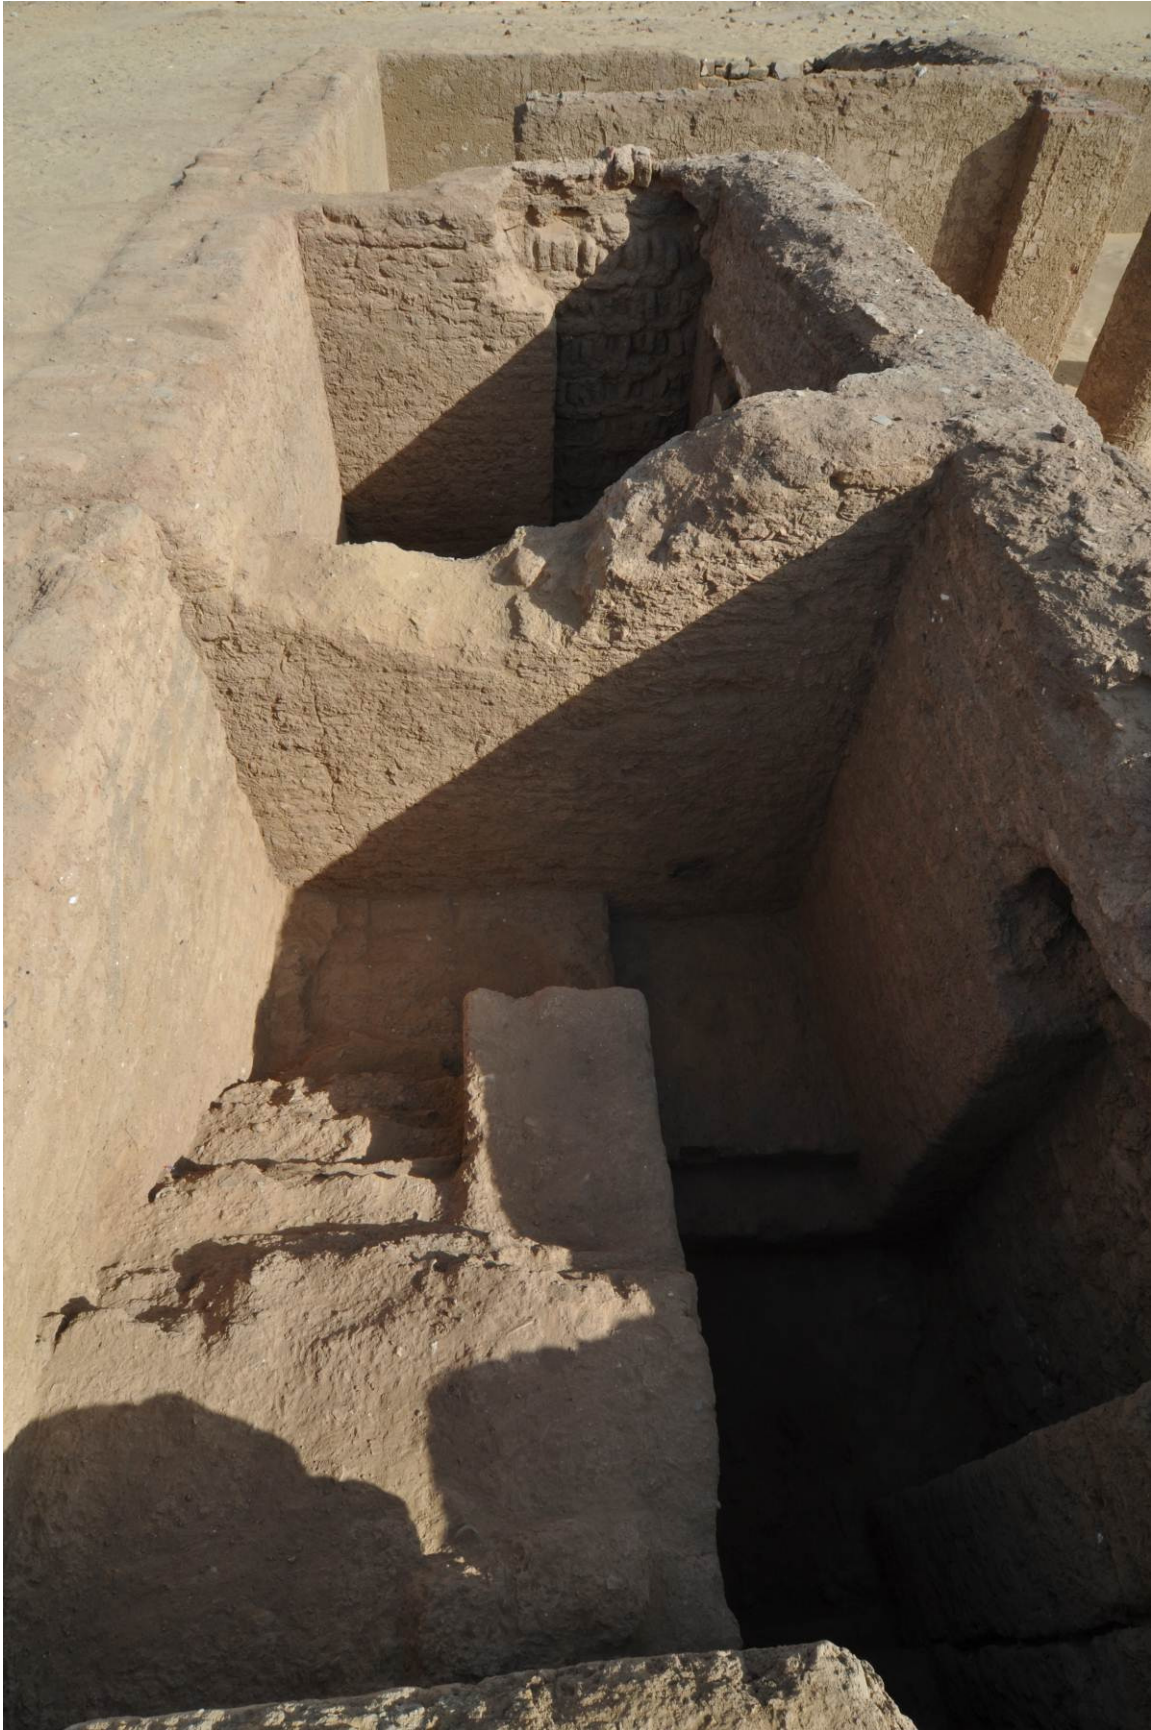
Fig. 3: B6, staircase in room 28 looking north

The western wing is formed by three rooms (R28-30) and a passageway (R35) connecting the central columned hall (R24) with rooms 29 and 30. All of them are preserved up to a height of ca. 3 m and were probably covered by flat roofs. Rooms 28 and 29 are of comparable size (2.85 x 2.47 m; 2.93 x 2.42 m), while room 30 is considerably bigger (4.10 x 5 m) and also provides access to the street north of B6, while the other two rooms were accessible only from within the building. Both rooms once provided access to the neighboring rooms via two doors. At a certain point, for unknown reasons, the doors in the eastern wall, once connecting room 28 and 29 with the columned hall, were blocked off with blocking walls build within the former doorframes. The blocking was undertaken in a first phase of renovation of the building, working from within the columned hall, and the blocking walls were nicely plastered over with brown mud. In room 29 the available space between the former doorframe and the blocking wall was equipped with a niche, which was white-plastered on the outside. In room 28 the blocking of the door wasn't furnished with any comparable alterations, as the room was equipped with a stairwell. Two flights of steps are preserved (fig. 3). The eastern one is built on top of a mud-substructure, paved with one course of mud bricks; the edges of the steps are protected by a row of baked bricks. The same can be said for the landing of the western flight, while the western flight itself consists of four steps, protected by wooden beams on a substructure of loamy sand once covered with mud. The stairwell provided access to the second floor of B6 or at least to the roof of the building. In a second phase of renovation it was decided to block off rooms 28 and 29 completely from the rest of the building, and the doors still connecting the rooms to the south and the north were blocked off as well. Those blockings were plastered with reddish brown plaster from the outside, showing that the building itself was still in use. The similar brickwork of these blockings with alternating rows of bedded bricks and bricks on edge suggests that both rooms were given up at the same time. Both rooms were found filled with dumped material, which consisted mainly of building debris. In room 29 altogether 16 *ostraka* (see Documentary Material) were found within the dump (DSU 31). The dump in room 28 (DSU 29)

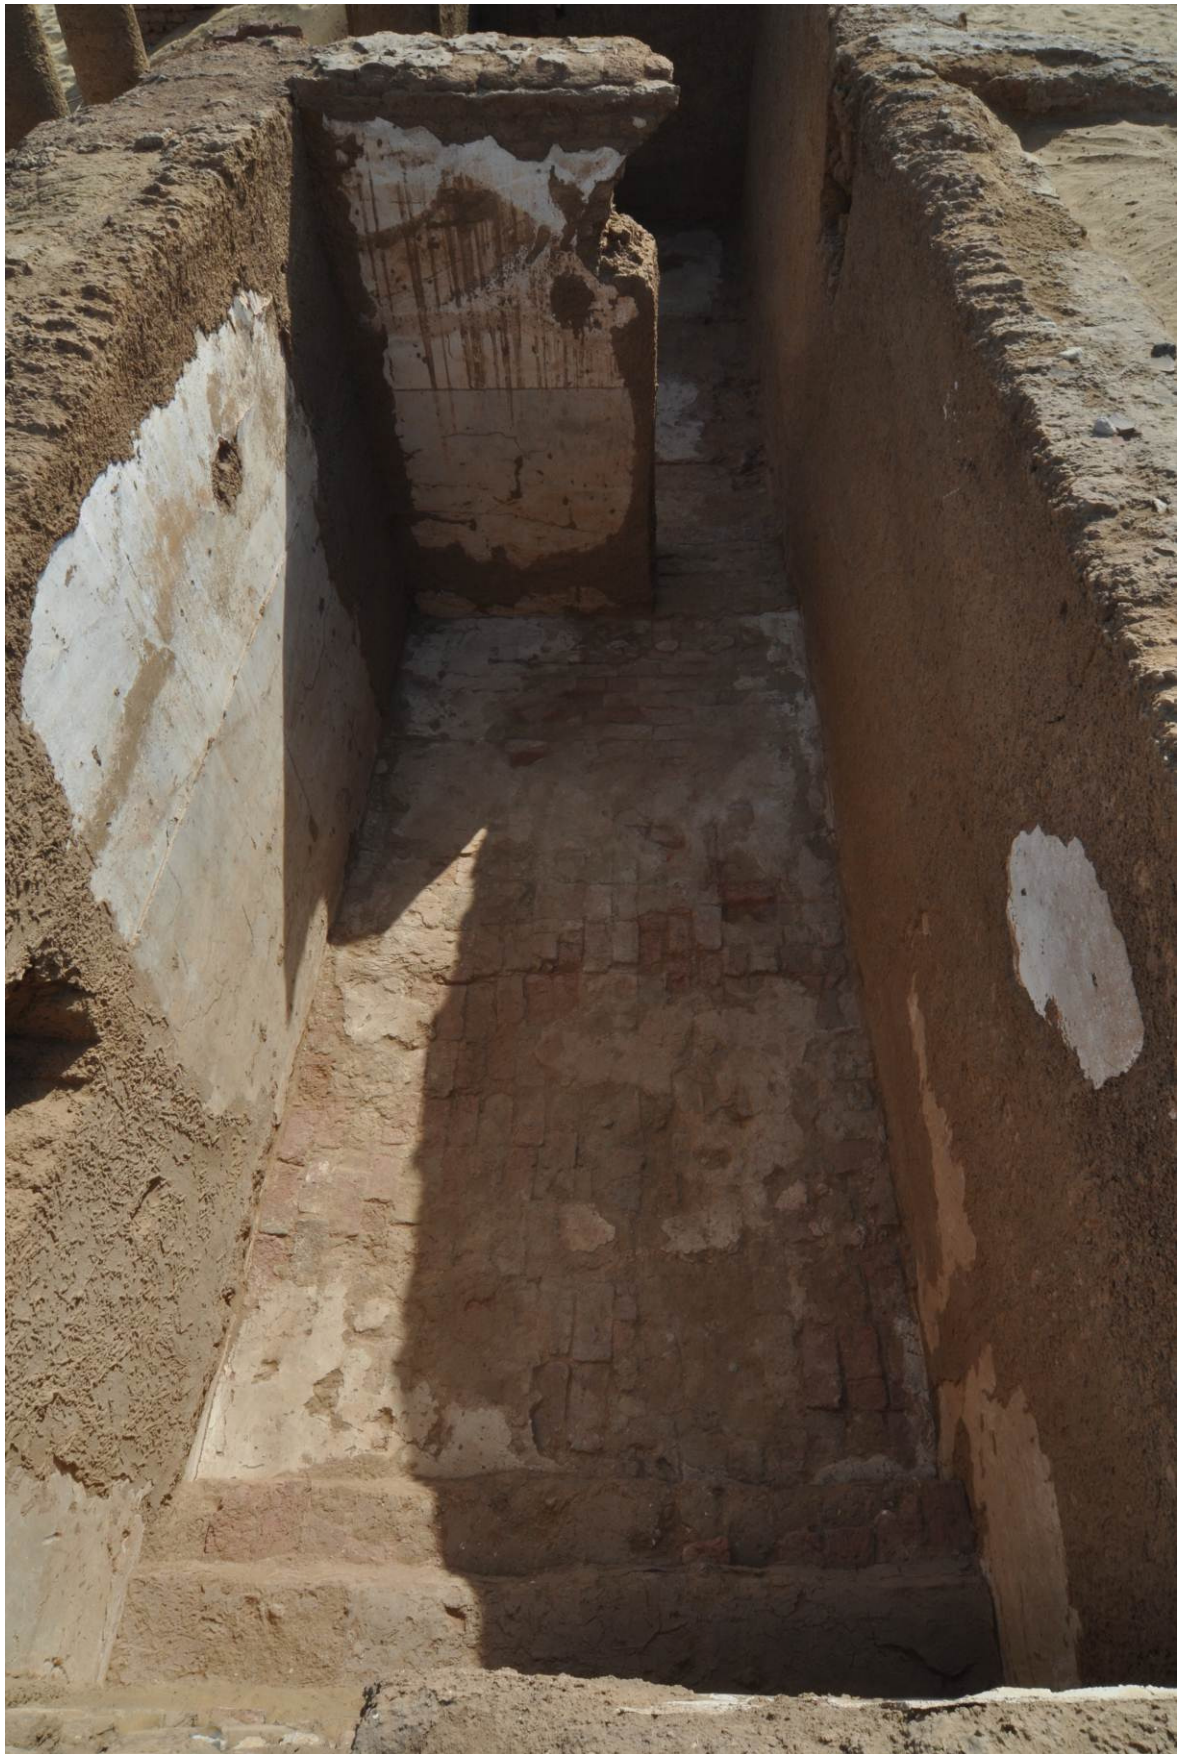
Fig. 4: B6, room 25 looking east

Room 25 (2.45 x 5.60 m) was accessible from the west street through a doorway located in the northwest corner (fig. 4). Two steps lead down to the level of the floor. When building B6 was built, the walls and floor already present were reused and integrated into B6. These walls and floor were part of a previous building, belonging to the *thermae*. The original floor is made of baked bricks coated with a thick layer of white hydraulic plaster. The same white plaster also covers the walls. The room was covered by a barrel vault.

When the room was incorporated into B6, the walls were probably re-plastered with mud plaster and the floor was covered with a mud floor. The above mentioned steps in front of the western wall and doorway were built. After some years, the room underwent a first renovation phase with a new coat of brown mud plaster on the walls and two new floors (first a thin white plaster and later a gray mud floor). In this phase the room was still connected to room 28 by a doorway (93 cm width). This doorway was blocked during a second phase of renovation. The blocked door was covered by new mud plaster, reddish brown in color. At the same time a new rough floor, made of compacted debris, was laid down. It covered the lower step, but the upper step remained in use.

The original white plaster of the *thermae* phase is not preserved everywhere on the walls. It was decorated with a raised plane dado (1.5 m from the baked brick floor). Some *dipinti* and *graffiti* were made both on the dado (west wall) and on the plaster above (see Documentary Material). Some of them are very high on the wall (up to 2.20 m above the floor). We therefore assume that the *graffiti* and *dipinti* were made after the *thermae* were abandoned.

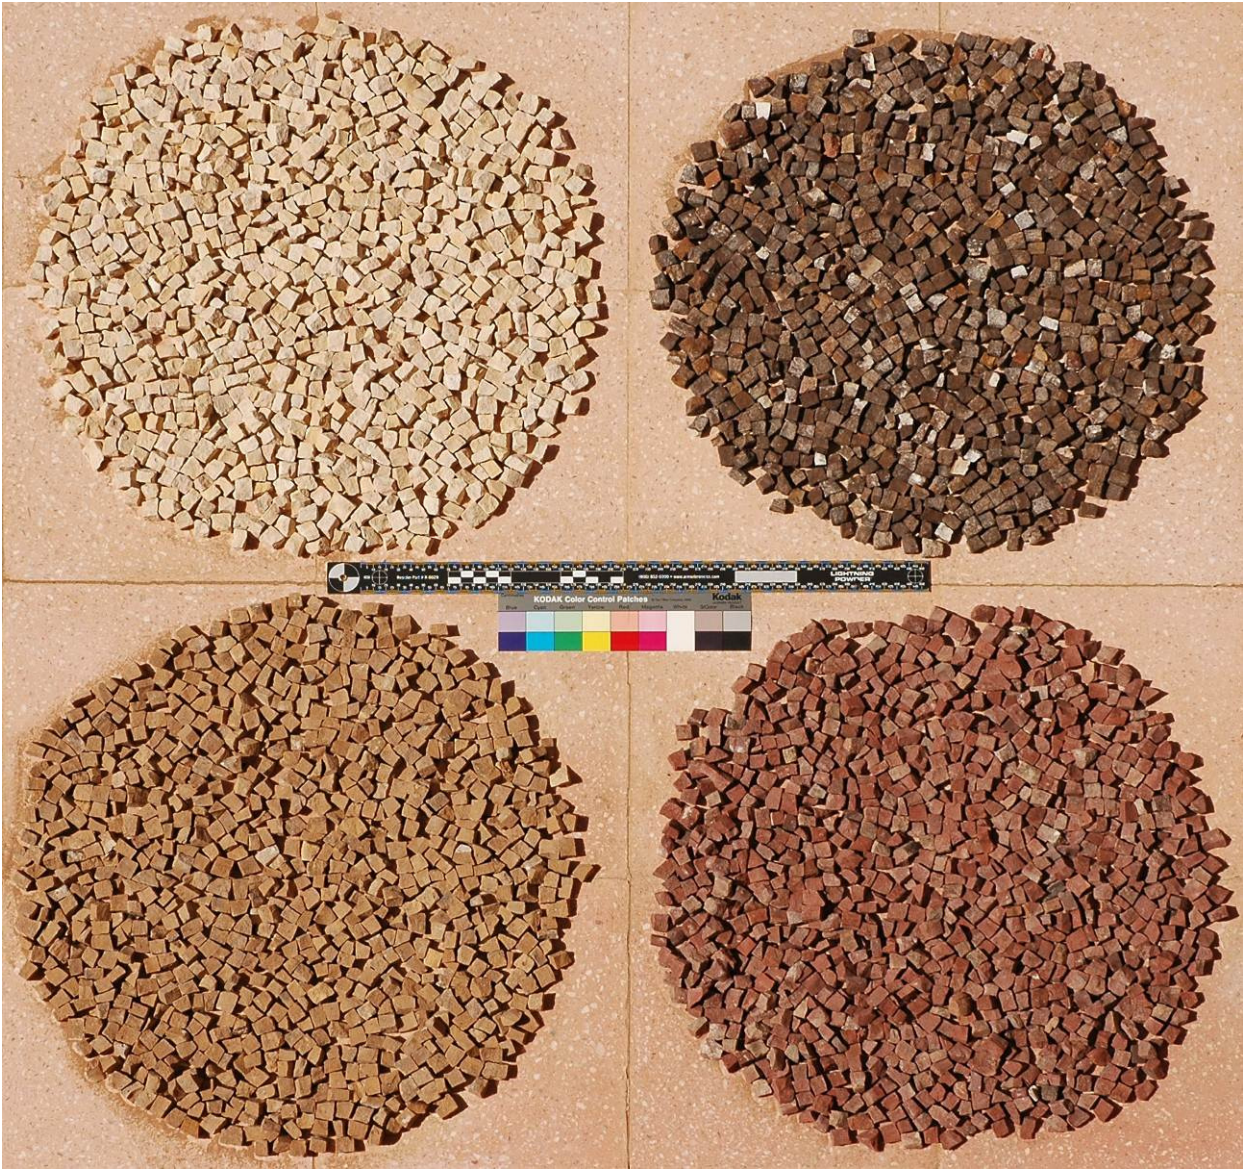
Fig. 5: mosaic *tesserae* from B6, room 30

A large amount of mosaic *tesserae* of four different colors has been found in Room 30, DSU 49 (fig. 5):

- approximately 11,825 white *tesserae* (Kg 47.58), cubic, made of limestone of slightly different tints (from bright white to yellowish and pinkish). Two different sizes have been identified: small (from 1.1 to 1.4 cm) and large (from 1.4 to 1.6 cm). Some *tesserae* have a rectangular section (dim. 1.1 x 1.5 x 1.7 or 0.9 x 1.2 x 1.9 cm);
- ca. 1047 red *tesserae* (Kg 3.8), cubic, made of sandstone. Three sizes are recognizable: small (1 cm), medium (from 1.2 to 1.5 cm), large (1.8x1.8x1.2 cm);
- ca. 3286 black *tesserae* (Kg 11.5), cubic, made of sandstone. Size: small (from 0.8 to 1.1 cm); medium (from 1.2 to 1.4 cm); large (from 1.4 to 1.6 cm);
- ca. 4203 dark yellow *tesserae* (Kg 17.4), made of sandstone. Size: small (from 0.9 to 1.1 cm); medium (from 1.2 to 1.6 cm); large (1.8 cm).

The estimated area that could have been covered with these *tesserae* is 4.30 sqm (20,430 pieces).

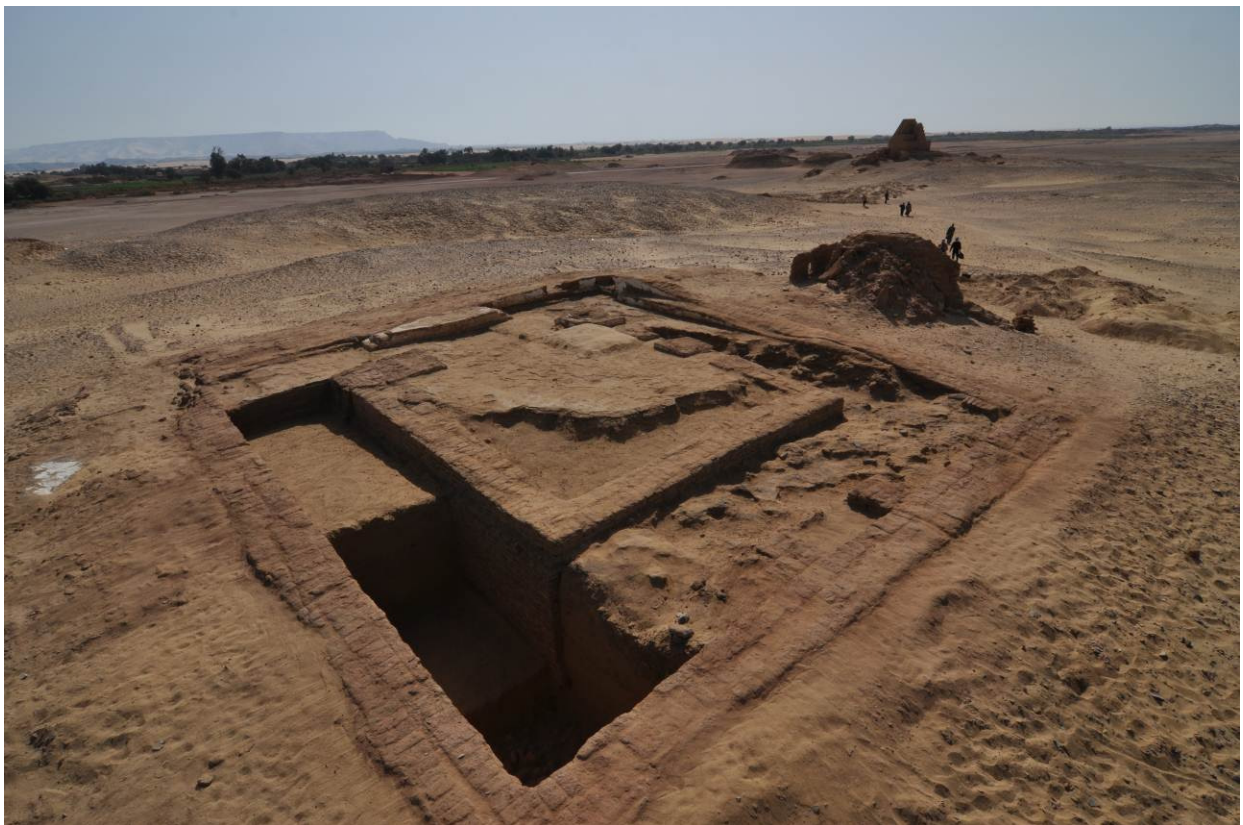
Fig. 7: B7, room 1 looking south-east.

The primary object of excavation in Area 2.3 in the 2012 season was room 1 of Building 7 (figs. 6-7). Surface clearance was also done in rooms 2, 3, and 4 located to the east of room 1, in order to clarify their plan and determine their relationship to room 1, but no further excavation was conducted.

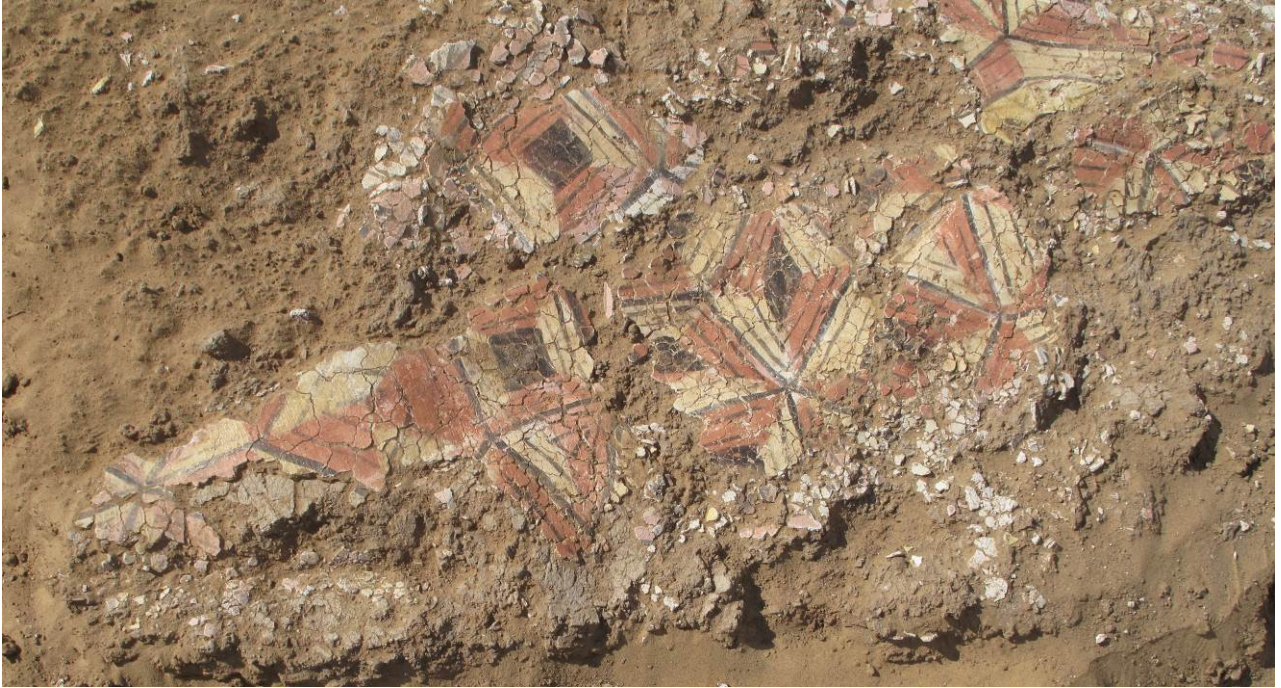
Fig. 8: B7, fragment of painted plaster from the ceiling of room 1

In course of excavating building seven the roof collapse was found. It contained a lot of painted plaster, mostly completely fragmented.

Luckily there were a couple of bigger pieces preserved as well and they could be carefully removed, treated with Paraloid B 72 in Acetone (5 and 10 percent) and subsequently being studied.

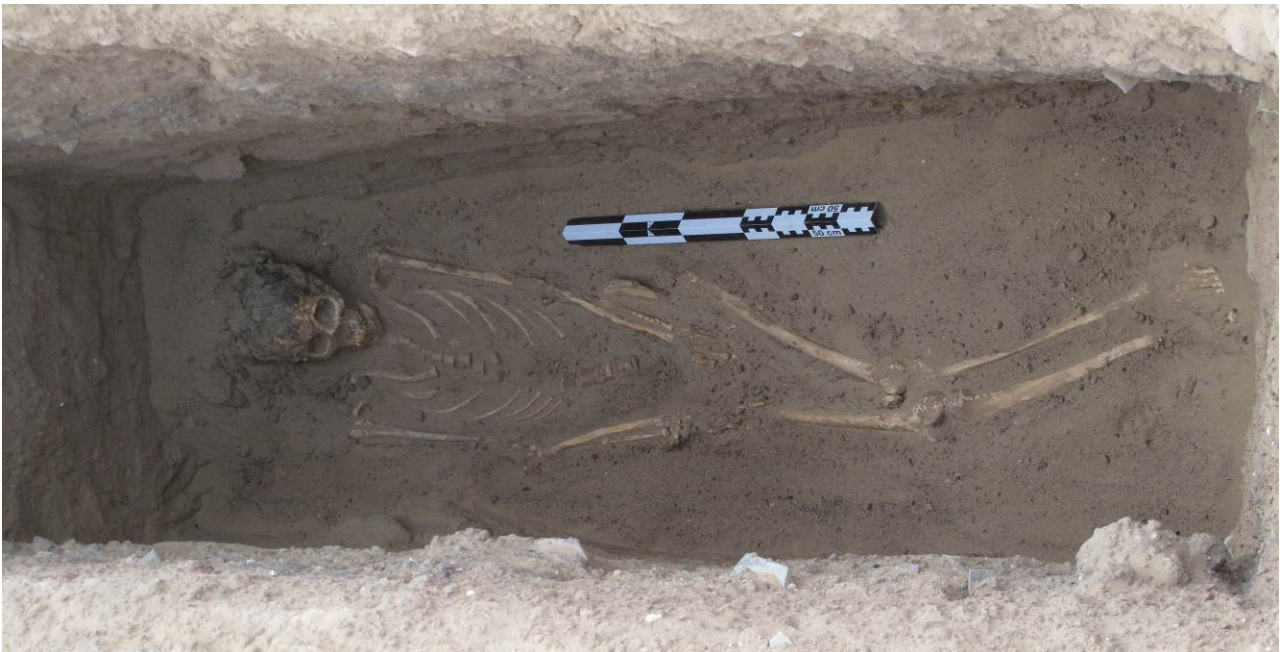
Fig. 9: B7, tomb 2 in room 1

The lower floor F27 between pillar base F3 and eastern wall F1 was cut by a burial pit (Tomb 2, fig. 9). The pit was overlaid with a mud-brick covering and sealed with the upper floor F23. The human remains were preserved intact. Another human burial (Tomb 1) was excavated in the northwest part of the room, in a sand layer that was part of the foundation fill of the external walls of room 1. Both burials were laid on their backs and oriented with the heads facing east. No evidence of coffins, biers or grave goods was found, and only Tomb 1 contained remains of textile, suggesting that the body was wrapped in a shroud. The bones were collected and will be studied by a physical anthropologist in the future.

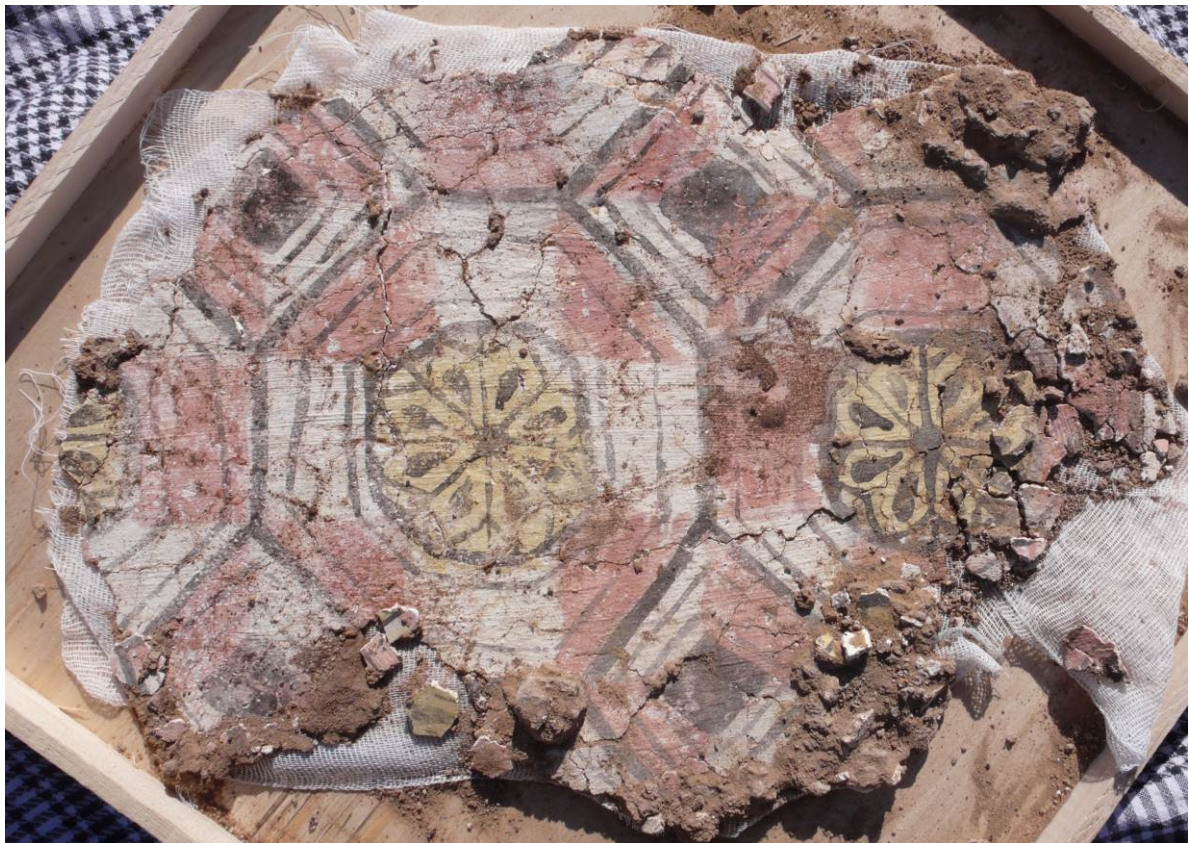
Fig. 11: B7, fragment of painted plaster from the ceiling of room 1

1. A pattern consisting of squares and triangles in red and yellow (fig. 10).
2. A pattern consisting of lozenges, octagons and squares in red and yellow (fig. 11).
3. A pattern consisting of hexagons, squares and lozenges in red and yellow, at least three different compositions.
4. Broad light and dark yellow bands, framing a purple band with a yellow garland.

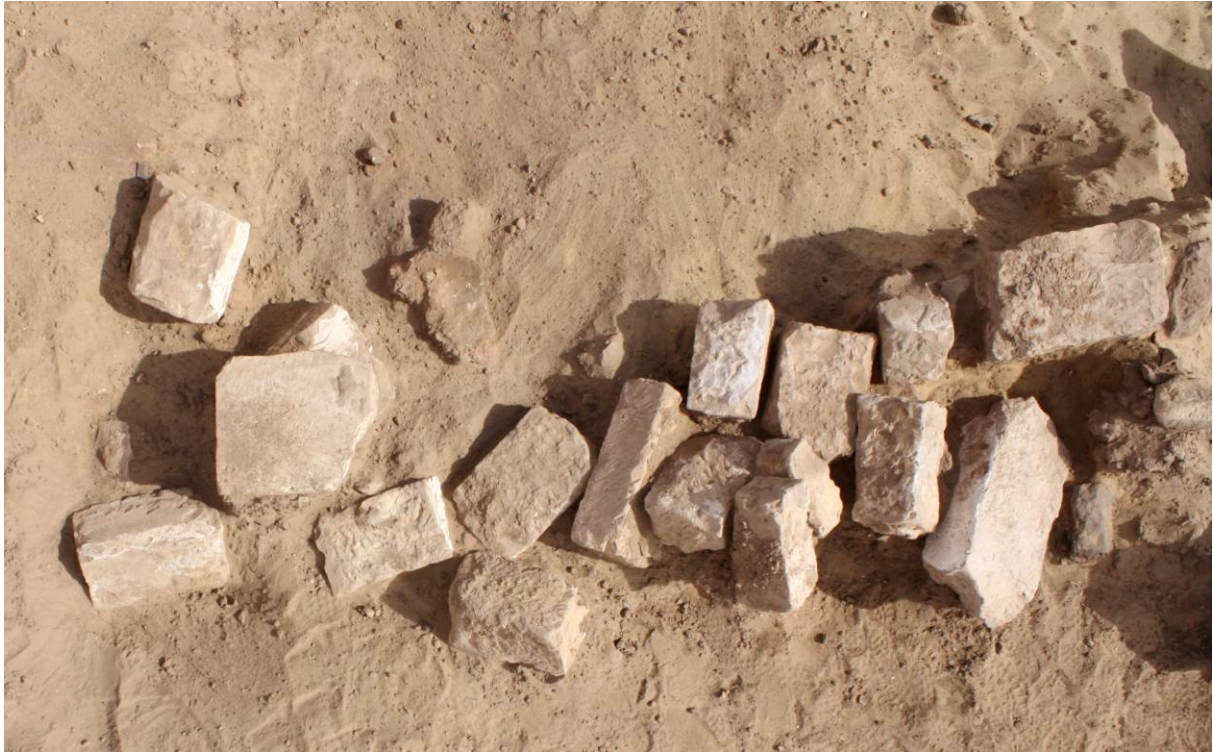
Fig. 12: Area 4.1, cluster of temple blocks (DSU185).

Temple blocks have been found mostly on the surface (DSU 159, 160, 181, and 185), above both the mudbrick collapses and the pits' edges. One particularly interesting cluster, DSU 185, revealed 7 decorated blocks (fig. 12) dated to the reign of Domitian, all pertinent in shape, size, and iconography to a gateway. The positioning of the blocks in the cluster and the discovery of another block for a door jamb in the vicinity, hint at the presence of an entrance to the late first century CE temple at this location, probably opened in the center of a forewall crossing squares AP50 and AP49.

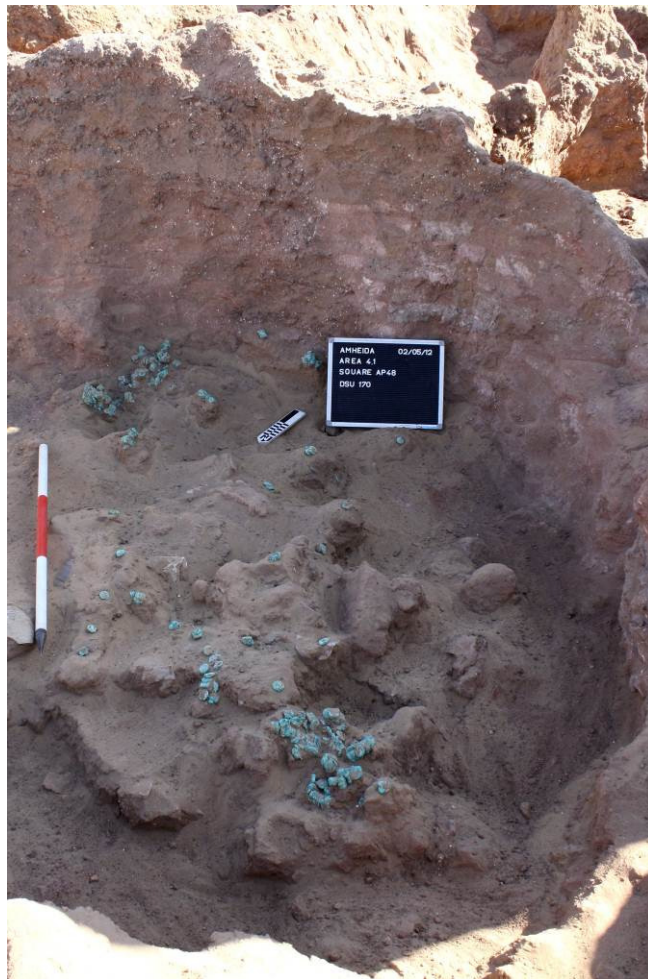
Fig. 13: Area 4.1, coin hoard in pit F90.

Noteworthy is the uncovering of a coin hoard (figs. 13-14) of ca. 850 tetradrachms divided in three textile bags (traces of fabrics are visible) lying on top of a mudbrick debris layer filling pit F90. Apart from pits F80 and F96, cut in the spoil heap layers created by the partial dismantling of wall F101, all the other investigated pits were dug into earlier anthropic stratigraphies, identifiable by a series of horizontal layers alternating thick strata of dark ash, lime spots, and red compacted clay very similar in nature and composition to those found in previous seasons. These layers are in direct stratigraphic relation with a series of walls chopped off and badly damaged in the cut of the pits. The numerous bread molds and complete vessels found in situ by these walls and the abutting anthropic strata suggest that the pits cut through occupational layers dated to the Second Intermediate Period or even, as is the case for wall F101, to earlier phases.

The other major discovery of the year was a hoard of about 850 coins found in Area 4, in adjoining pits. Only a fraction of these have been cleaned so far, but all of those read to date are tetradrachms minted in Alexandria by Roman emperors from Nero to Antoninus Pius. Most suffer from severe copper corrosion and will take quite a bit of time and effort to clean sufficiently to allow them to be read. As there is no intact stratigraphy in this pitted area, devastated by *sebbakhin*, we cannot recover the original context with any confidence. If the hoard was deposited during the

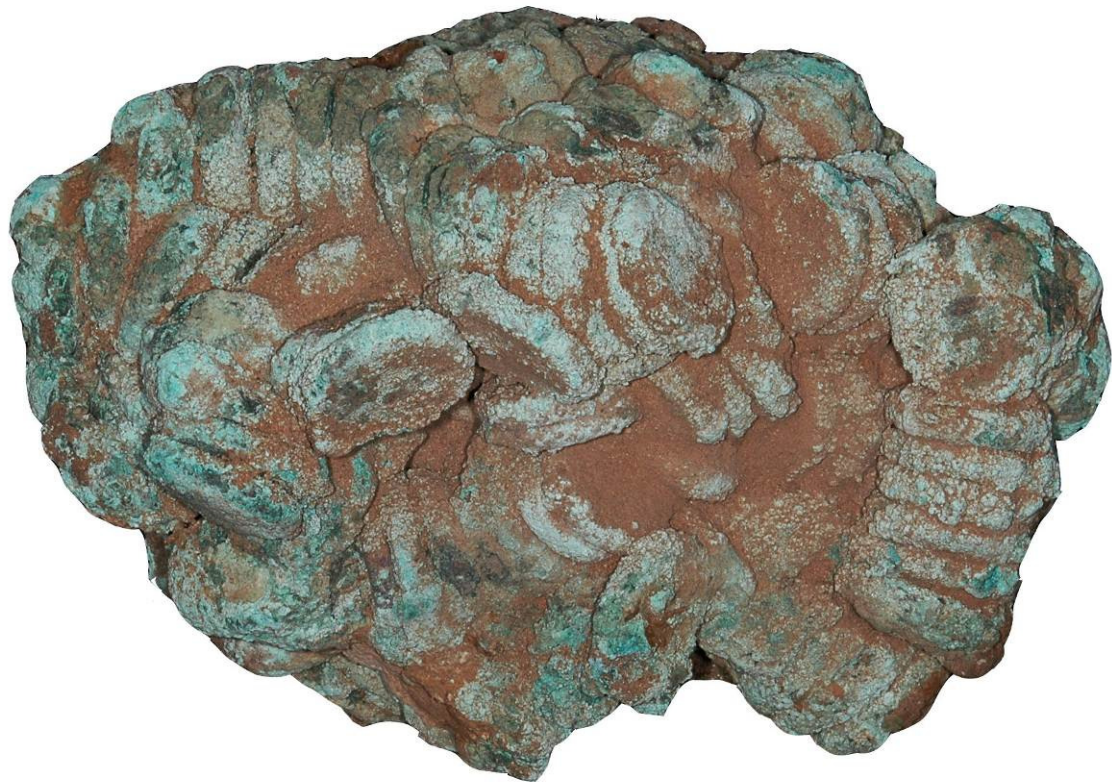
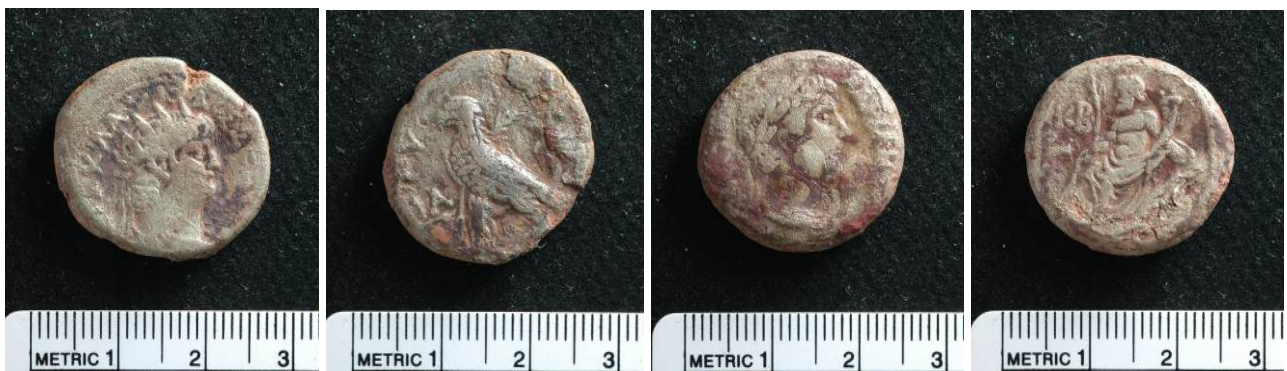
Fig. 14: Area 4.1, coin hoard and two restored coins

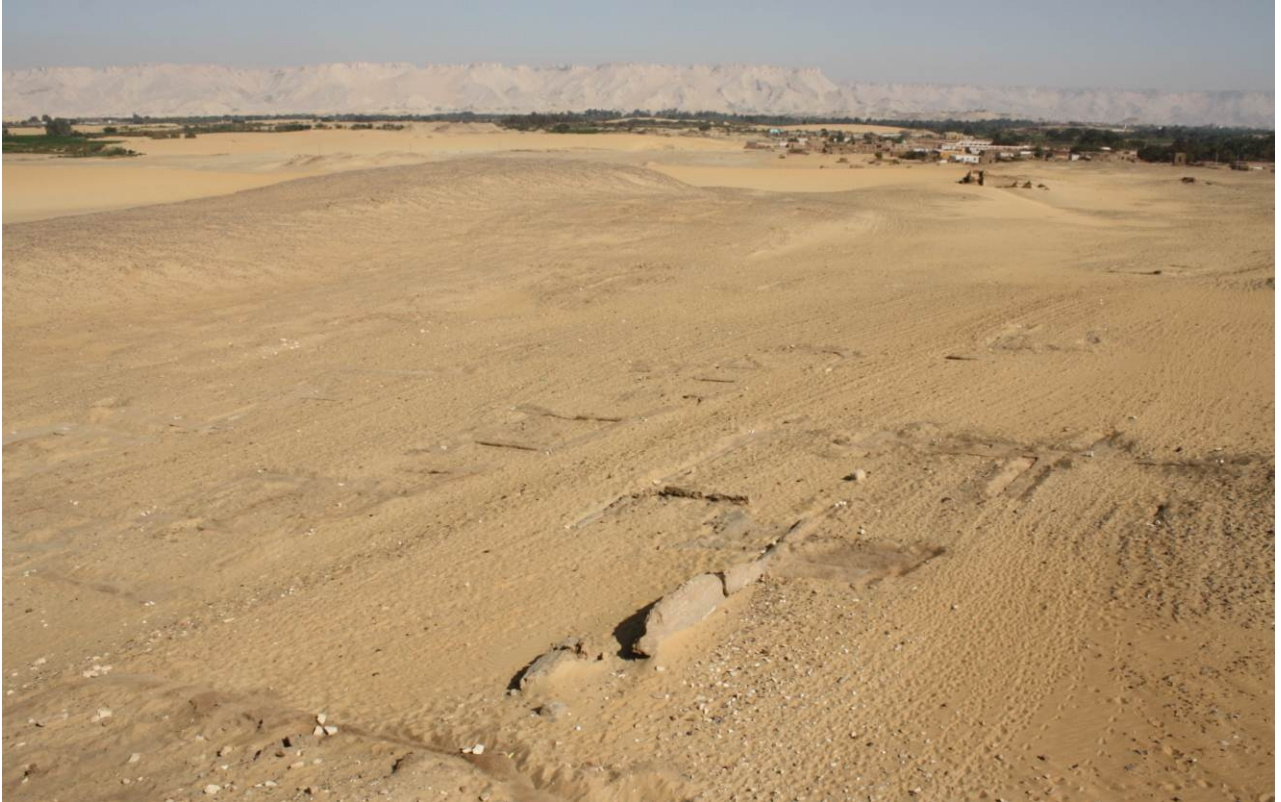
Fig. 15: Topographic survey, wide north-south street in Area 8

Area 8 is instead defined mostly by smaller rooms lining up along streets and corridors that are predominantly east-west oriented. From their sizes and orientations they do not seem to be part of dwellings but rather of street shops or other utilitarian buildings, possibly storage facilities. To the west of the temple hill, a large north-south street, at least 4 meters wide, is clearly visible from the

surface. Its orientation and size are similar to those of another street, identified in the 2010 survey, that crosses the ancient city on the other side of the temple hill, to the east (fig. 15).

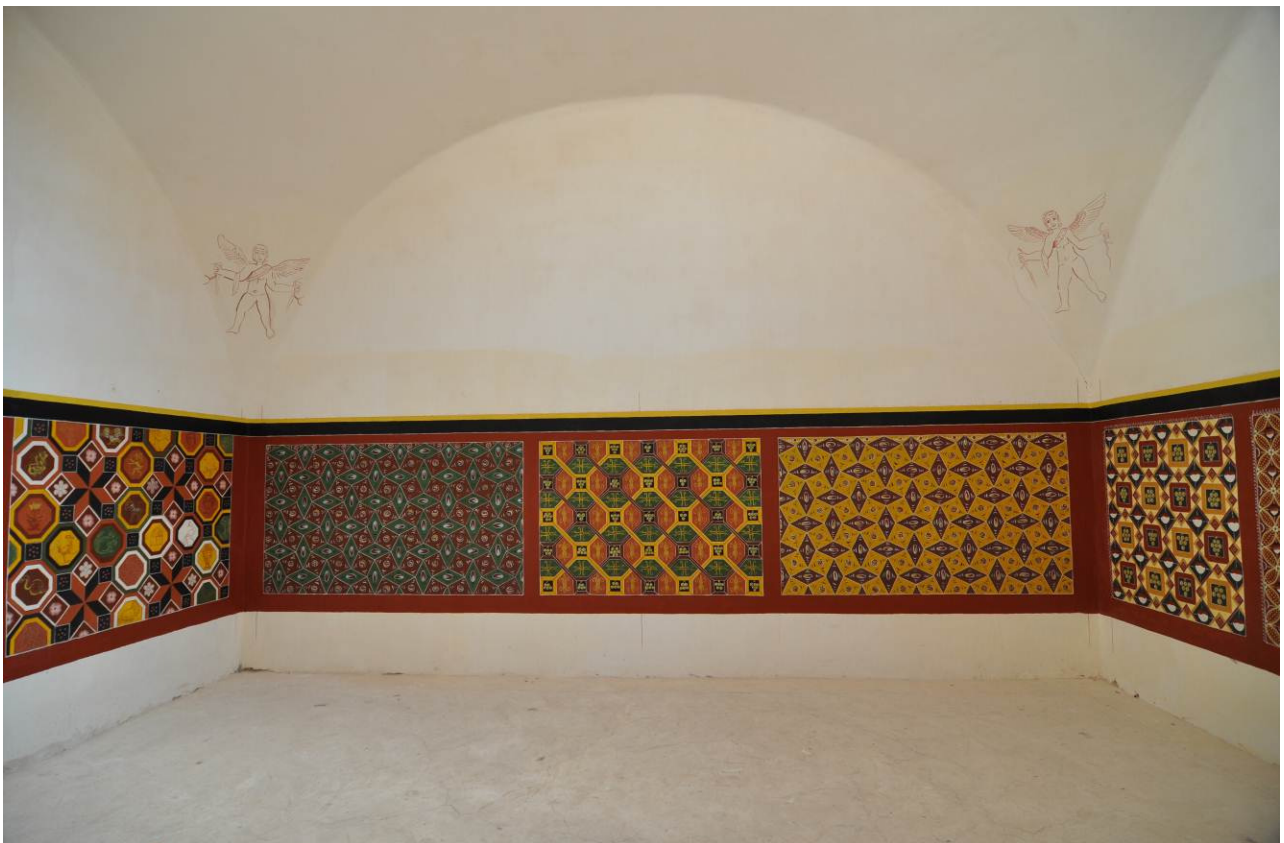
Fig. 16: Replica of Serenos' house, geometric patterns in the domed room

In the replica reconstruction the “wallpapers” (the geometrical patterns) in the domed room have been completed. The second “squiggly diamond” pattern is based on two fragments from the original house, coming from the southeast corner (fig. 16).
