Dakhleh Oasis Project
Columbia University
Excavations at Amheida 2008
Architectural Conservation Work

Architectural conservation work on the North Tower at Amheida was carried out from 16 to 23 February under the direction of Dr Nicholas Warner with the assistance of SCA Inspector Ibrahim ‘Abd al-Hamid Ibrahim and SCA Conservator Baha’a Goma’a Ahmed.

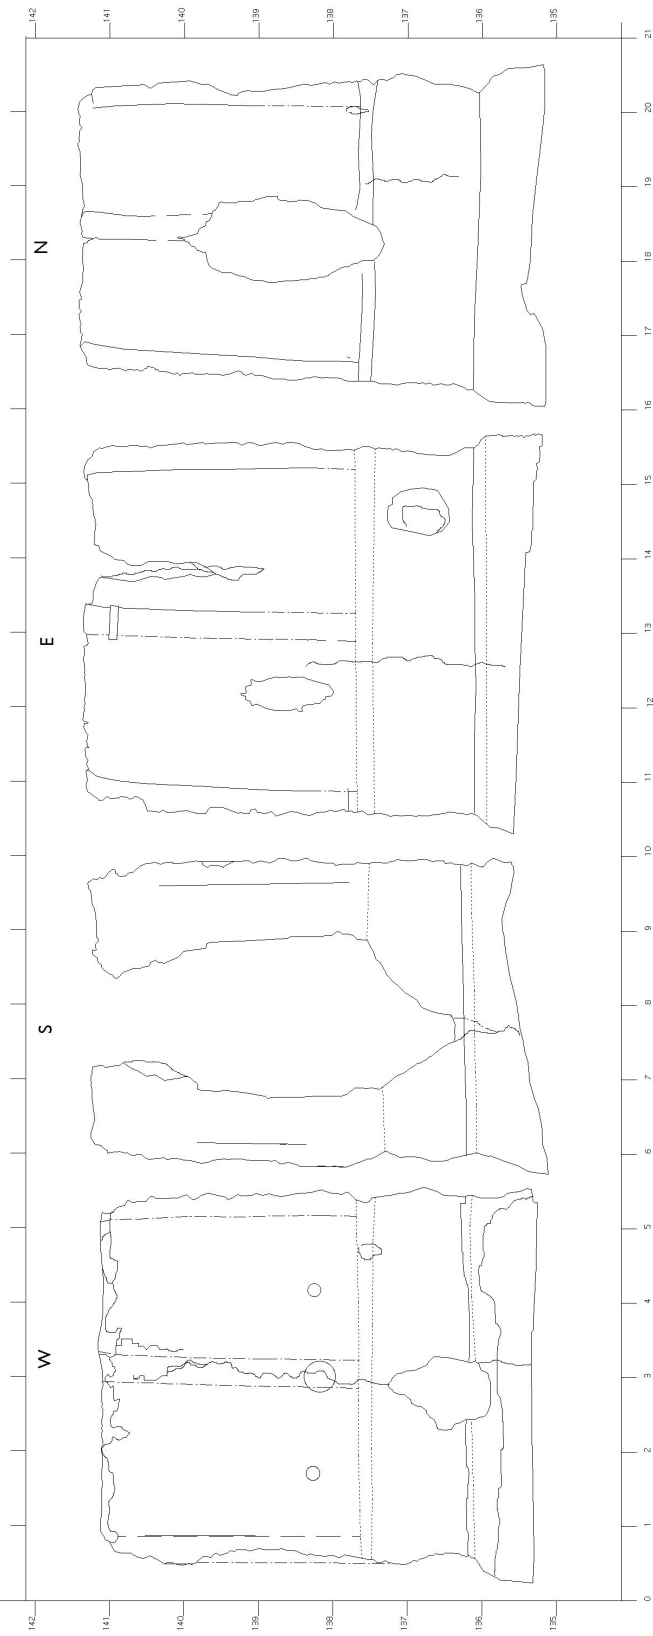
AMHEDA NORTH TOWER EXISTING CONDITION
External elevations 2008

plastered with mud and limewashed. A number of cracks were observed in the structure which are detailed on the attached drawings; the most severe running full height being on the west flank wall.

After consideration it was decided not to stitch the crack on the west flank wall, as the areas of surrounding masonry had been consolidated.

The crack on the west elevation should be monitored to see if it opens up any further in which case stitching with treated timbers every 90cm should be carried out.

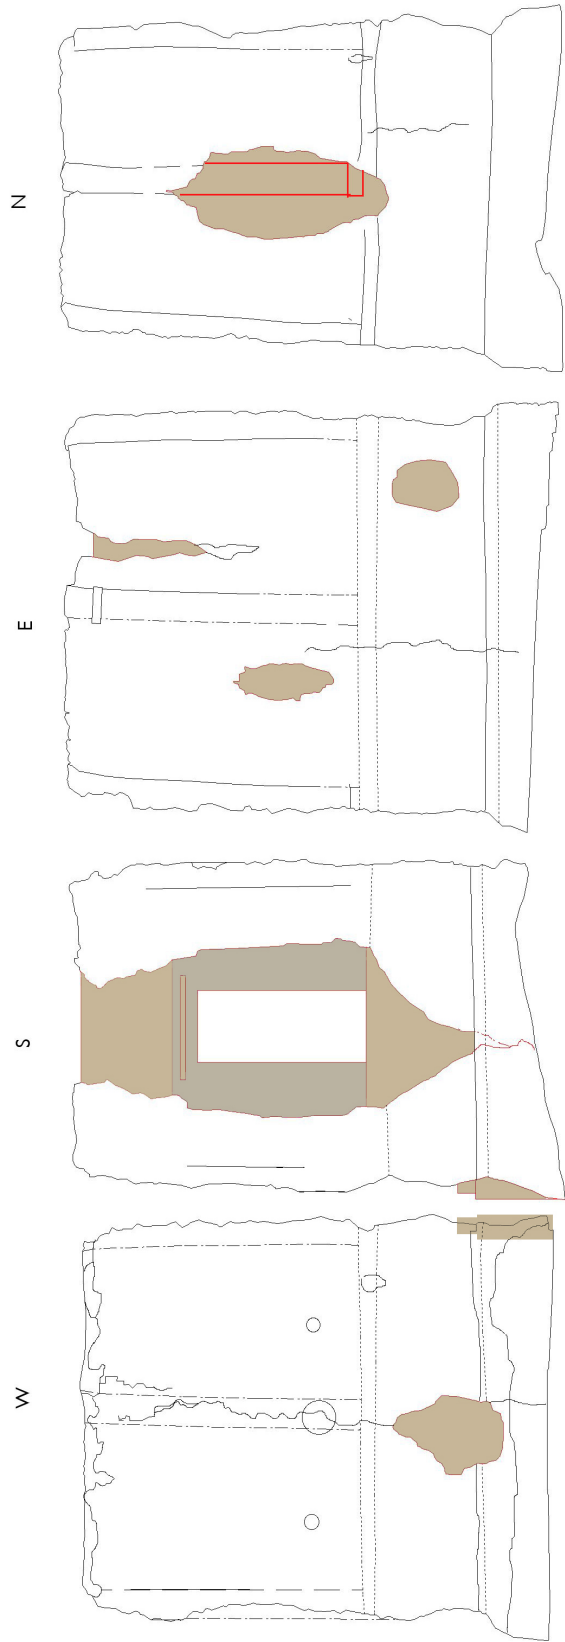
AMHEIDA NORTH TOWER INTERVENTIONS
External elevations 2008

All openings due to collapse in the perimeter wall were filled with mudbrick in mud mortar to match the original bonding pattern as far as possible. On the north side, the infill provided the opportunity to reconstruct a section of the external pilaster on the external wall, and a shallow arched niche (hypothetical) on the internal wall. This niche (53 x 90cm to apex of niche head) is off-centred, being centred instead on the area of loss. The rebuilt wall follows the batter of the external façade.

On the south side, a painted steel grille double door with padlock, 90cm wide x 210cm high, was installed at the level of the original entrance. Timber lintels in the form of acacia wood (*sunt*), treated against insect attack with sump oil, were provided for this opening. Access to the interior can henceforth only be gained by ladder.
