Amheida 2007-2009: New Results from the Excavations

Paola Davoli

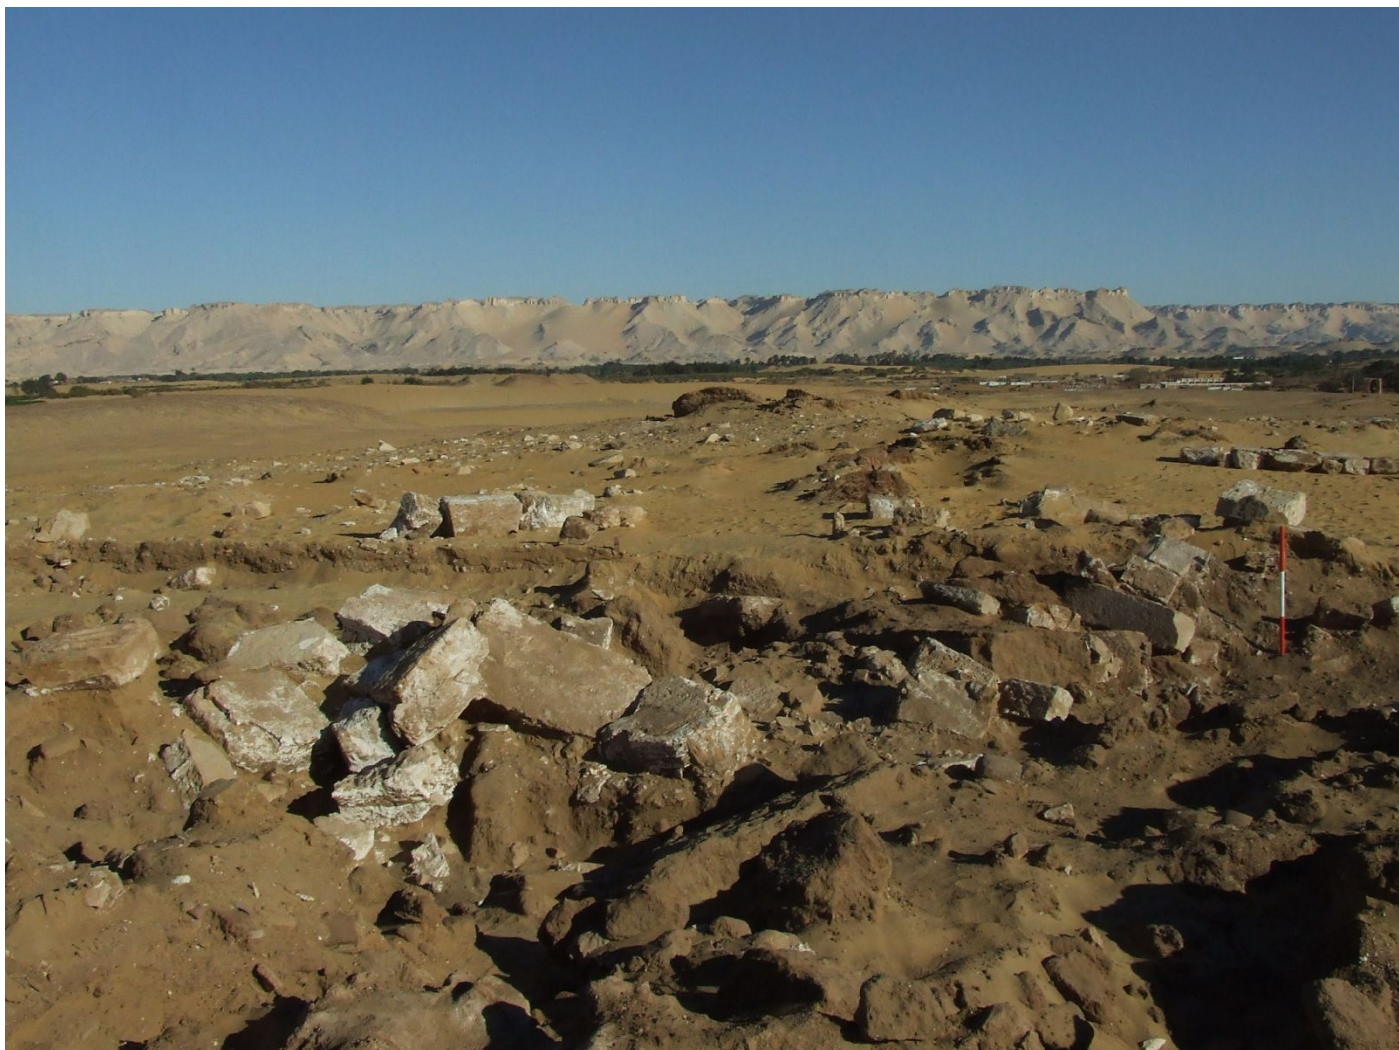
Plate 2: Area 4.1. Alignment of blocks and pieces of walls found in 2008.

In spite of the complete destruction of the temple, the evidence collected so far allows us not only to reconstruct parts of the decoration of the temples of the different periods,⁶ but also to suggest a possible location and the approximate dimensions of the Roman period temple of Thoth. Key elements in the formulation of this hypothesis are: the aligned clusters of blocks, a collapsed corner of the temple found in 2005, the position of scattered column drums and that of a cavetto cornice presumably of the main gate (Plate 3).

These are of course very faint evidence, but still they are the only clues we have in the field to the position and dimensions of the temple. This hypothesis is thus only tentative. A possible wall runs in square AQ 50, while the external northeast corner of the temple was located in square AP 49. The geometric distance between these two elements is about 16 m. Interestingly, the maximum concentration of blocks lies between these virtual lines, while the column drums and the cavetto cornice of the gate are located in the easternmost part of this area, suggesting that the forepart of the temple was to the east. We thus can argue that the entrance of the temple was oriented to the southeast. In the absence of clear archaeological evidence related to the length of the building, we can estimate it by comparison and applying the ratio between the short and the long side as it has been calculated for Dendara and Edfu temples.⁷ By applying this ratio on a short side of 16 meters we obtain a length of 26.5 m. However, it must be pointed out that these proportions were not systematically applied to the temples of this period.⁸ Future investigations in some other squares will hopefully clarify the general outline of the building.

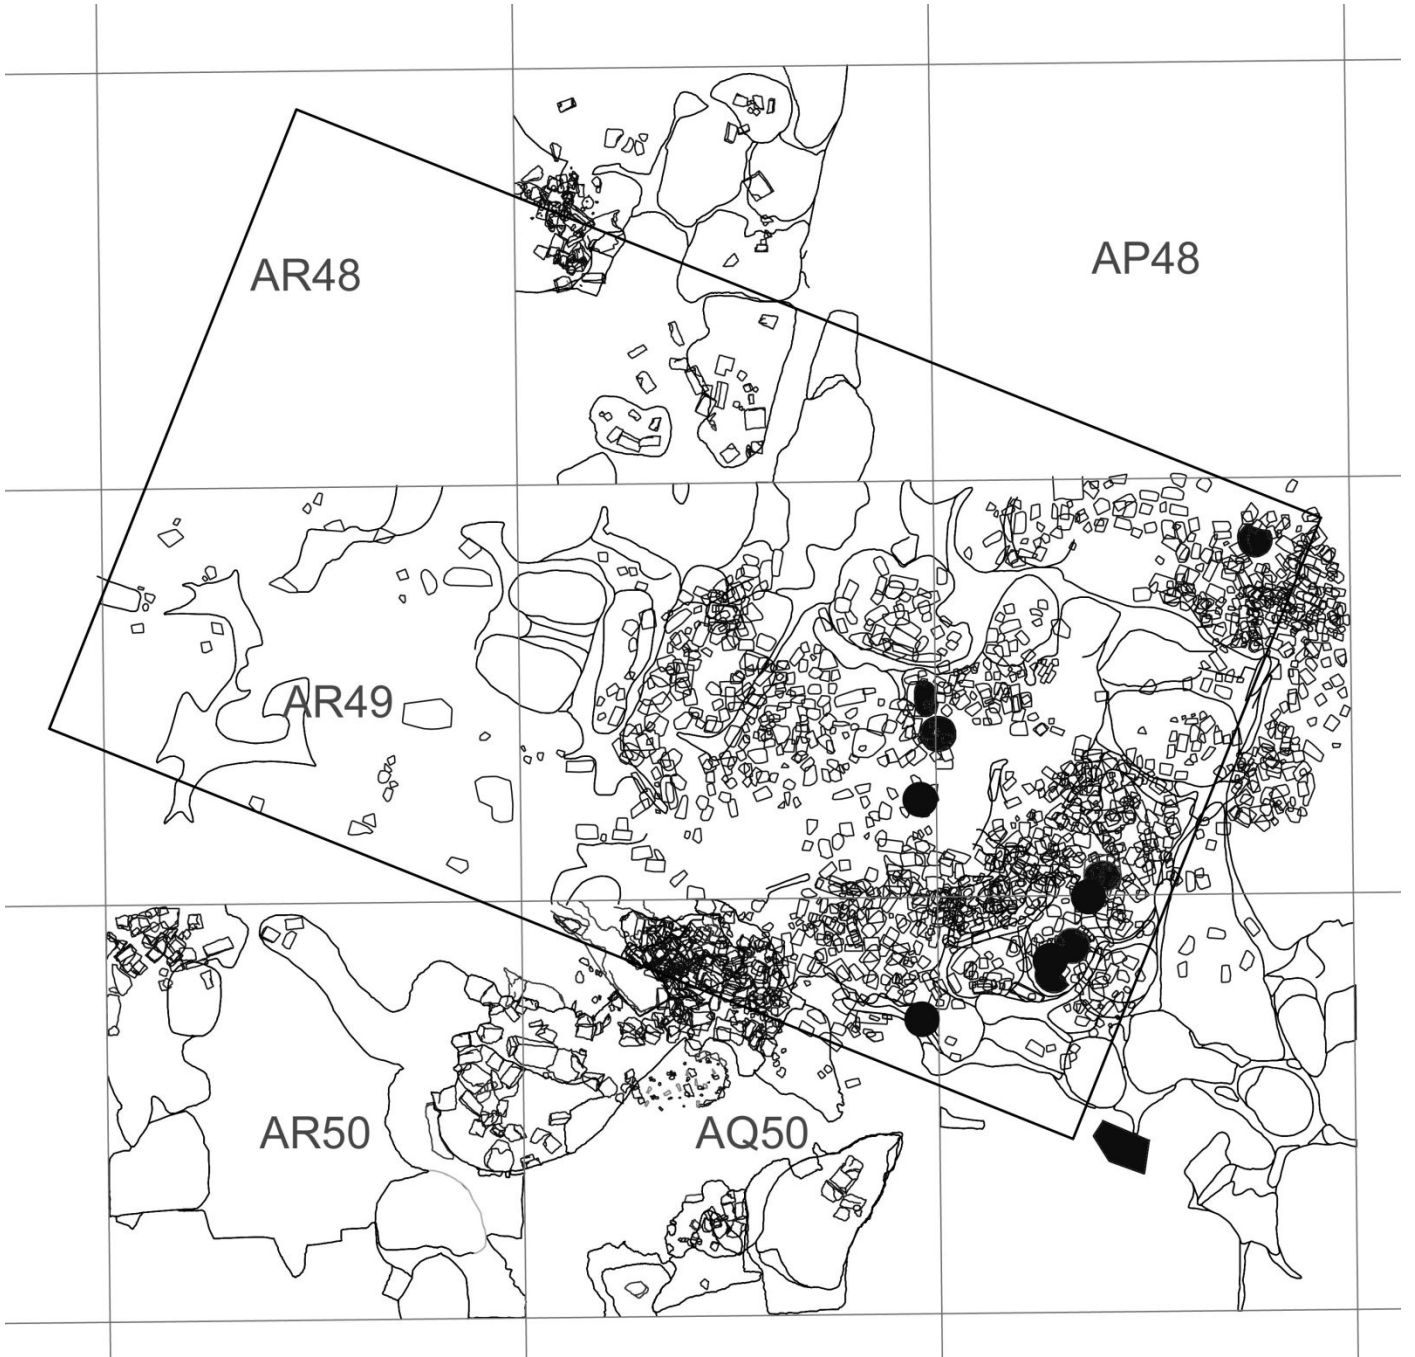
Plate 3: Area 4.1. Area with the maximum concentration of blocks and the hypothetical position of the Roman period temple of Thoth (square 10 x 10 m). The columns drums and the cavetto cornice are marked in black.

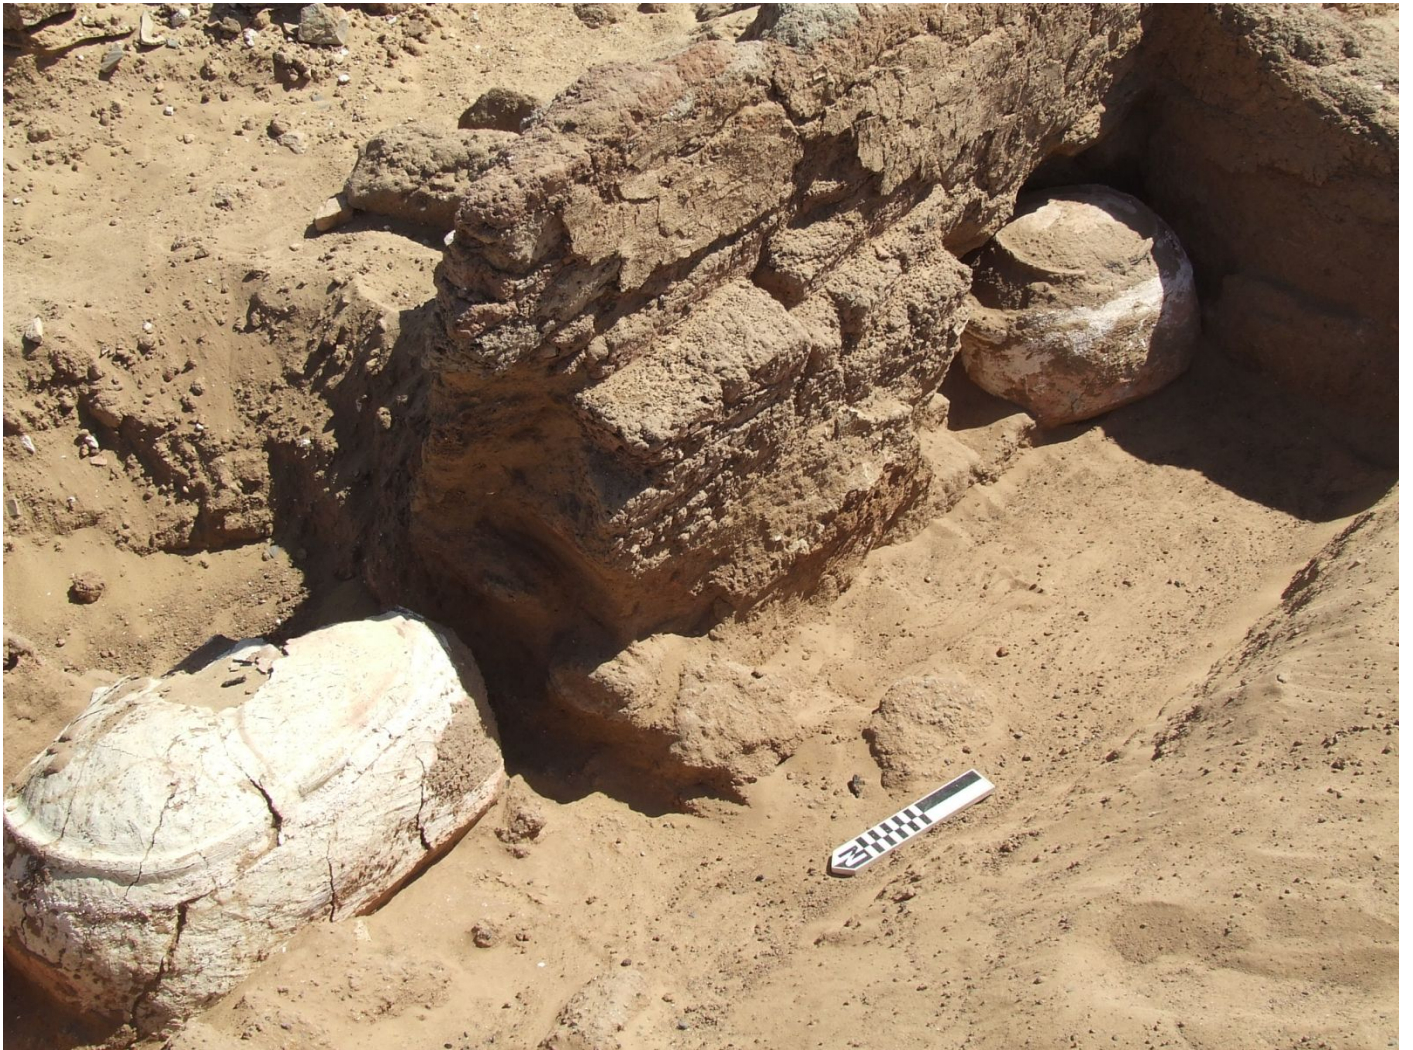
Plate 4: Area 4.1. Coffins of the birds.

One of the most interesting discoveries of the last seasons is an area of 3 x 5.5 m which was not disturbed by the pits diggers (DSU 120). Its excavation is not yet finished, but it can be interpreted as an animal necropolis, datable probably to the Late Period or the beginning of the Ptolemaic period. Five sealed pottery coffins have been recovered, and many other fragments of similar containers have been found scattered in the area (Plate 4). The coffins are hand made and of relatively poor quality, with an oval shape (70–46 x 40–35 x h 40–21 cm) and a cover sealed to the body with gypsum plaster. No inscriptions or other signs have been traced on them. Two of them were emptied of their contents, which consisted of hundreds of small bones and dark dust. The bones from one coffin were examined by Salima Ikram, who recognized raptors and ibis. No trace of mummification is visible.

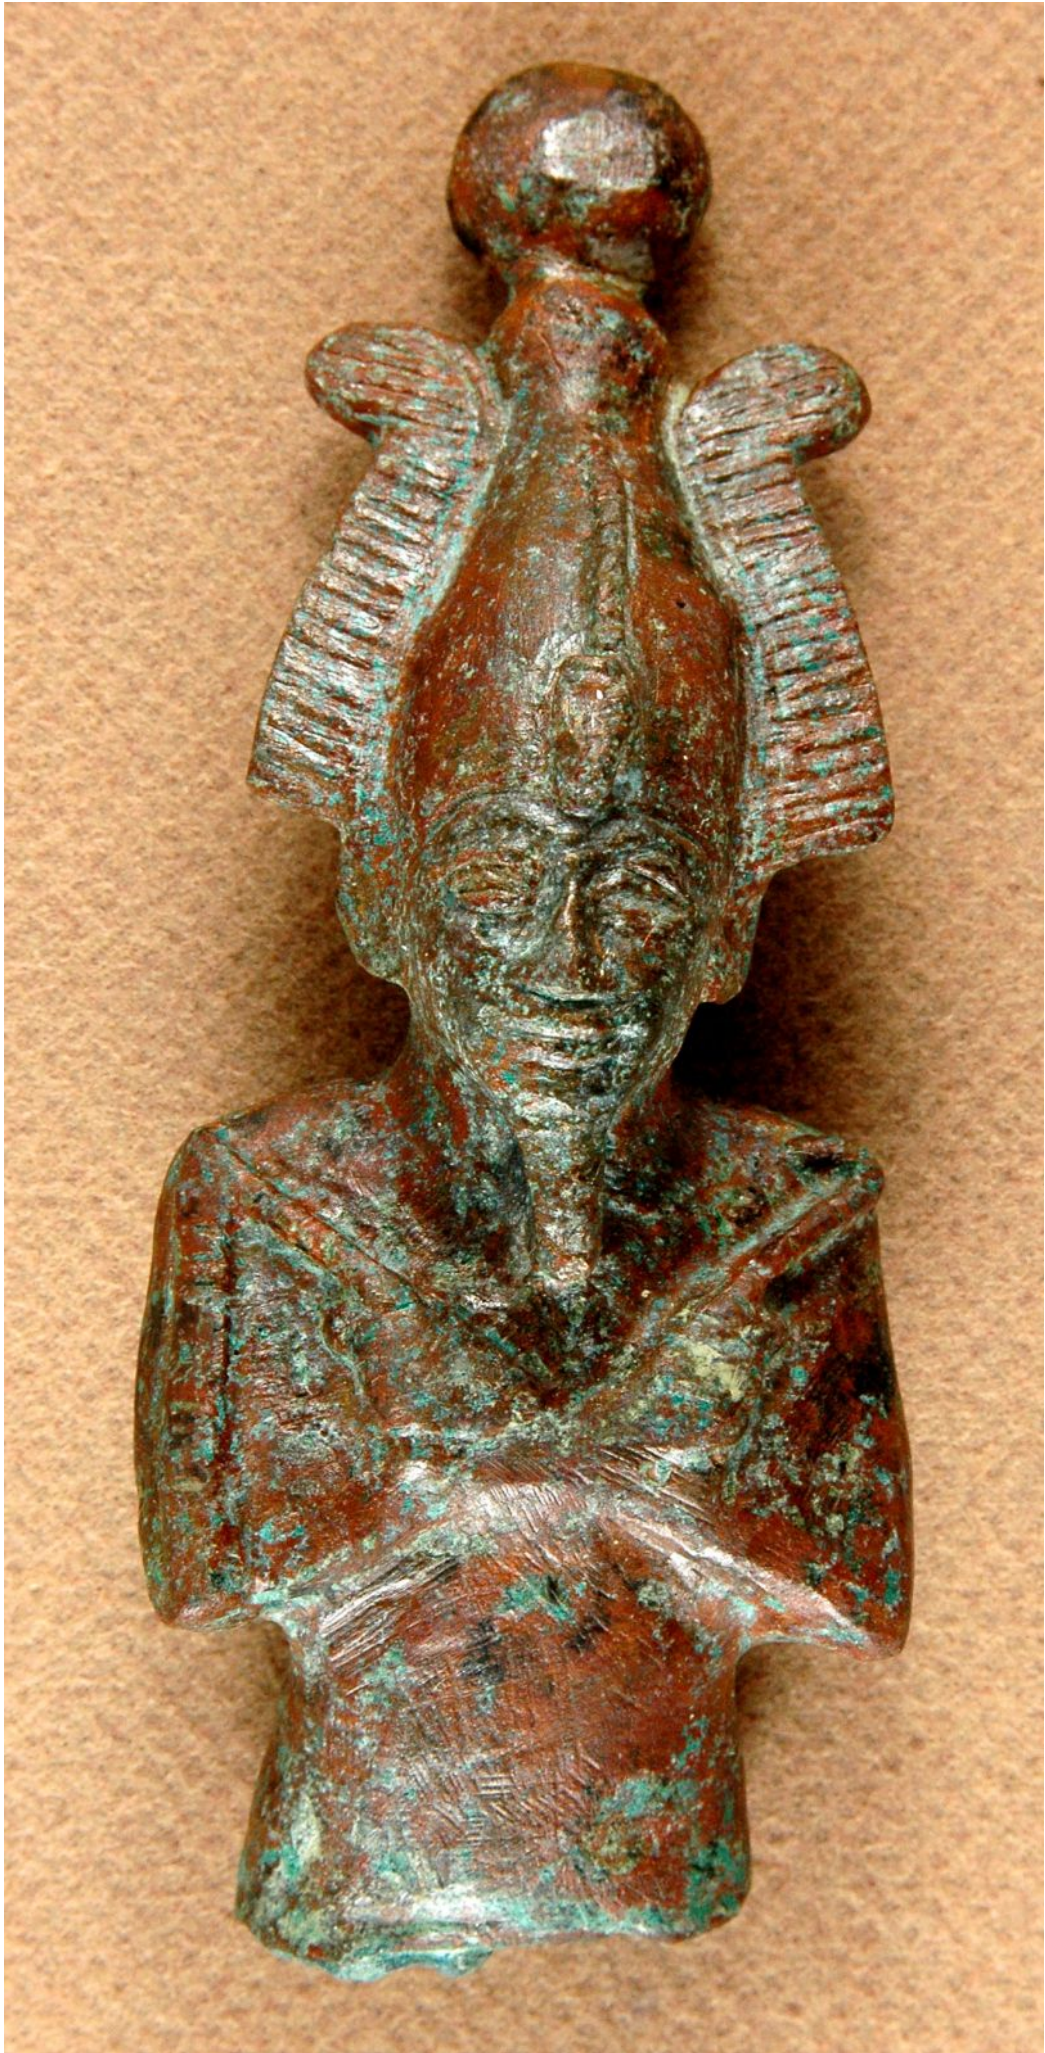
Plate 5: Area 4.1. A sample of Osiris bronze statuettes.

From the same context of the coffins came a cluster of 40 miniature pottery vessels and about 45 bronze fragments of Osiris statuettes and pendants.⁹ The restoration of the bronzes revealed the presence of statues of different sizes, with inlaid eyes and gilded surfaces (Plate 5).¹⁰ Among these figurines one is of particular interest, being made of unfired clay. Osiris figurines are very common finds in animal necropoleis and in the related temples.¹¹ The difficulty of dating them precisely through a stylistic analysis is well known, and our objects are no exception in this regard.

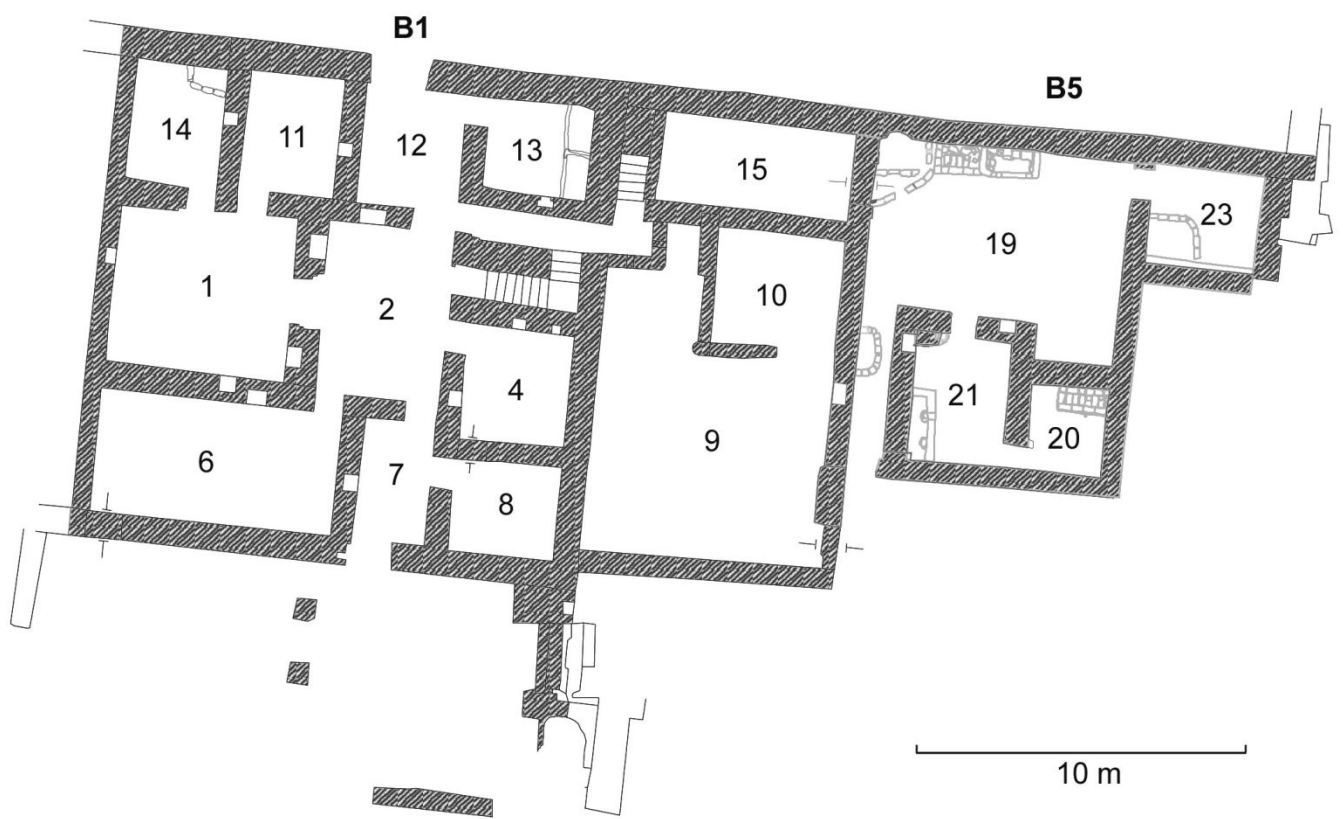
Plate 7: Area 2.1. Plan of the last phase of B1 and B5 (around 365 CE).

The excavation of the interior of Serenos' house (labelled B1) ended in 2007 with the investigation of the western half of the building and of the courtyard (fPlates 6, 7).¹² A second entrance from the western alley was found, leading to a vestibule (R 12) that gave access to the central Room 2 and to Room 13 (Plate 8). Two phases of use are evident in R 13: during the earlier phase the walls were painted in purple and decorated with squared panels ("panel style") with classical motifs, on top of which names of Greek gods like Dionysos and Hephaistos were written. During the second phase, the room underwent a restoration due to the shifting of the western wall towards the west, and it was transformed into a sort of storeroom: the walls were painted with whitewash, and two square bins were added abutting the North wall.

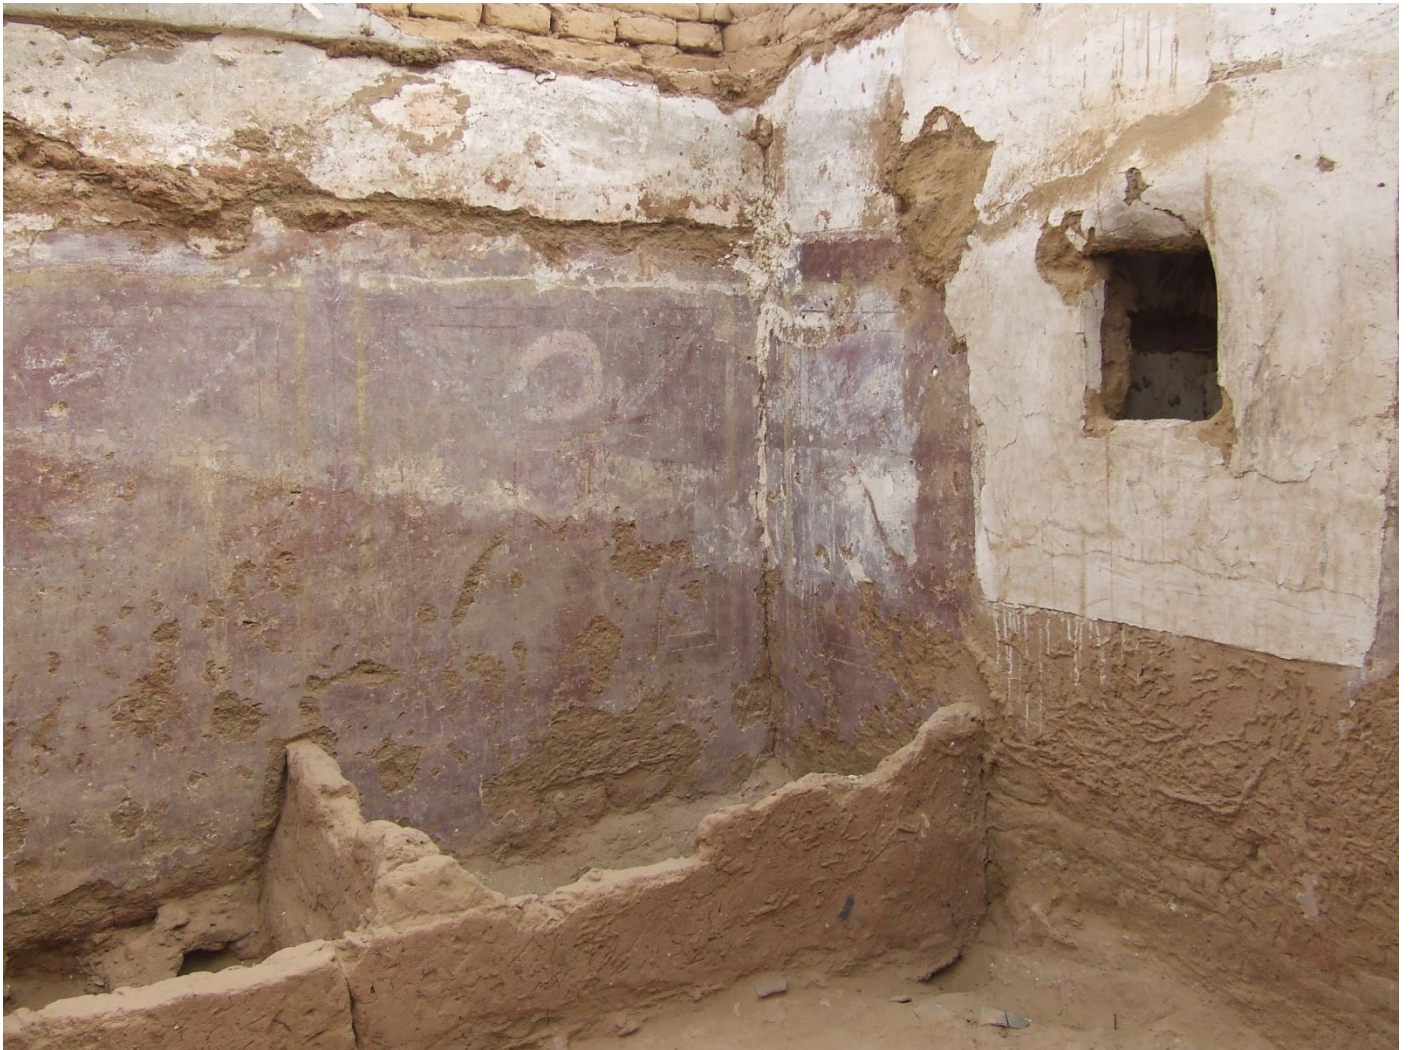
Plate 8: Room 13 in Serenos' house, with purple paintings.

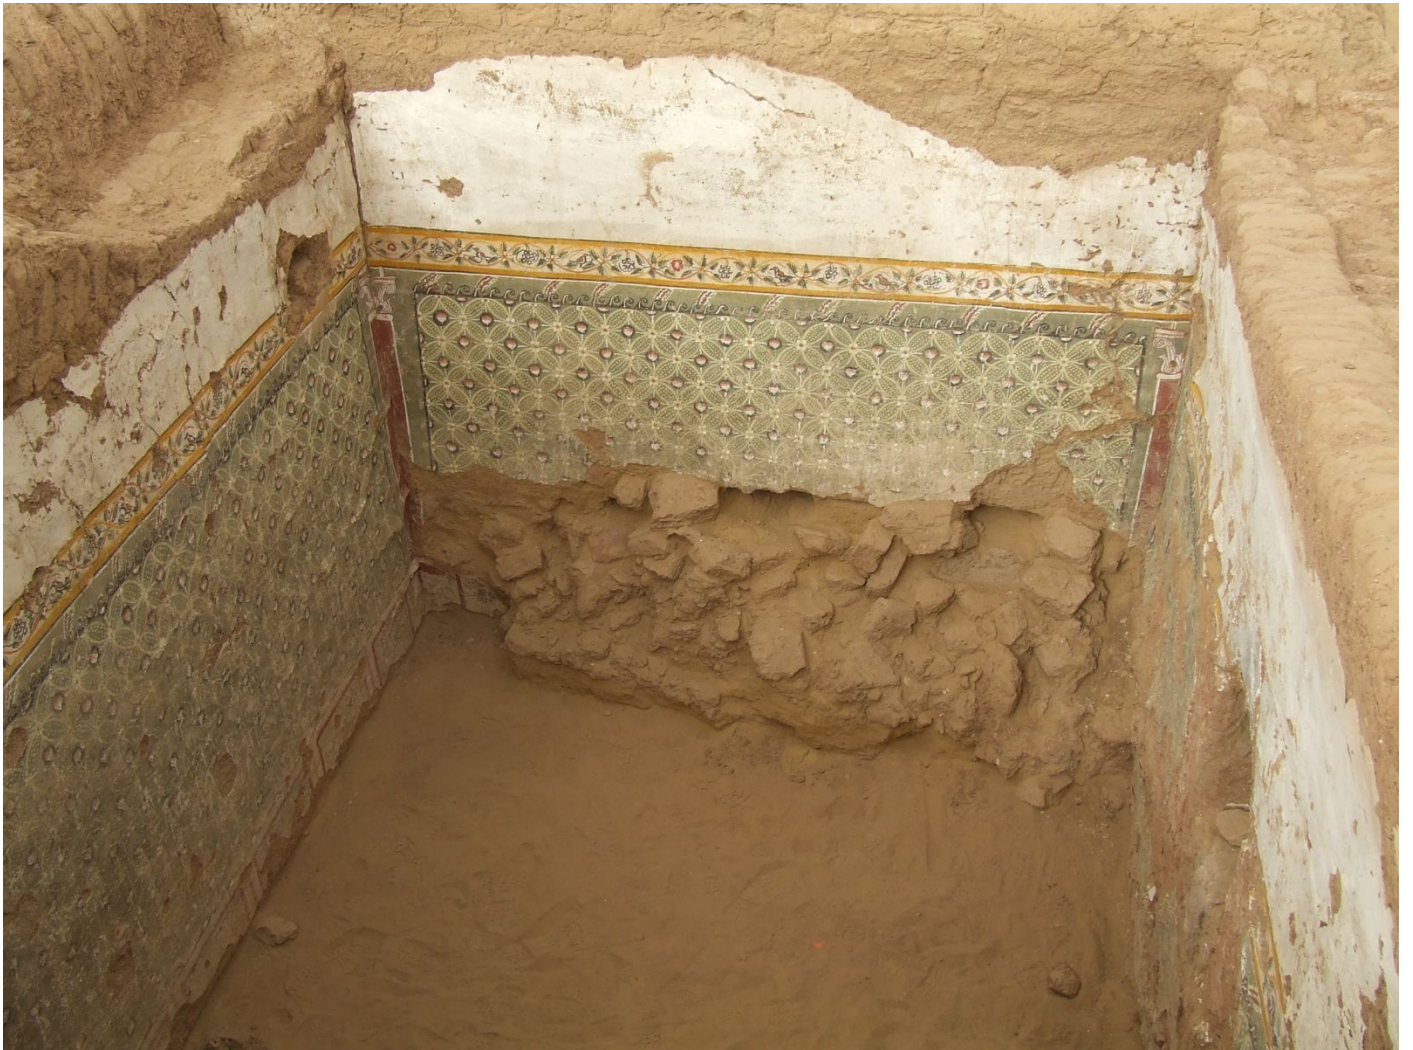
Plate 9: Room 11 in Serenos' house, with green paintings.

Similar damage due to the shifting of the western wall is clearly visible in Room 11, a side space that, like Room 14, was entered by the painted Room 1. These two rooms were decorated with similar patterns, while their barrel vaults were whitewashed. Room 11 is painted with a green background up to 1.7 m above the floor (Plate 9). A geometric design of intersecting yellow circles with a rose petal in the centre fills the central rectangular panel on each wall.¹³ This "wall-paper" pattern, following the effective definition of Helen Whitehouse, is topped by a band of vine leaves, grapes, flowers, and birds. Columns or pillars with Corinthian capitals flank the panels at the corners of the room. A similar decorative pattern, but simpler and on a red background, covers the walls in Room 14 (Plate 10). In both R 11 and 14 the excavation was not complete because of the precarious stability of two walls.

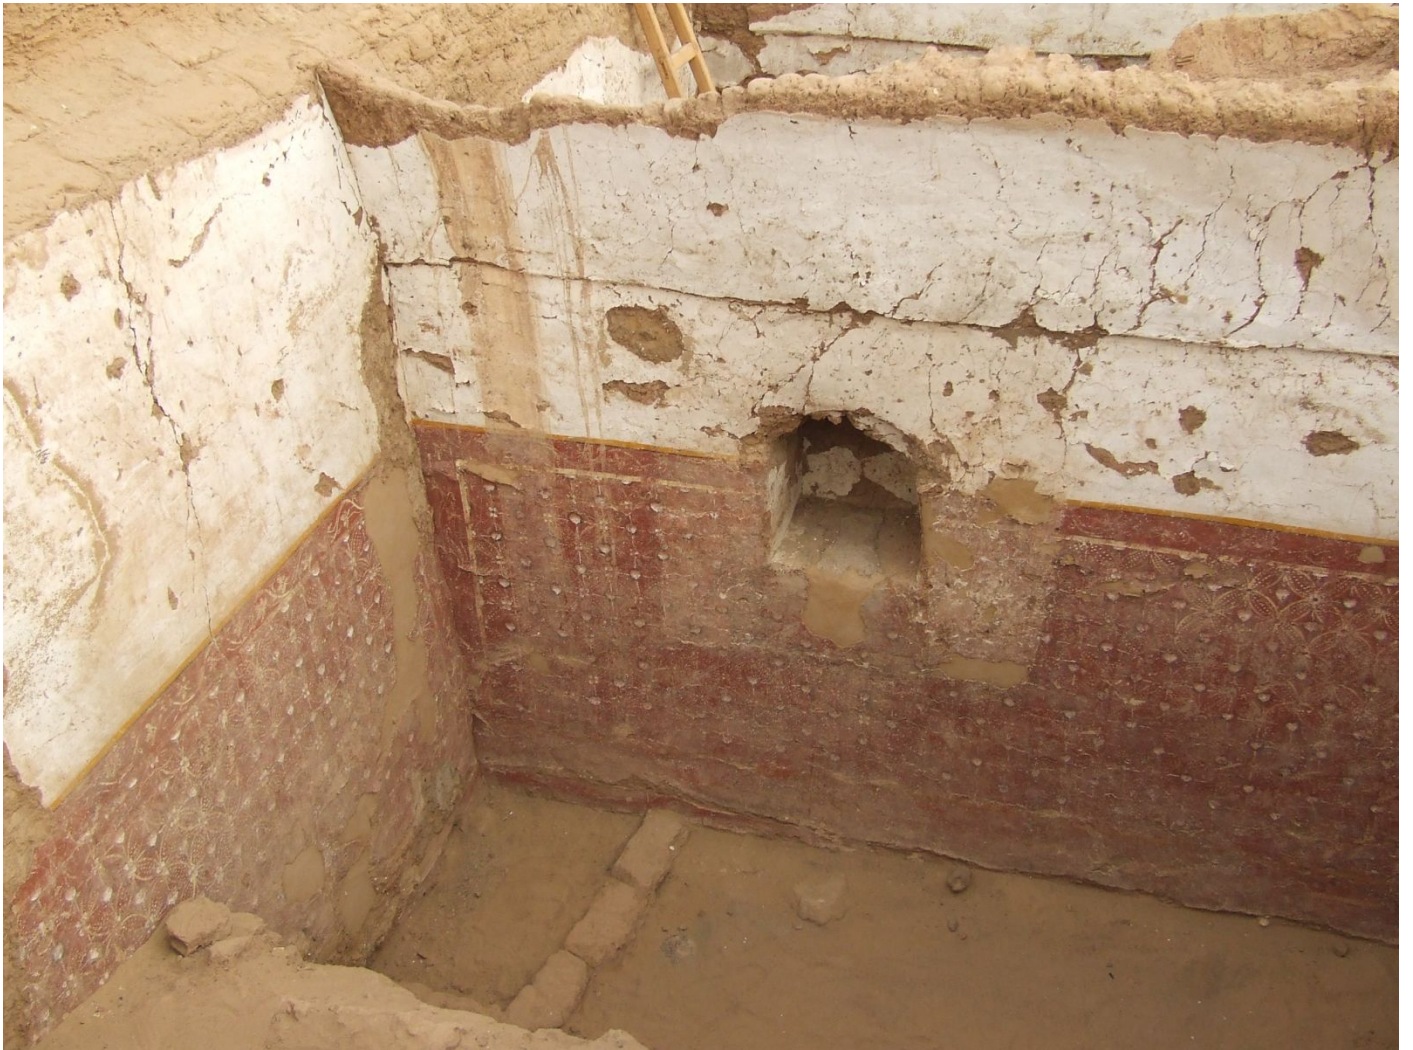
Plate 10: Room 14 in Serenos' house, with red paintings.

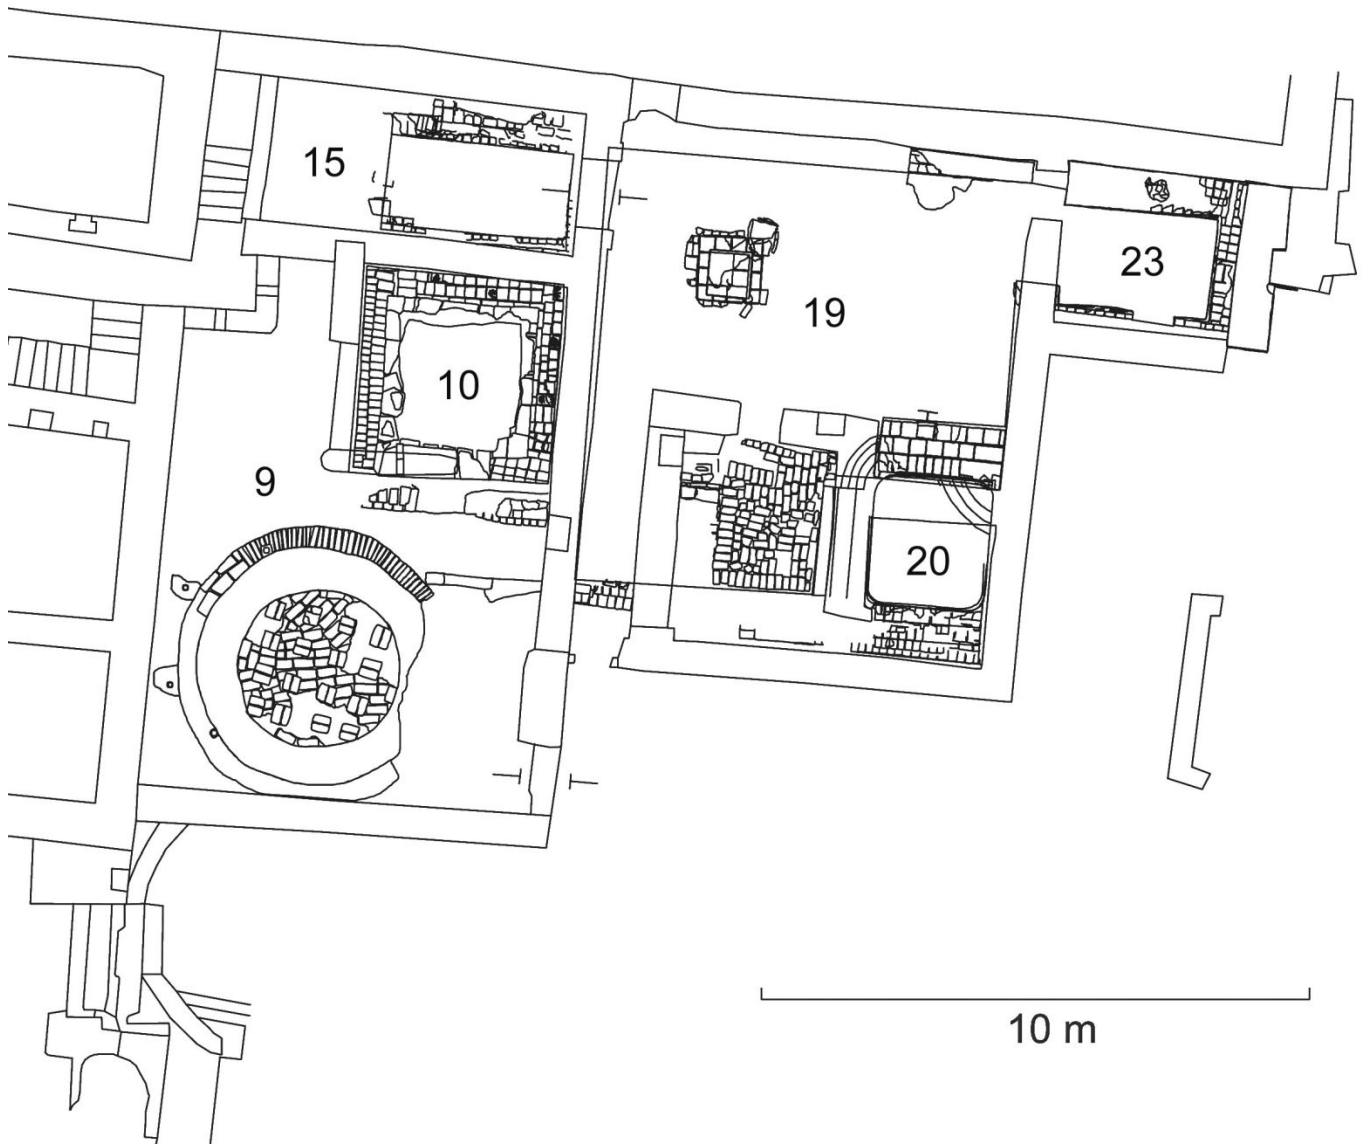
Plate 12: *Thermae* layer in R 9 and 10: plan of the *laconicum* and *latrina*.

The most impressive feature of the *thermae* preserved in this area is a round mud-brick room with a hypocaust in baked bricks (Plate 13). It can be identified as a *laconicum* or a hot dry-steamed room, which was heated by hot air under the floor. It should have been connected with the *latrina*, but their entrances disappeared during the destruction of the building. This circular room has a diameter of about 4.3 m and was built in mud-brick, with a baked tile floor resting on the hypocaust.¹⁵ The wall and the floor were lime plastered. The floor or *suspensura* is quite thin, being made by tiles and white plaster for a thickness of no more than 8 cm.¹⁶ Probably for this reason, the floor was repaved with wooden planks fixed with iron nails to some crossing beams set on

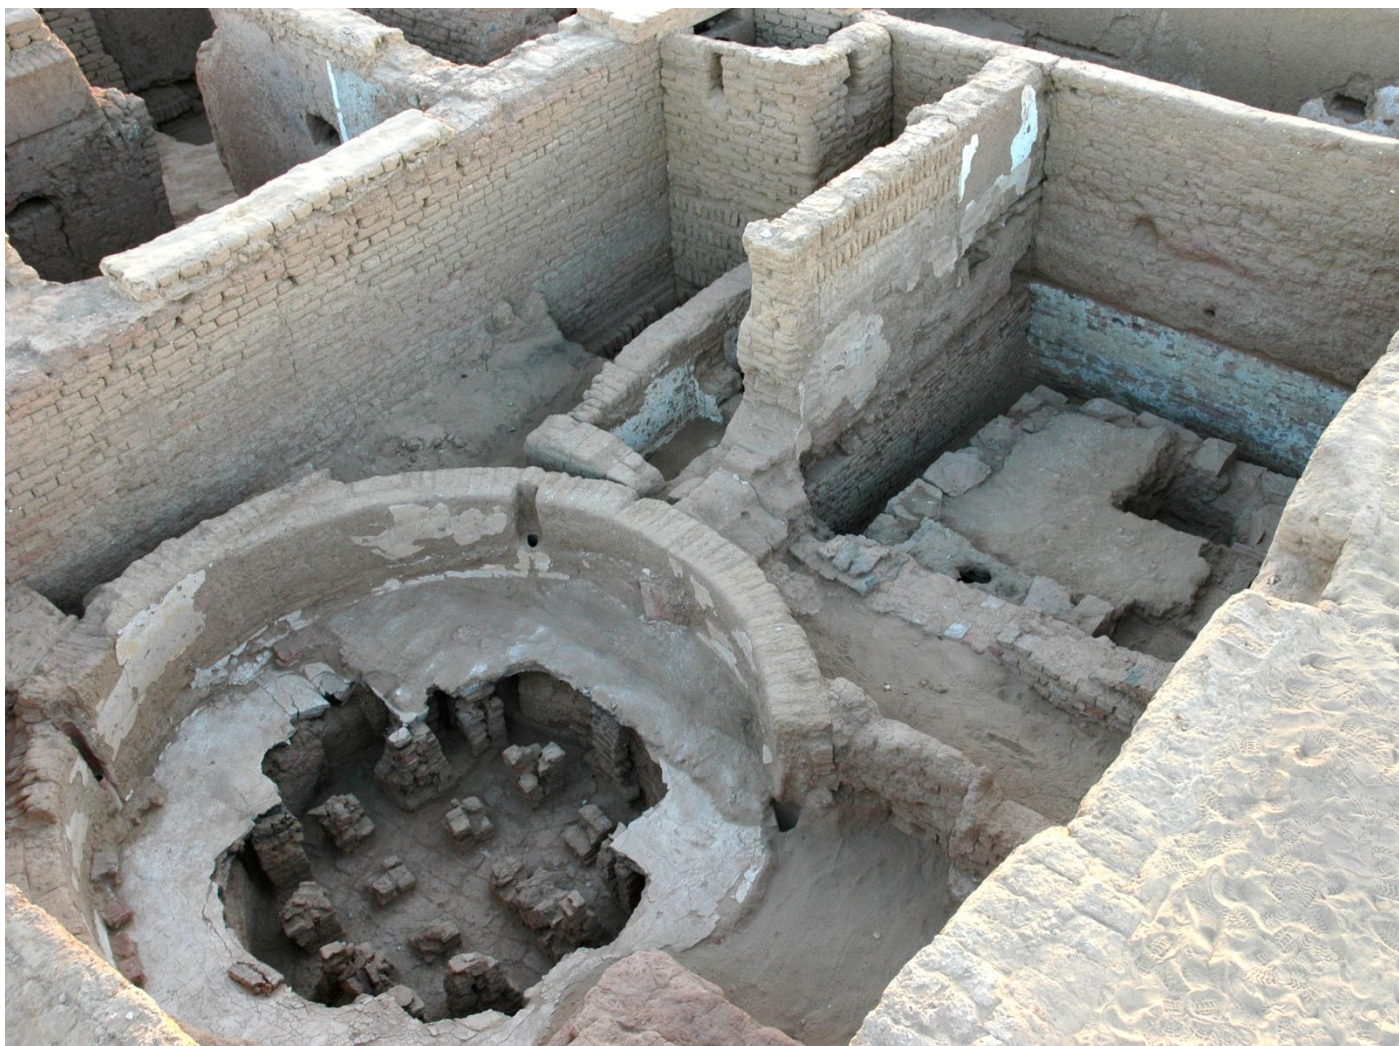
Plate 13: *Thermae* layer in R 9 and 10: the *laconicum* and *latrina*.

The hypocaust was realized directly into the *gebel* and has a diameter of 2.9 m and a depth of 0.85 m, with 16 freestanding baked brick pillars (*pilae*) set on a mud brick floor. They are arranged on 4 rows of 4 pillars each. The channel that conveyed hot air enters the hypocaust from the south and was dug into the *gebel*. A similar round room was found in the 2009 season but has not yet been excavated, located outside the courtyard to the east, below the level of the street flanking this block of houses.

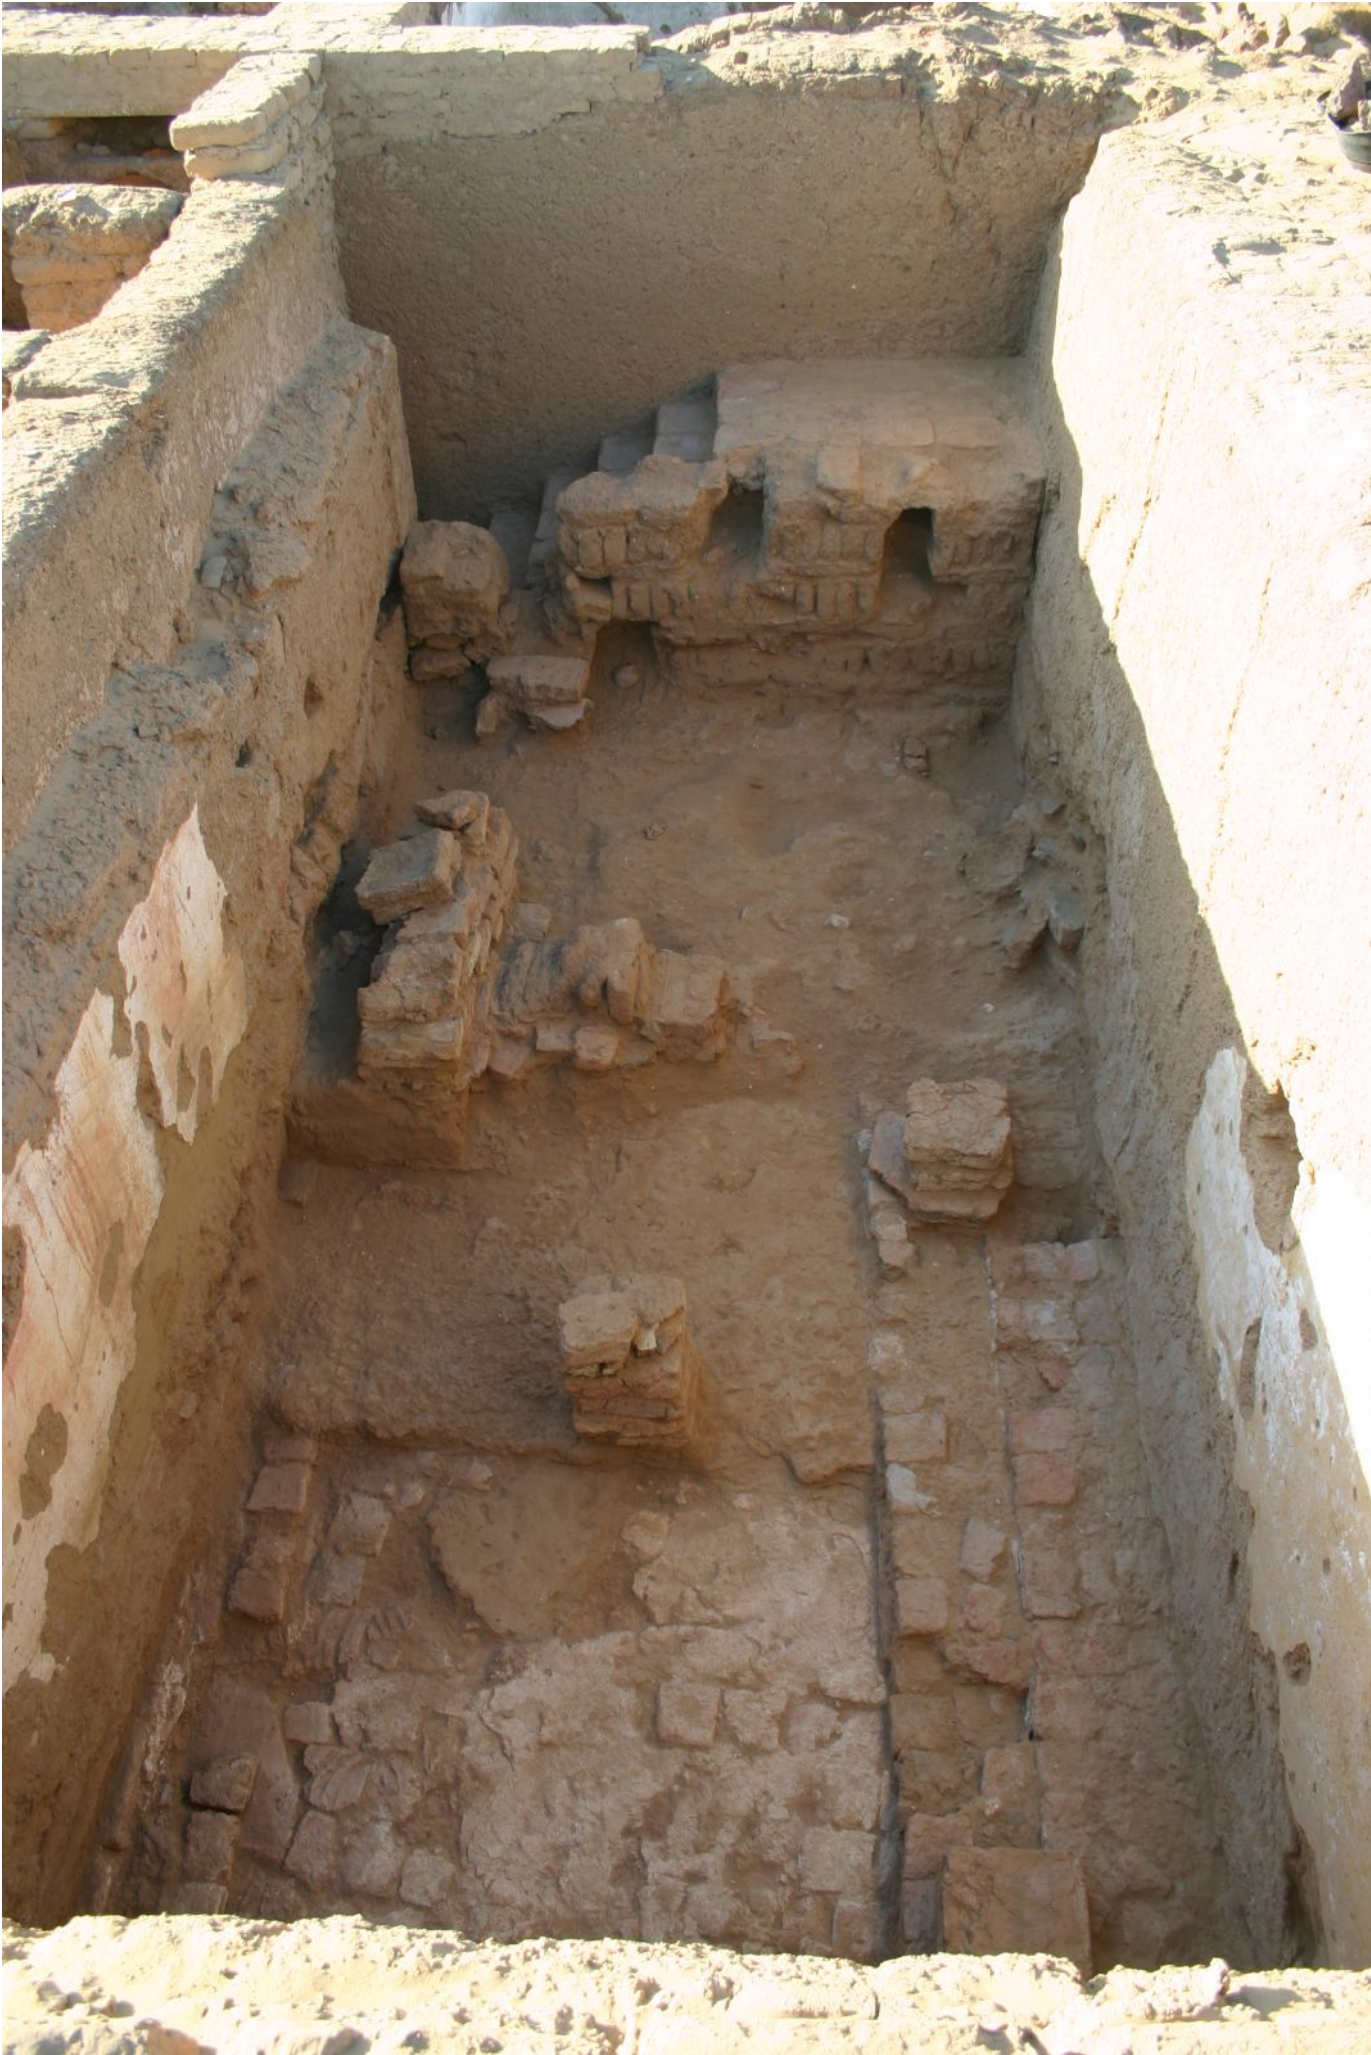
Plate 14: Room 15 view towards South. In the foreground is the backed-brick floor of a *thermae* room. To the left is the wall with the teacher's dipinto.

During the 2008 season the excavation was extended northward to investigate a building (B 5), which was linked to R 15 through a door originally opened in its north wall (Plate 16). Room 15 was already excavated in 2006 and turned out to be originally a school room annexed to Serenos' house in a second phase and then transformed into a storeroom. During the school phase, a Greek literary text was painted in red by a teacher on the white plaster of the east wall.¹⁷ The door that originally connected R 15 with R 19 was blocked off with a wall when the room was annexed to the house. It was evident that the room to the north, Room 19, was originally part of the same school building with R 15. In fact, other two literary texts were painted in red on the white plaster of the west wall in R 19 (Plate 17). However, it is also clear that the building soon changed its function and underwent two major remodelling phases.

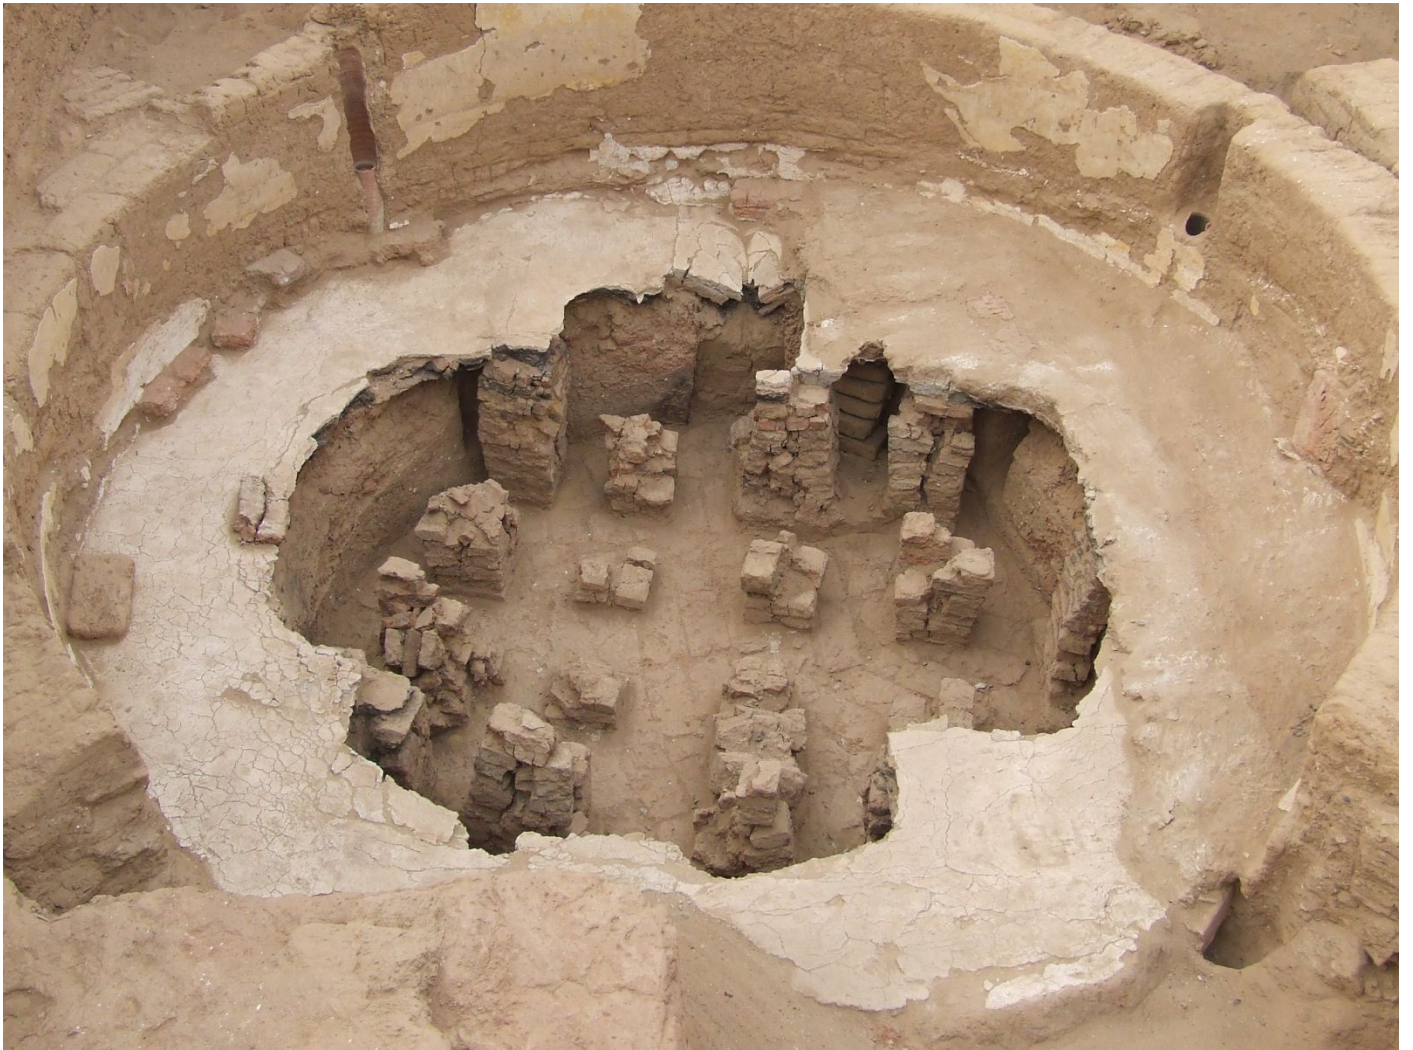
Plate 15: Detail of the *laconicum* and the hypocaust.

series of mud and baked bricks within a mud layer 10 cm thick. Unfortunately only the nails and the impressions of the planks survived (Plate 15).
