Amheida 2007-2009: New Results from the Excavations

Paola Davoli

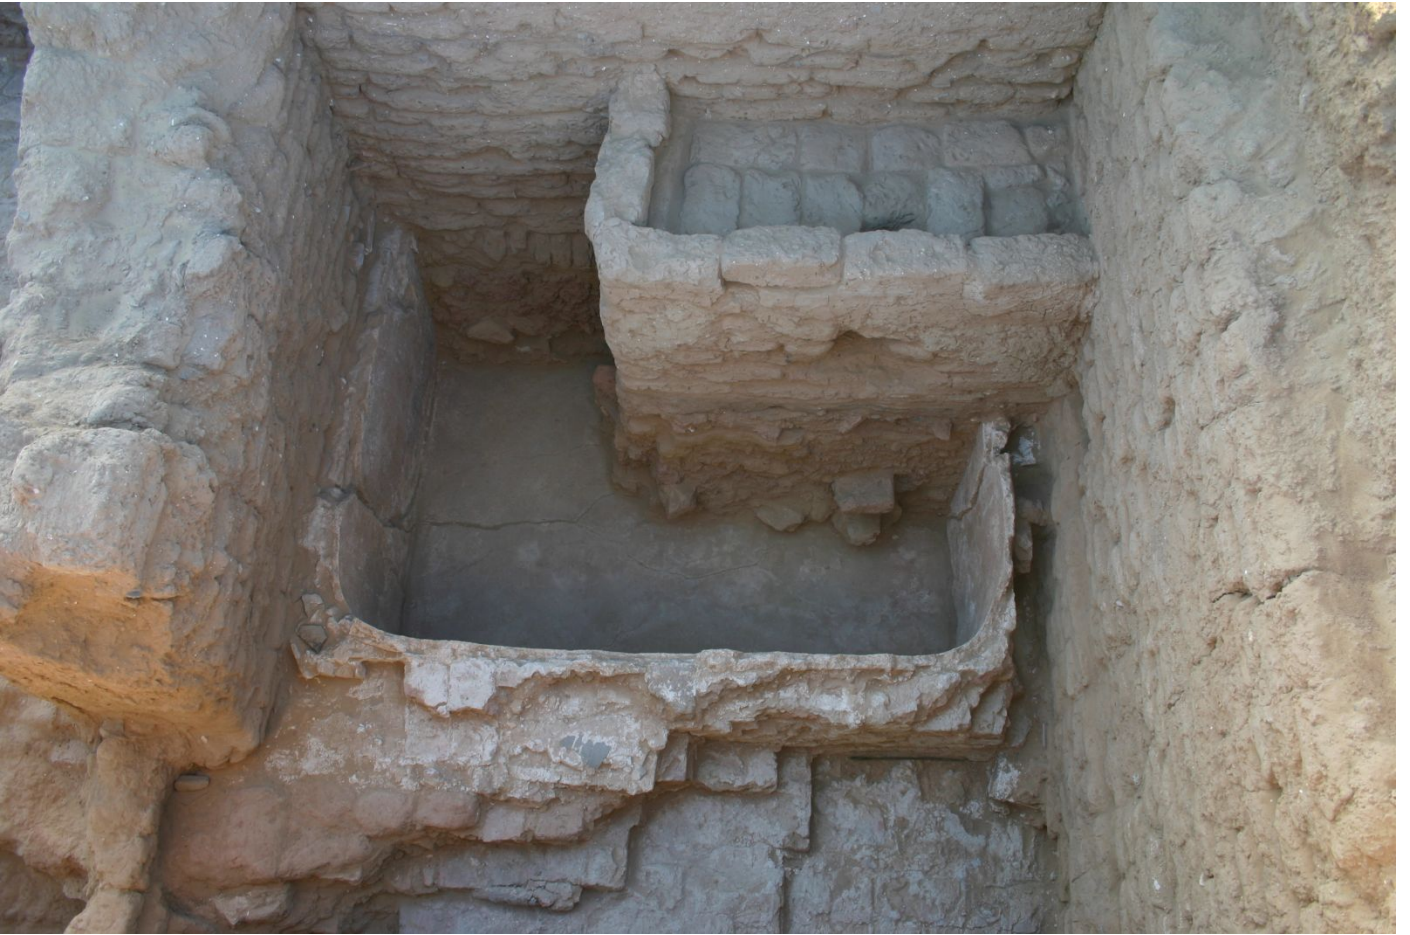
Plate 18: Room 20 in B5. Water basin of the *thermae* layer below a mud-brick bin.

Several walls belonging to earlier phases were found under the mud floors. Some of them subdivided R 19 into three smaller rooms with an unknown function. These walls were built on top of a debris layer that covered the remains of the *thermae*, which extended far beyond the courtyard area (R 9 and 10): Room 19 was built on top of what appears to be a wide rectangular space in which water was used. The floor was roughly made with backed-brick tiles and bricks and was covered by a thick layer of waterproof lime plaster. The base (1.20 x 1.20 m) of a squared pillar on which probably a *labrum* once stood was identified in the middle of R 19. The broken limestone *labrum* has been found next to it on the floor.¹⁸ The excess water present into the room drained into the *latrina* through a hole placed at floor level in the south wall. A baked-brick shallow platform was at the northeastern corner of this wide room. Only part of it was demolished, and it is still possible to reconstruct its shape and function. It measured 4.3 m east-west and was approximately 1 meter in height. At its centre a sunken basin (2.35 x 2.15 m) or tub one meter deep was made with waterproof plaster (Plate 18). Three round steps in a corner, now covered by a mud-brick bin, allowed for a gradual immersion into the water.

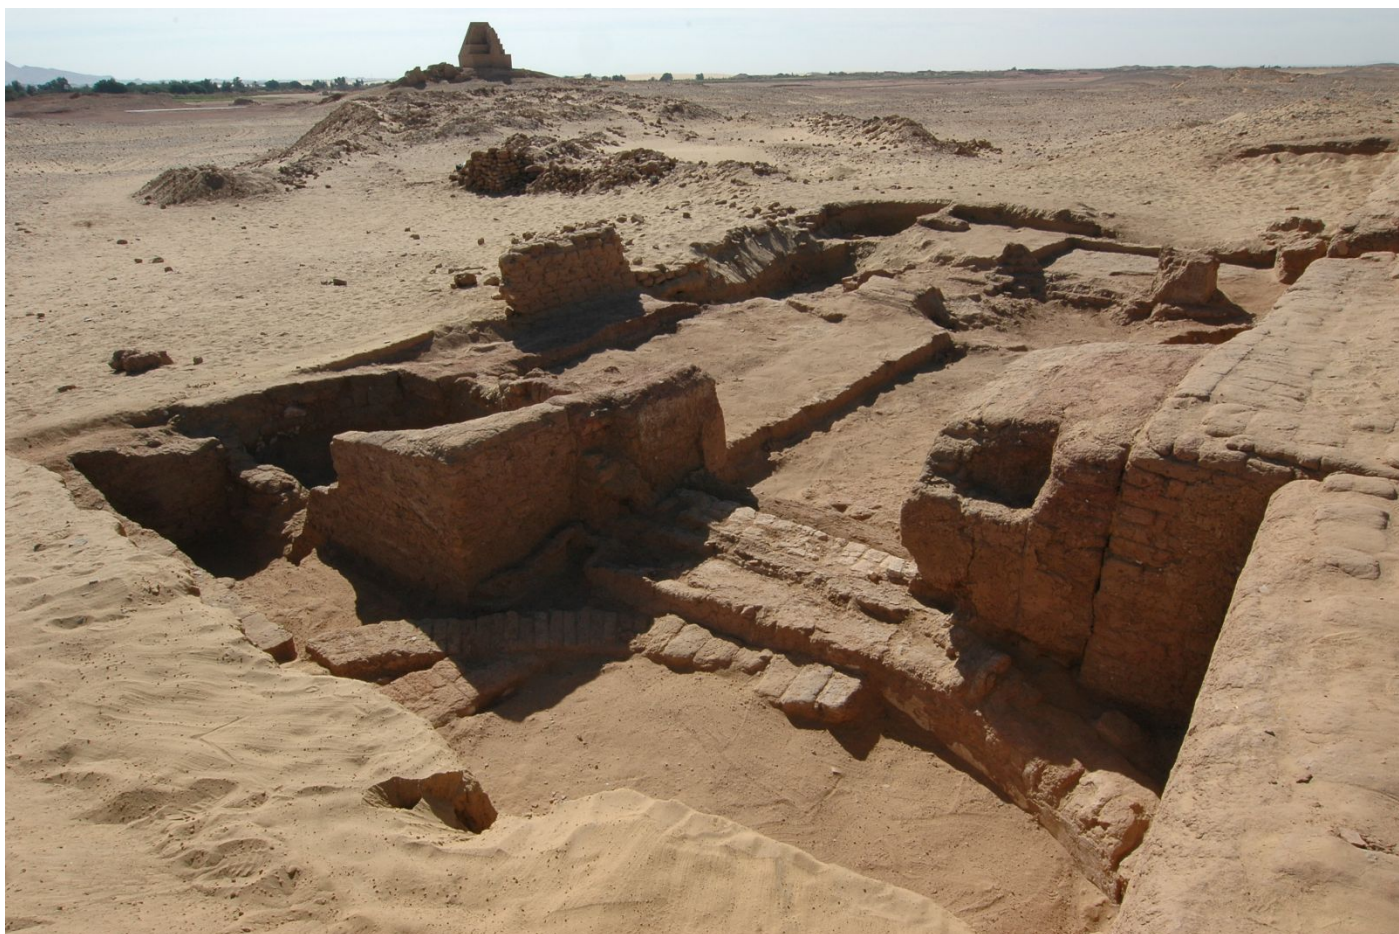
Plate 19: The street on the East side of Serenos' house and the gate (view towards South-East).

During the short 2009 season, a trench of 10 by 7 meters was cut in the north-south oriented street running in front of the eastern entrance of Serenos' house (building B1). Three superimposed floor levels of this street, which is 6 m wide, have been identified. On the latest one the impression of three east-west oriented beams was clearly visible. These impressions together with others of reeds on several flat pieces of mud support the hypothesis that a flat roof covered at least this portion of the street. The access to the street from the north was blocked by a doorway or gate built at the northeast corner of the house, of which only the two mud brick jambs and the threshold remain (Plate 19).
